## Profile/Photo Observation Report

Date:	<b>01/25/2025</b>	Weather:		Coding:	<b>PACP 7.0</b>
Pipe Length (ft):	<b>281.0</b>	Owner:	<b>City of Hobart</b>	Pre Clean:	<b>Heavy Cleaning</b>
P.O.#:	<b>YES502259</b>	Surveyor:	<b>Steven Bucklin</b>	PSR:	<b>P-303-004-003</b>
Customer:	<b>City of Hobart</b>	Clean Date:	<b>10/14/2024</b>	Shape:	<b>C</b>

Street:	<b>Ridgelawn Drive</b>	Flow Control:	<b>Not Controlled</b>
City:	<b>Hobart, IN</b>	Year Renewed:	
Location:	<b>Local rural streets with light traffic, t</b>	Tape/Media #:	
Purpose:	<b>Sewer System Evaluation Survey (SS</b>	Dia/Height:	<b>18"</b>
Use:	<b>Sanitary Sewage Pipe</b>	Material:	<b>VCP</b>
Drain Area:		Lining:	<b>None</b>
Category:	<b>NA</b>		
Comment:			
Location Details:	<b>GRAVEL DRIVEWAY APPROACH</b>	Direction of Survey:	<b>Downstream</b>
US MH:	<b>M-303-004</b>	DS MH:	<b>M-303-003</b>
		Total Length Surveyed (ft):	<b>293.7</b>

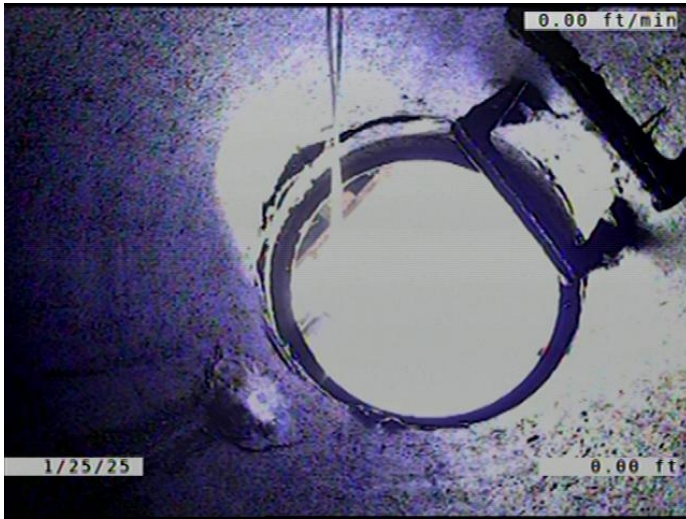
Code: **AMH**  
Description: **Manhole**

Distance (ft): **.0**  
Structural Grade: **0**  
O&M Grade: **0**  
Clock Start/From:  
Clock To:  
1st Value:  
2nd Value:  
Value Percent:  
Continuous Index:  
Within 8" of Joint: **NO**  
Remarks: **M-303-004**

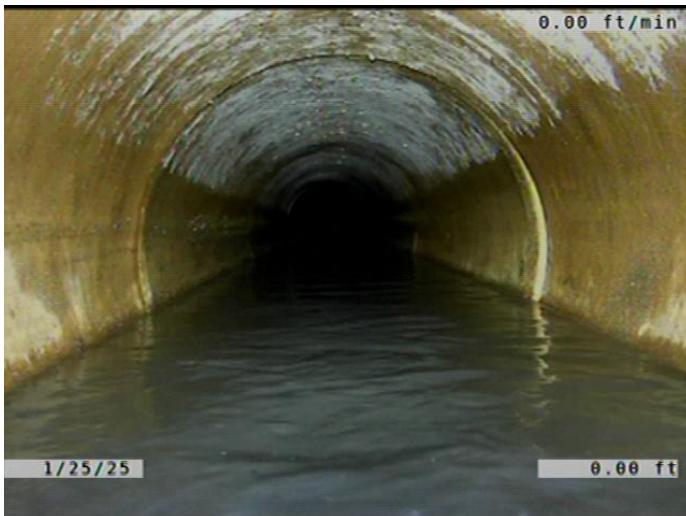
Code: **MWL**  
Description: **Miscellaneous Water Level**

Distance (ft): **.0**  
Structural Grade: **0**  
O&M Grade: **0**  
Clock Start/From:  
Clock To:  
1st Value:  
2nd Value:  
Value Percent: **35.000**  
Continuous Index:  
Within 8" of Joint: **NO**  
Remarks:

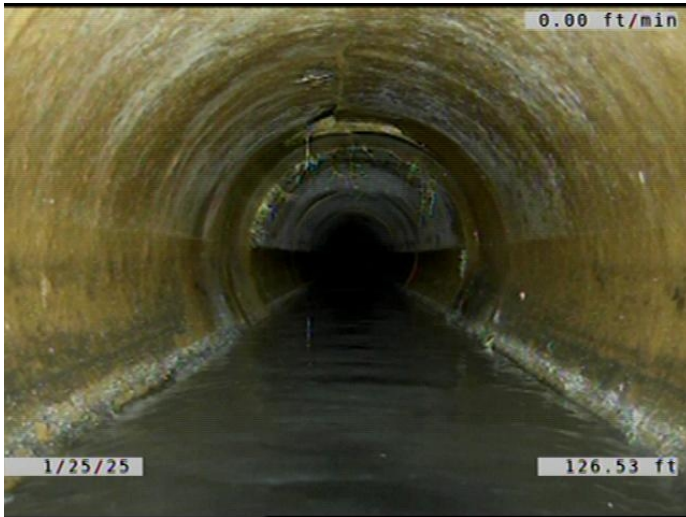
Code: **MWL**  
Description: **Miscellaneous Water Level**

Distance (ft): **126.5**  
Structural Grade: **0**  
O&M Grade: **0**  
Clock Start/From:  
Clock To:  
1st Value:  
2nd Value:  
Value Percent: **20.000**  
Continuous Index:  
Within 8" of Joint: **NO**  
Remarks:

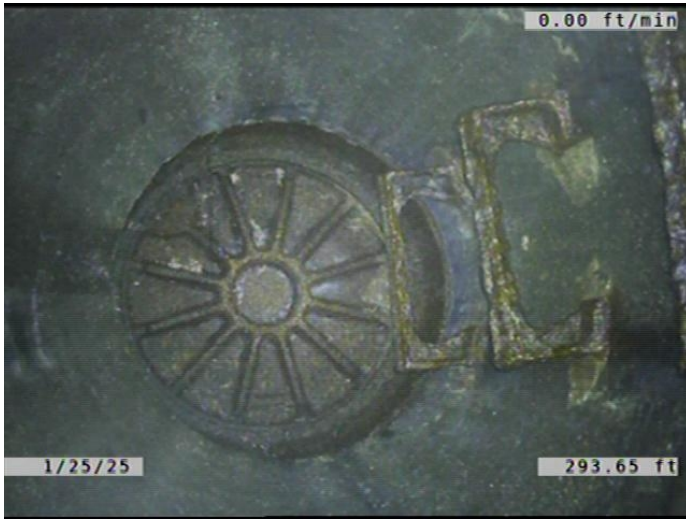
Code:	<b>AMH</b>
Description:	<b>Manhole</b>
Distance (ft):	<b>293.6</b>
Structural Grade:	<b>0</b>
O&M Grade:	<b>0</b>
Clock Start/From:	
Clock To:	
1st Value:	
2nd Value:	
Value Percent:	
Continuous Index:	
Within 8" of Joint:	<b>NO</b>
Remarks:	<b>M-303-003</b>
