## Profile/Photo Observation Report

Date:	<b>01/25/2025</b>	Weather:		Coding:	<b>PACP 7.0</b>
Pipe Length (ft):	<b>367.0</b>	Owner:	<b>City of Hobart</b>	Pre Clean:	<b>Heavy Cleaning</b>
P.O.#:	<b>YES502259</b>	Surveyor:	<b>Steven Bucklin</b>	PSR:	<b>P-303-073-004</b>
Customer:	<b>City of Hobart</b>	Clean Date:	<b>10/13/2024</b>	Shape:	<b>C</b>

Street:	<b>Ridgelawn Drive</b>	Flow Control:	<b>Not Controlled</b>
City:	<b>Hobart, IN</b>	Year Renewed:	
Location:	<b>Easement/Right of Way</b>	Tape/Media #:	
Purpose:	<b>Sewer System Evaluation Survey (SS</b>	Dia/Height:	<b>18"</b>
Use:	<b>Sanitary Sewage Pipe</b>	Material:	<b>VCP</b>
Drain Area:		Lining:	<b>None</b>

US MH: **M-303-073** DS MH: **M-303-004** Total Length Surveyed (ft): **363.5**

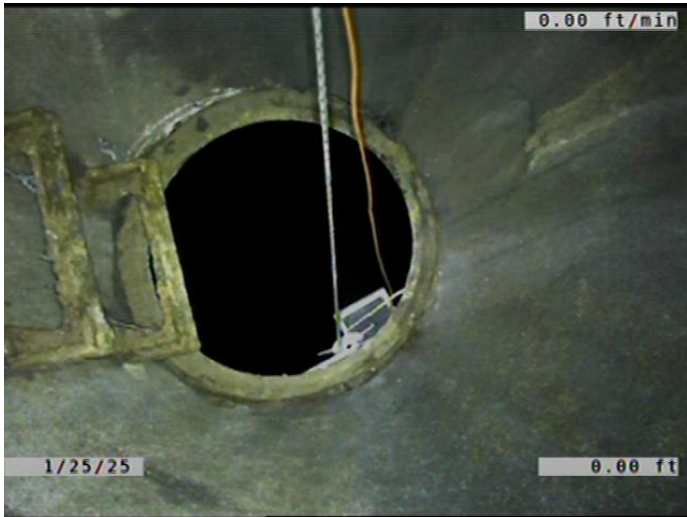
Code: **AMH**  
Description: **Manhole**

Distance (ft): **.0**  
Structural Grade: **0**  
O&M Grade: **0**  
Clock Start/From:  
Clock To:  
1st Value:  
2nd Value:  
Value Percent:  
Continuous Index:  
Within 8" of Joint: **NO**  
Remarks: **M-303-004**

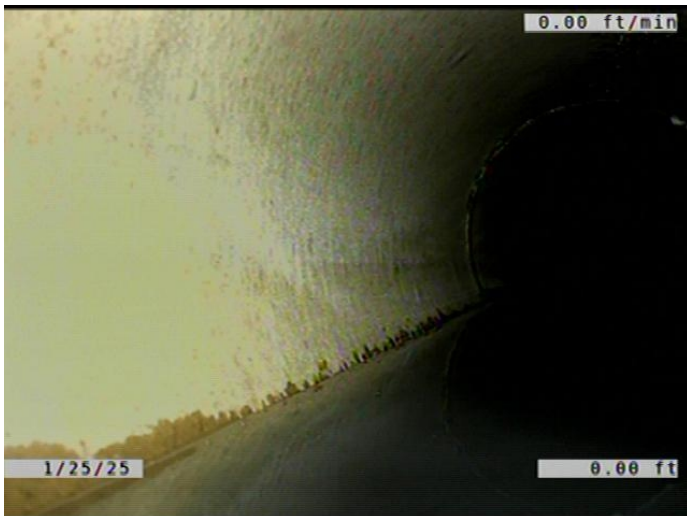
Code: **MWL**  
Description: **Miscellaneous Water Level**

Distance (ft): **.0**  
Structural Grade: **0**  
O&M Grade: **0**  
Clock Start/From:  
Clock To:  
1st Value:  
2nd Value:  
Value Percent: **15.000**  
Continuous Index:  
Within 8" of Joint: **NO**  
Remarks:

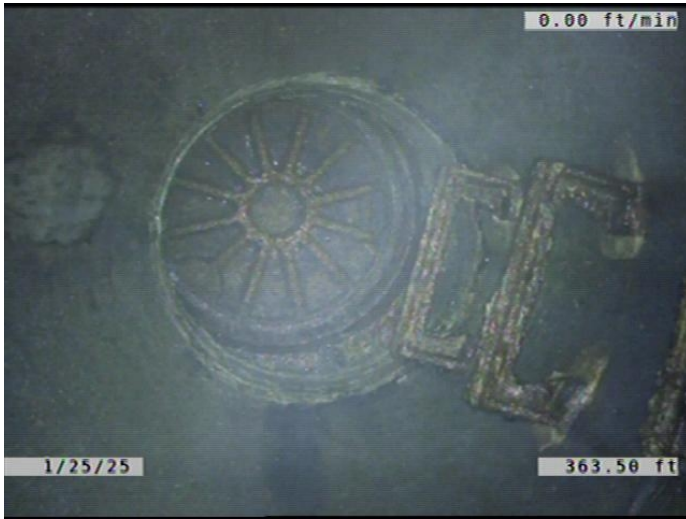
Code:	AMH
Description:	Manhole
Distance (ft):	363.5
Structural Grade:	0
O&M Grade:	0
Clock Start/From:	
Clock To:	
1st Value:	
2nd Value:	
Value Percent:	
Continuous Index:	
Within 8" of Joint:	NO
Remarks:	M-303-073
