Profile/Photo Observation Report

Date:	04/12/2018	Weather:		Coding:	PACP 6.0
Pipe Length (ft):		Owner:	City of Hobart	Pre Clean:	No Pre-Cleaning
P.O.#:	33-1	Surveyor:	M. Pielacha	PSR:	M-303-020-M-303-071
Customer:	City of Hobart	Clean Date:		Shape:	C

Street:	Off 40th Place	Flow Control:	Not Controlled
City:	Hobart, IN	Year Renewed:	
Location:	Light Highway	Tape/Media #:	DEP 33
Purpose:	Routine Assessment	Dia/Height:	6"
Use:	Sanitary	Material:	PVC
Drain Area:		Lining:	
Category:	NA		
Comment:			
Location Details:		Direction of Survey:	Upstream
US MH:	M-303-020	DS MH:	M-303-071
		Total Length Surveyed (ft):	104.8

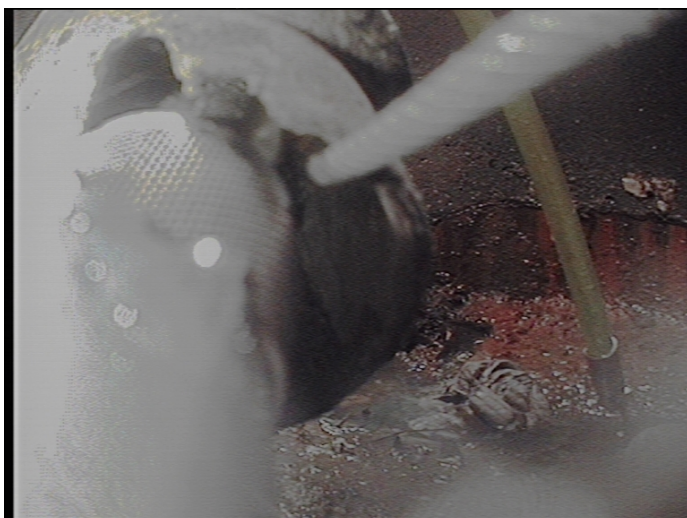
Position	Code	Observation	Video (sec)	Grade
	.0	AMH	Manhole	0	NA
	.0	MWL	Water Level	6	NA
	3.4	MCU(S01)	Camera Underwater	64	M 4
	11.0	MCU(F01)	Camera Underwater	108	M 4
	11.0	DAE(S02)	Deposits Attached Encrustation	111	M 2
	24.8	DAE(F02)	Deposits Attached Encrustation	185	M 2
	24.8	MWL	Water Level	188	NA
	104.8	AMH	Manhole	696	NA
	Code: AMH Description: Manhole Distance (ft): .0 Structural Grade: 0 O&M Grade: 0 Clock Start/From: Clock To: 1st Value: 2nd Value: Value Percent: Continuous Index: Within 8" of Joint: NO Remarks: M-303-071

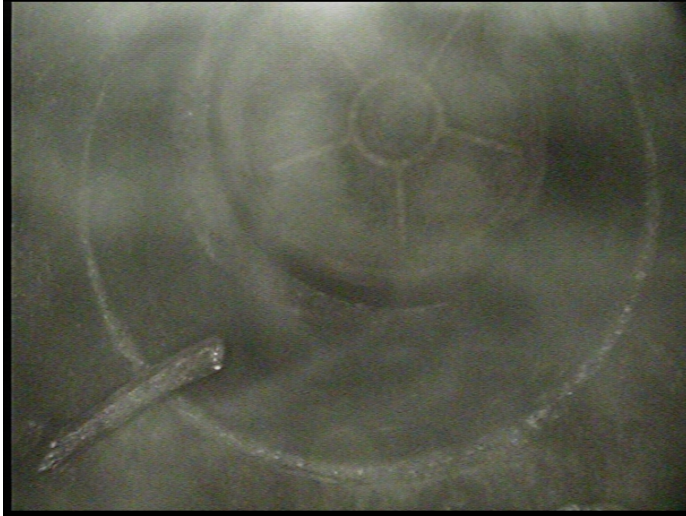
Code:	AMH
Description:	Manhole
Distance (ft):	104.8
Structural Grade:	0
O&M Grade:	0
Clock Start/From:	
Clock To:	
1st Value:	
2nd Value:	
Value Percent:	
Continuous Index:	
Within 8" of Joint:	NO
Remarks:	M-303-020
