Profile/Photo Observation Report

Date:	03/28/2018	Weather:		Coding:	PACP 6.0
Pipe Length (ft):	330.5	Owner:	NA	Pre Clean:	Not Known
P.O.#:		Surveyor:	Selasie Honu	PSR:	P-303-022-021
Customer:		Clean Date:	01/01/1900	Shape:	C

Street:	KENWOOD ST	Flow Control:	Not Controlled
City:	Hobart, IN	Year Renewed:	
Location:	Other	Tape/Media #:	
Purpose:	Not Known	Dia/Height:	10"
Use:	Sanitary	Material:	VCP
Drain Area:	NA	Lining:	
Category:	NA		
Comment:

Location Details:		Direction of Survey:	Upstream
US MH:	M-303-021	DS MH:	M-303-022
		Total Length Surveyed (ft):	151.3

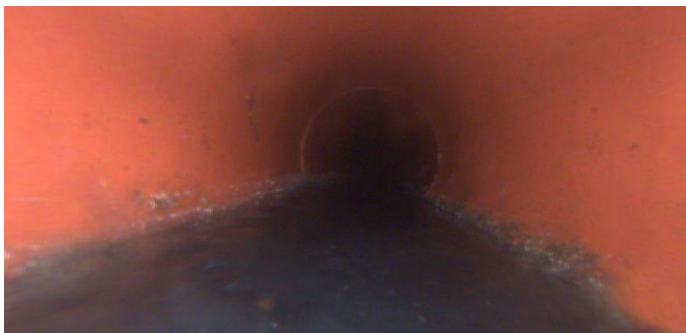
Code: **AMH**
Description: **Manhole**

Distance (ft): **.0**
Structural Grade: **0**
O&M Grade: **0**
Clock Start/From:
Clock To:
1st Value:
2nd Value:
Value Percent:
Continuous Index:
Within 8" of Joint: **NO**
Remarks: **M-303-022**

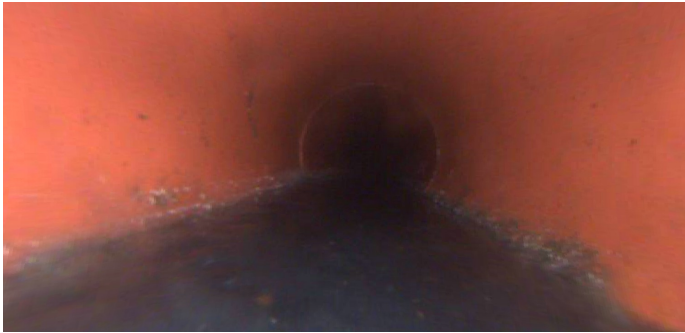
Code:	MWL
Description:	Water Level

Distance (ft):	.0
Structural Grade:	0
O&M Grade:	0
Clock Start/From:	
Clock To:	
1st Value:	
2nd Value:	
Value Percent:	5.000
Continuous Index:	
Within 8" of Joint:	NO
Remarks:
