## Profile/Photo Observation Report

Date:	<b>09/25/2018</b>	Weather:		Coding:	<b>PACP 6.0</b>
Pipe Length (ft):	<b>184.8</b>	Owner:	<b>NA</b>	Pre Clean:	<b>Not Known</b>
P.O.#:		Surveyor:	<b>Selasie Honu</b>	PSR:	<b>P-303-025-024</b>
Customer:		Clean Date:	<b>01/01/1900</b>	Shape:	<b>C</b>

Street:	<b>Maxwell St</b>	Flow Control:	<b>Not Controlled</b>
City:	<b>Hobart, IN</b>	Year Renewed:	
Location:	<b>Light Highway</b>	Tape/Media #:	
Purpose:	<b>Routine Assessment</b>	Dia/Height:	<b>10"</b>
Use:	<b>Sanitary</b>	Material:	<b>VCP</b>
Drain Area:	<b>NA</b>	Lining:	
Category:	<b>NA</b>		
Comment:

Location Details:		Direction of Survey:	<b>Downstream</b>
US MH:	<b>M-303-024</b>	DS MH:	<b>M-303-025</b>
		Total Length Surveyed (ft):	<b>165.0</b>

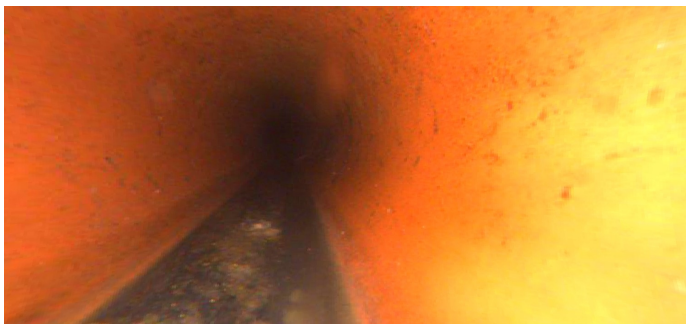
Code: **AMH**  
Description: **Manhole**

Distance (ft): **.0**  
Structural Grade: **0**  
O&M Grade: **0**  
Clock Start/From:  
Clock To:  
1st Value:  
2nd Value:  
Value Percent:  
Continuous Index:  
Within 8" of Joint: **NO**  
Remarks: **M-303-024**

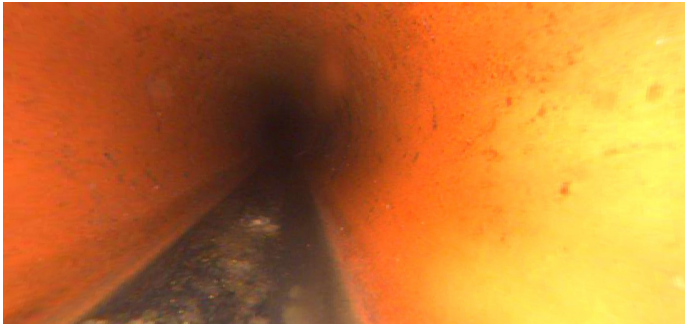
Code:	<b>MWL</b>
Description:	<b>Water Level</b>

Distance (ft):	<b>.0</b>
Structural Grade:	<b>0</b>
O&M Grade:	<b>0</b>
Clock Start/From:	
Clock To:	
1st Value:	
2nd Value:	
Value Percent:	<b>5.000</b>
Continuous Index:	
Within 8" of Joint:	<b>NO</b>
Remarks:

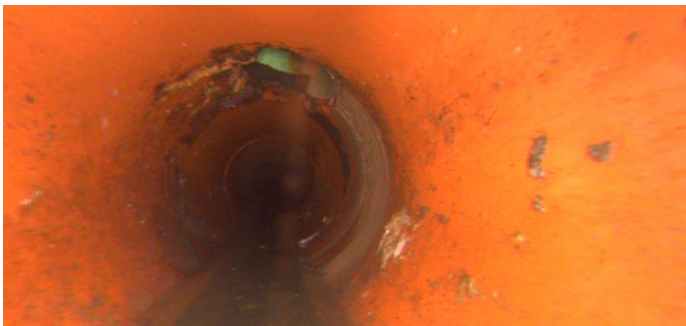
Code: **TF**  
Description: **Tap Factory**

Distance (ft): **42.1**  
Structural Grade: **0**  
O&M Grade: **0**  
Clock Start/From: **12**  
Clock To:  
1st Value: **4.000**  
2nd Value:  
Value Percent:  
Continuous Index:  
Within 8" of Joint:  
Remarks:

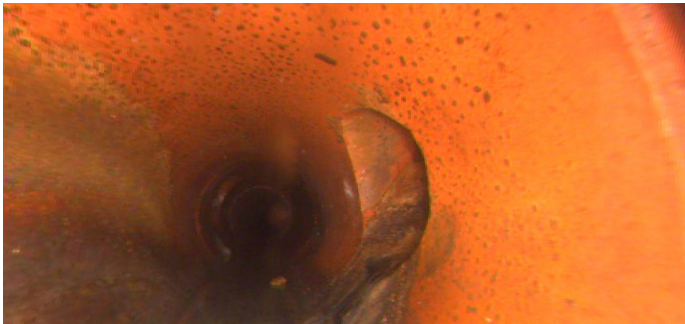
Code: **TF**  
Description: **Tap Factory**

Distance (ft): **69.6**  
Structural Grade: **0**  
O&M Grade: **0**  
Clock Start/From: **10**  
Clock To:  
1st Value: **4.000**  
2nd Value:  
Value Percent:  
Continuous Index:  
Within 8" of Joint:  
Remarks:

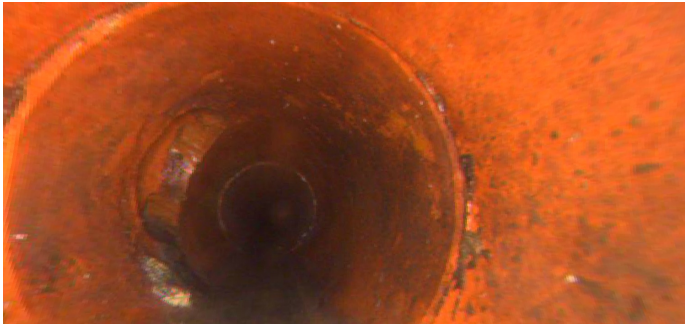
Code: **TF**  
Description: **Tap Factory**

Distance (ft): **71.2**  
Structural Grade: **0**  
O&M Grade: **0**  
Clock Start/From: **10**  
Clock To:  
1st Value: **4.000**  
2nd Value:  
Value Percent:  
Continuous Index:  
Within 8" of Joint:  
Remarks:

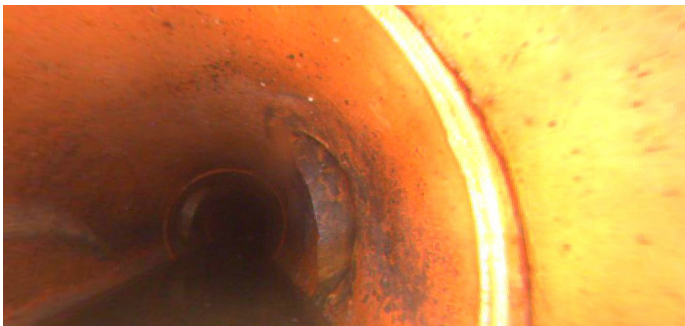
Code: **TF**  
Description: **Tap Factory**

Distance (ft): **148.7**  
Structural Grade: **0**  
O&M Grade: **0**  
Clock Start/From: **3**  
Clock To:  
1st Value: **4.000**  
2nd Value:  
Value Percent:  
Continuous Index:  
Within 8" of Joint:  
Remarks:

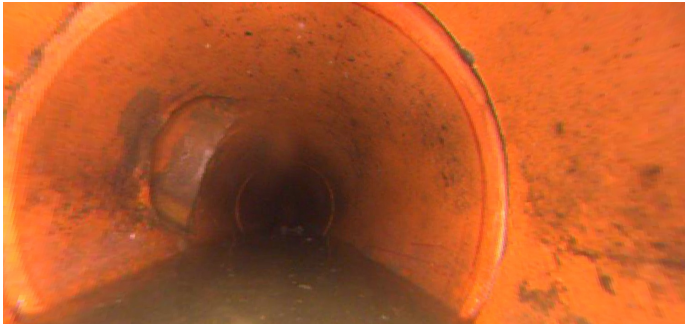
Code: **TF**  
Description: **Tap Factory**

Distance (ft): **150.5**  
Structural Grade: **0**  
O&M Grade: **0**  
Clock Start/From: **9**  
Clock To:  
1st Value: **4.000**  
2nd Value:  
Value Percent:  
Continuous Index:  
Within 8" of Joint:  
Remarks:

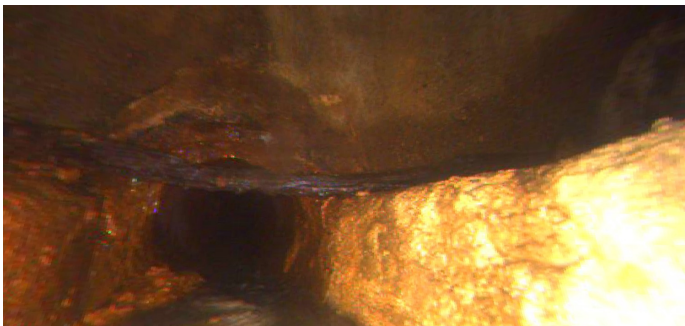
Code: **AMH**  
Description: **Manhole**

Distance (ft): **165.0**  
Structural Grade: **0**  
O&M Grade: **0**  
Clock Start/From:  
Clock To:  
1st Value:  
2nd Value:  
Value Percent:  
Continuous Index:  
Within 8" of Joint: **NO**  
Remarks: **M-303-025**
