Profile/Photo Observation Report

Date:	03/02/2024	Weather:		Coding:	PACP 7.0
Pipe Length (ft):	333.0	Owner:	City of Hobart	Pre Clean:	Heavy Cleaning
P.O.#:		Surveyor:	S. Bucklin	PSR:	P-303-033-027
Customer:	City of Hobart	Clean Date:	06/26/2023	Shape:	C

Street:	RIDGELAWN DR	Flow Control:	Not Controlled
City:	Hobart, IN	Year Renewed:	
Location:	Easement/Right of Way	Tape/Media #:	
Purpose:	Sewer System Evaluation Survey (SS	Dia/Height:	18"
Use:	Sanitary Sewage Pipe	Material:	VCP
Drain Area:		Lining:	None
Category:	NA		
Comment:			
Location Details:		Direction of Survey:	Downstream
US MH:	M-303-027	DS MH:	M-303-033
		Total Length Surveyed (ft):	336.0

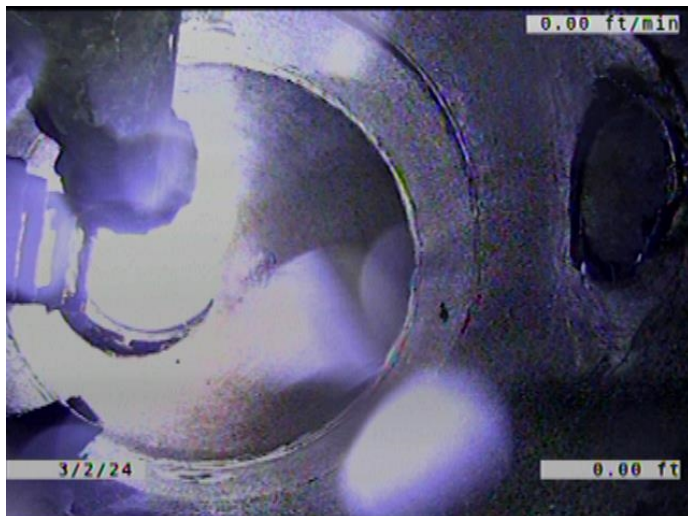
Code: **AMH**
Description: **Manhole**

Distance (ft): **.0**
Structural Grade: **0**
O&M Grade: **0**
Clock Start/From:
Clock To:
1st Value:
2nd Value:
Value Percent:
Continuous Index:
Within 8" of Joint: **NO**
Remarks: **M-303-027**

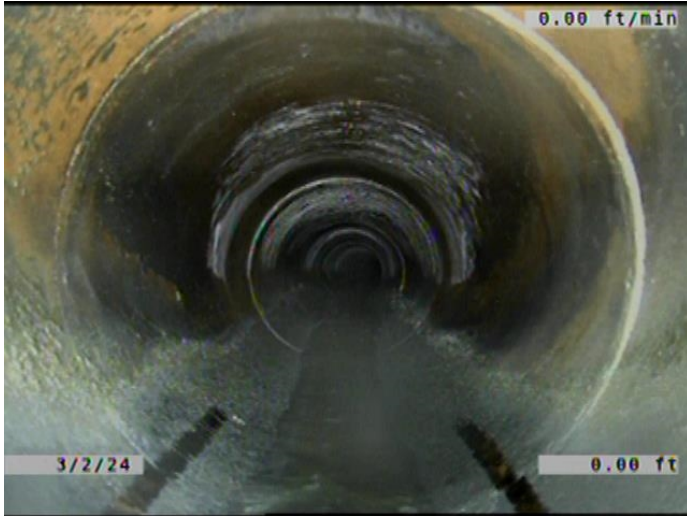
Code: **MWL**
Description: **Miscellaneous Water Level**

Distance (ft): **.0**
Structural Grade: **0**
O&M Grade: **0**
Clock Start/From:
Clock To:
1st Value:
2nd Value:
Value Percent: **5.000**
Continuous Index:
Within 8" of Joint: **NO**
Remarks:

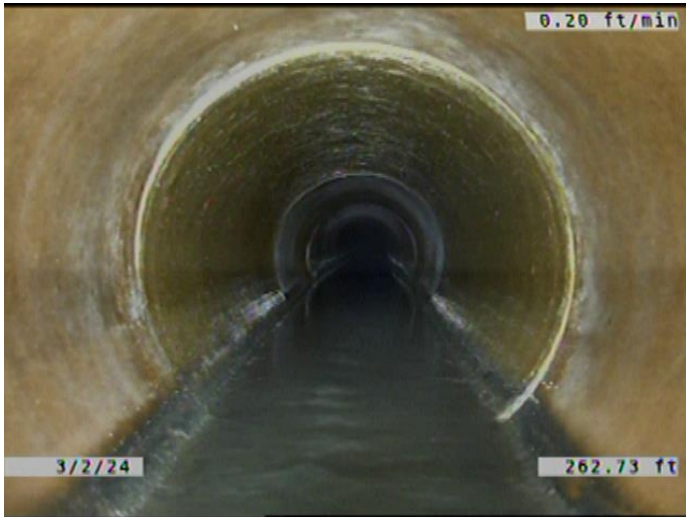
Code: **MWL**
Description: **Miscellaneous Water Level**

Distance (ft): **262.7**
Structural Grade: **0**
O&M Grade: **0**
Clock Start/From:
Clock To:
1st Value:
2nd Value:
Value Percent: **15.000**
Continuous Index:
Within 8" of Joint: **NO**
Remarks:

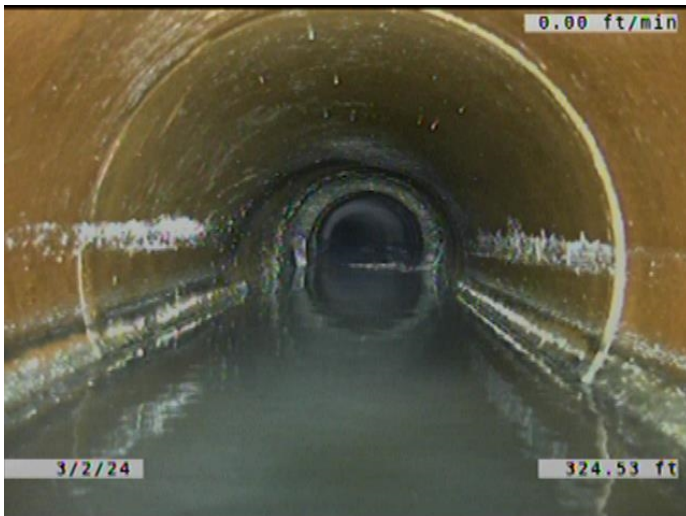
Code:	MWL
Description:	Miscellaneous Water Level
Distance (ft):	324.5
Structural Grade:	0
O&M Grade:	0
Clock Start/From:	
Clock To:	
1st Value:	
2nd Value:	
Value Percent:	35.000
Continuous Index:	
Within 8" of Joint:	NO
Remarks:

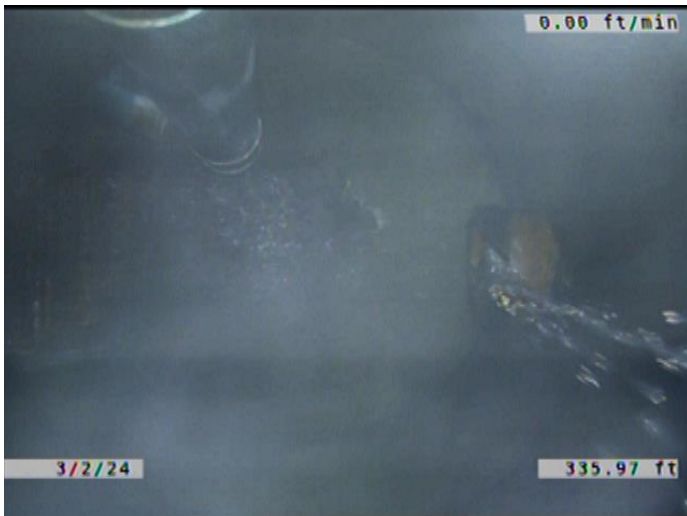
Code: **AMH**
 Description: **Manhole**

Distance (ft): **336.0**
 Structural Grade: **0**
 O&M Grade: **0**
 Clock Start/From:
 Clock To:
 1st Value:
 2nd Value:
 Value Percent:
 Continuous Index:
 Within 8" of Joint: **NO**
 Remarks: **M-303-033**
