Profile/Photo Observation Report

Street:	W 38TH AVE	Flow Control:	Not Controlled
City:	Hobart, IN	Year Renewed:	
Location:	Other	Tape/Media #:	
Purpose:	Not Known	Dia/Height:	10"
Use:	Sanitary	Material:	VCP
Drain Area:	NA	Lining:	
Category:	NA		
Comment:

Location Details:		Direction of Survey:	Downstream
US MH:	M-303-029	DS MH:	M-303-030
		Total Length Surveyed (ft):	328.1

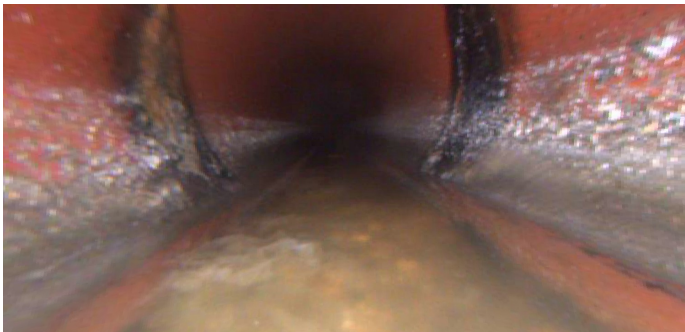
Code:	AMH
Description:	Manhole

Distance (ft):	.0
Structural Grade:	0
O&M Grade:	0
Clock Start/From:	
Clock To:	
1st Value:	
2nd Value:	
Value Percent:	
Continuous Index:	
Within 8" of Joint:	NO
Remarks:	M-303-029

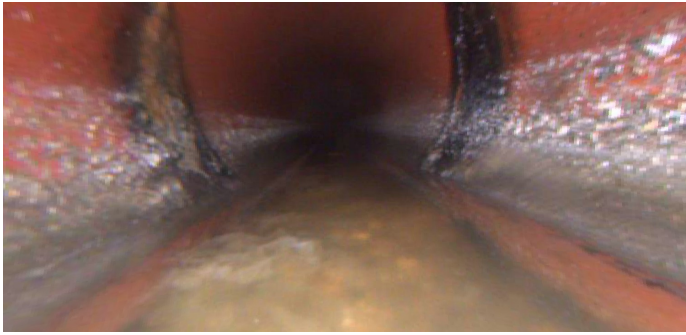
Code: **MWL**
Description: **Water Level**

Distance (ft): **.0**
Structural Grade: **0**
O&M Grade: **0**
Clock Start/From:
Clock To:
1st Value:
2nd Value:
Value Percent: **5.000**
Continuous Index:
Within 8" of Joint: **NO**
Remarks:

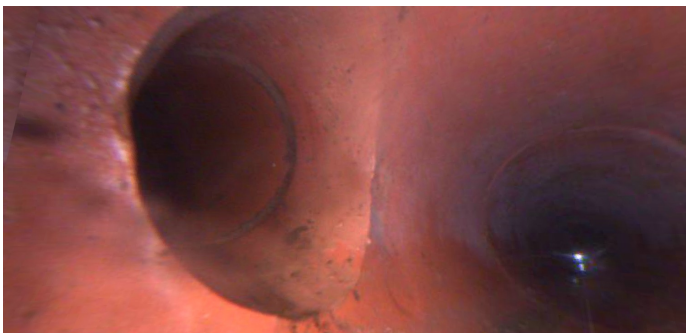
Code: **TF**
Description: **Tap Factory**

Distance (ft): **76.6**
Structural Grade: **0**
O&M Grade: **0**
Clock Start/From: **3**
Clock To:
1st Value: **4.000**
2nd Value:
Value Percent:
Continuous Index:
Within 8" of Joint:
Remarks:

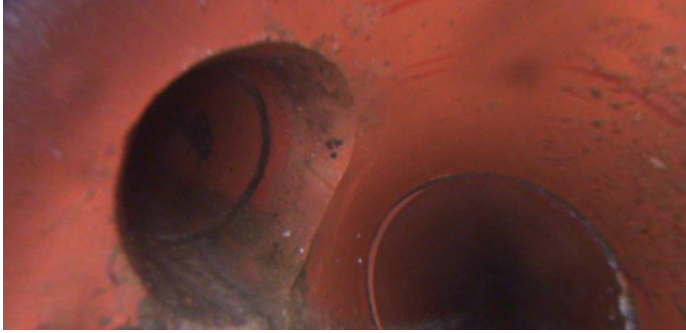
Code: **TF**
Description: **Tap Factory**

Distance (ft): **77.9**
Structural Grade: **0**
O&M Grade: **0**
Clock Start/From: **10**
Clock To:
1st Value: **4.000**
2nd Value:
Value Percent:
Continuous Index:
Within 8" of Joint:
Remarks:

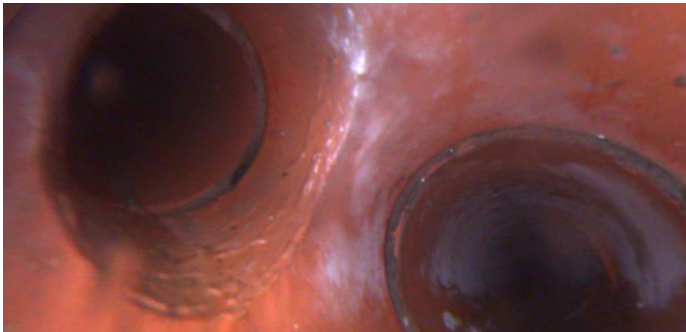
Code: **TF**
Description: **Tap Factory**

Distance (ft): **120.2**
Structural Grade: **0**
O&M Grade: **0**
Clock Start/From: **10**
Clock To:
1st Value: **4.000**
2nd Value:
Value Percent:
Continuous Index:
Within 8" of Joint:
Remarks:

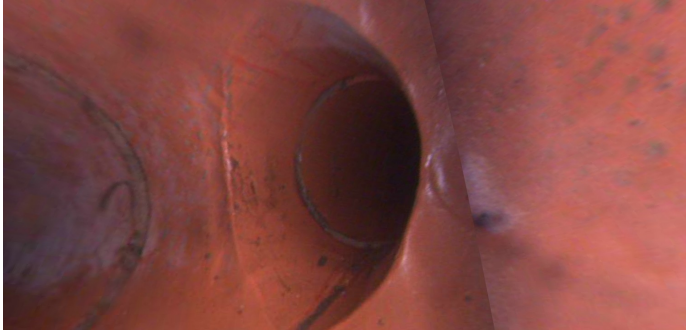
Code: **TF**
Description: **Tap Factory**

Distance (ft): **122.3**
Structural Grade: **0**
O&M Grade: **0**
Clock Start/From: **3**
Clock To:
1st Value: **4.000**
2nd Value:
Value Percent:
Continuous Index:
Within 8" of Joint:
Remarks:

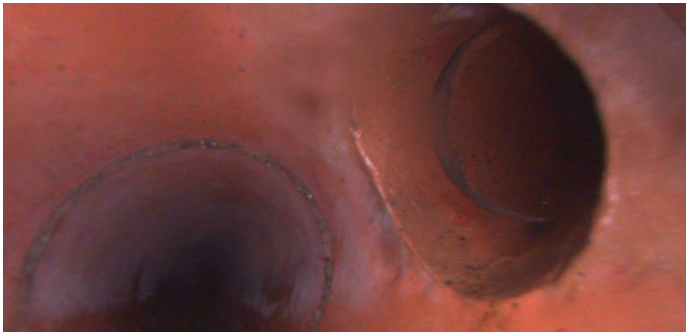
Code: **TF**
Description: **Tap Factory**

Distance (ft): **154.5**
Structural Grade: **0**
O&M Grade: **0**
Clock Start/From: **2**
Clock To:
1st Value: **4.000**
2nd Value:
Value Percent:
Continuous Index:
Within 8" of Joint:
Remarks:

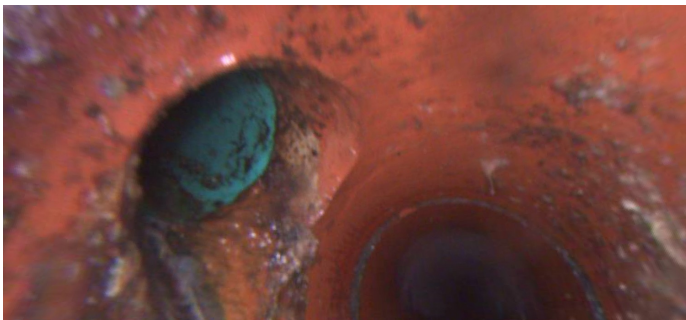
Code: **TFA**
Description: **Tap Factory Active**

Distance (ft): **196.7**
Structural Grade: **0**
O&M Grade: **0**
Clock Start/From: **10**
Clock To:
1st Value: **4.000**
2nd Value:
Value Percent:
Continuous Index:
Within 8" of Joint:
Remarks:

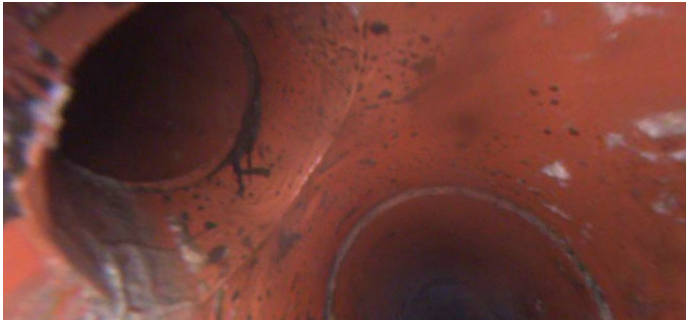
Code: **TF**
Description: **Tap Factory**

Distance (ft): **254.4**
Structural Grade: **0**
O&M Grade: **0**
Clock Start/From: **10**
Clock To:
1st Value: **4.000**
2nd Value:
Value Percent:
Continuous Index:
Within 8" of Joint:
Remarks:

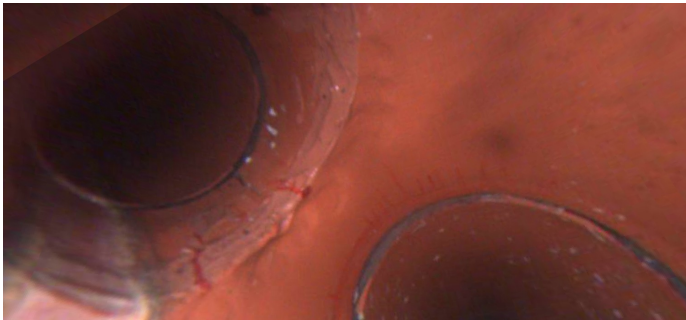
Code: **TF**
Description: **Tap Factory**

Distance (ft): **306.9**
Structural Grade: **0**
O&M Grade: **0**
Clock Start/From: **10**
Clock To:
1st Value: **4.000**
2nd Value:
Value Percent:
Continuous Index:
Within 8" of Joint:
Remarks:

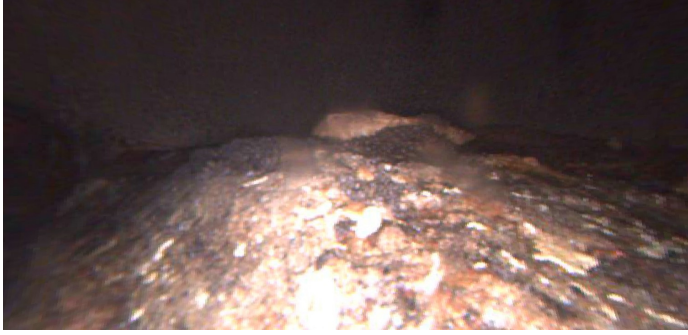
Code:	AMH
Description:	Manhole
Distance (ft):	328.1
Structural Grade:	0
O&M Grade:	0
Clock Start/From:	
Clock To:	
1st Value:	
2nd Value:	
Value Percent:	
Continuous Index:	
Within 8" of Joint:	NO
Remarks:	M-303-030
