Profile/Photo Observation Report

Date:	03/28/2018	Weather:		Coding:	PACP 6.0
Pipe Length (ft):	221.6	Owner:	NA	Pre Clean:	Not Known
P.O.#:		Surveyor:	Selasie Honu	PSR:	P-303-049-048
Customer:		Clean Date:	01/01/1900	Shape:	C

Street:	W 37TH AVE	Flow Control:	Not Controlled
City:	Hobart, IN	Year Renewed:	
Location:	Other	Tape/Media #:	
Purpose:	Not Known	Dia/Height:	10"
Use:	Sanitary	Material:	VCP
Drain Area:	NA	Lining:	
Category:	NA		
Comment:

Location Details:		Direction of Survey:	Downstream
US MH:	M-303-049	DS MH:	M-303-048
		Total Length Surveyed (ft):	223.9

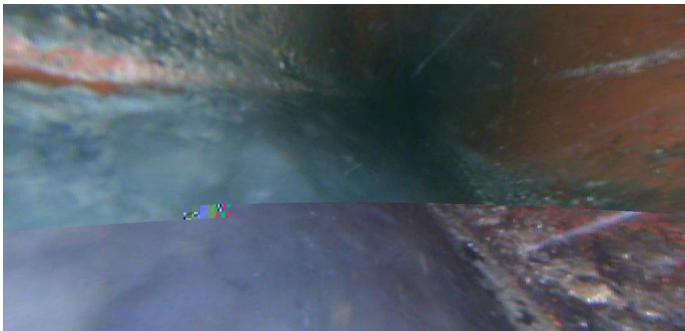
Code: **AMH**
Description: **Manhole**

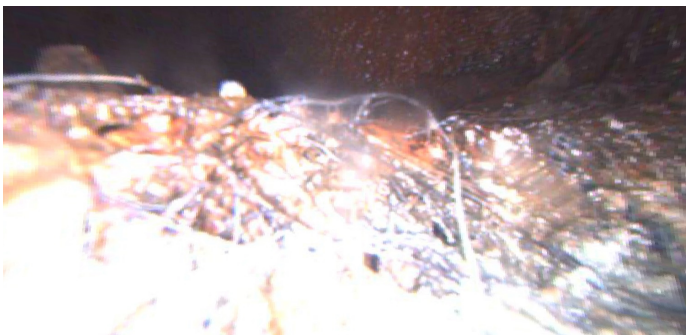
Code: **AMH**
Description: **Manhole**

Distance (ft): **223.9**
Structural Grade: **0**
O&M Grade: **0**
Clock Start/From:
Clock To:
1st Value:
2nd Value:
Value Percent:
Continuous Index:
Within 8" of Joint: **NO**
Remarks: **M-303-048**
