Profile/Photo Observation Report

Date:	04/19/2018	Weather:		Coding:	PACP 6.0
Pipe Length (ft):	260.4	Owner:	NA	Pre Clean:	No Pre-Cleaning
P.O.#:		Surveyor:	Byrd Fitzgerald	PSR:	P-305-002-001
Customer:		Clean Date:	01/01/1900	Shape:	C

Street:	OFF W 49TH AVE	Flow Control:	Not Controlled
City:	Hobart, IN	Year Renewed:	
Location:	Yard	Tape/Media #:	
Purpose:	Routine Assessment	Dia/Height:	10"
Use:	Sanitary	Material:	XXX
Drain Area:	NA	Lining:	Cured in Place
Category:	NA		
Comment:

Location Details:		Direction of Survey:	Upstream
US MH:	M-305-002	DS MH:	M-305-001
		Total Length Surveyed (ft):	262.0

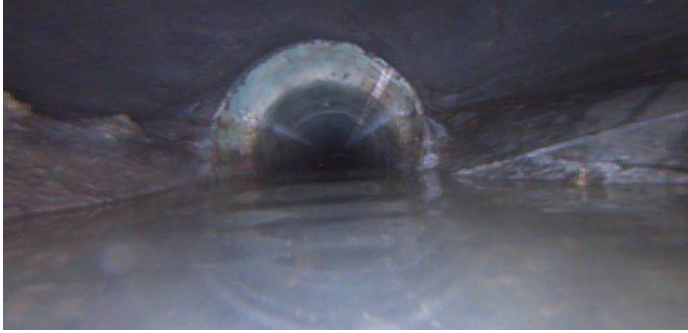
Code:	AMH
Description:	Manhole
Distance (ft):	262.0
Structural Grade:	0
O&M Grade:	0
Clock Start/From:	
Clock To:	
1st Value:	
2nd Value:	
Value Percent:	
Continuous Index:	
Within 8" of Joint:	NO
Remarks:	M-305-002
