Profile/Photo Observation Report

Date:	04/19/2018	Weather:		Coding:	PACP 6.0
Pipe Length (ft):	298.5	Owner:	NA	Pre Clean:	No Pre-Cleaning
P.O.#:		Surveyor:	Justin Gonzales	PSR:	P-305-004-003
Customer:		Clean Date:	01/01/1900	Shape:	C

Street:	OFF W 49TH AVE	Flow Control:	Not Controlled
City:	Hobart, IN	Year Renewed:	
Location:	Yard	Tape/Media #:	
Purpose:	Routine Assessment	Dia/Height:	10"
Use:	Sanitary	Material:	PVC
Drain Area:	NA	Lining:	Cured in Place
Category:	NA		
Comment:

Location Details:		Direction of Survey:	Upstream
US MH:	M-305-004	DS MH:	M-305-003
		Total Length Surveyed (ft):	295.6

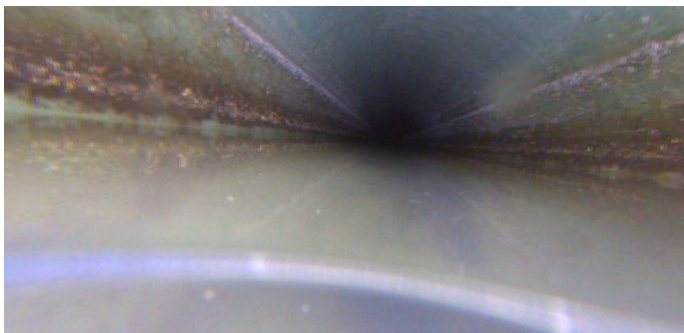
Code: **AMH**
Description: **Manhole**

Distance (ft): **.0**
Structural Grade: **0**
O&M Grade: **0**
Clock Start/From:
Clock To:
1st Value:
2nd Value:
Value Percent:
Continuous Index:
Within 8" of Joint: **NO**
Remarks: **M-305-003**

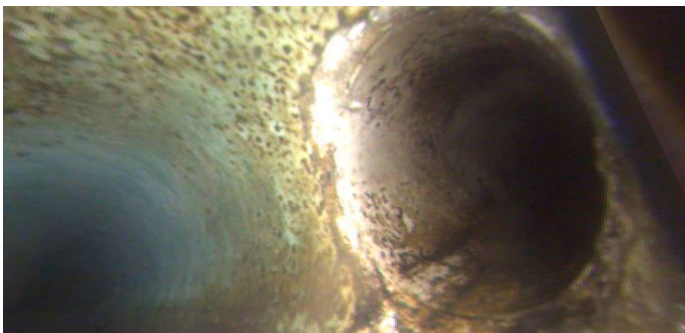
Code: **TF**
Description: **Tap Factory**

Distance (ft): **72.1**
Structural Grade: **0**
O&M Grade: **0**
Clock Start/From: **9**
Clock To:
1st Value: **4.000**
2nd Value:
Value Percent:
Continuous Index:
Within 8" of Joint:
Remarks:

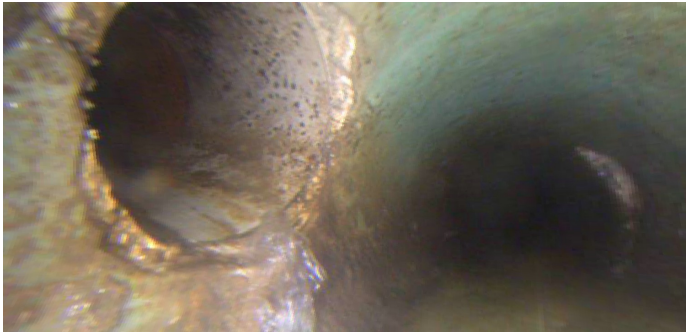
Code: **TFA**
Description: **Tap Factory Active**

Distance (ft): **74.0**
Structural Grade: **0**
O&M Grade: **0**
Clock Start/From: **3**
Clock To:
1st Value: **4.000**
2nd Value:
Value Percent:
Continuous Index:
Within 8" of Joint:
Remarks:

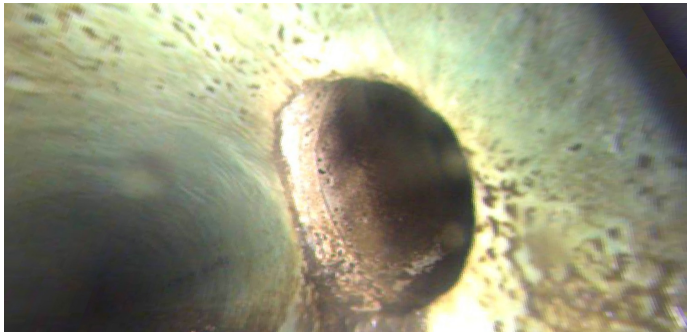
Code:	TF
Description:	Tap Factory
Distance (ft):	127.8
Structural Grade:	0
O&M Grade:	0
Clock Start/From:	9
Clock To:	
1st Value:	4.000
2nd Value:	
Value Percent:	
Continuous Index:	
Within 8" of Joint:	
Remarks:

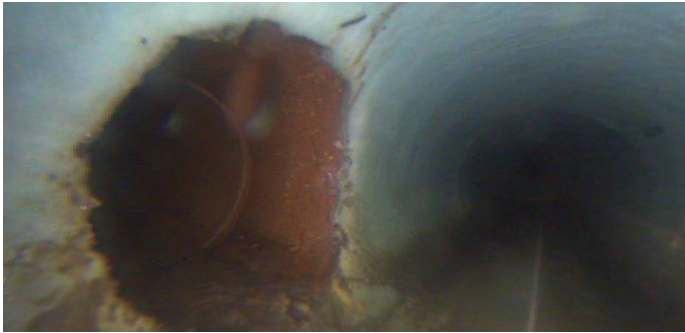
Code: **TF**
Description: **Tap Factory**

Distance (ft): **146.4**
Structural Grade: **0**
O&M Grade: **0**
Clock Start/From: **3**
Clock To:
1st Value: **4.000**
2nd Value:
Value Percent:
Continuous Index:
Within 8" of Joint:
Remarks:

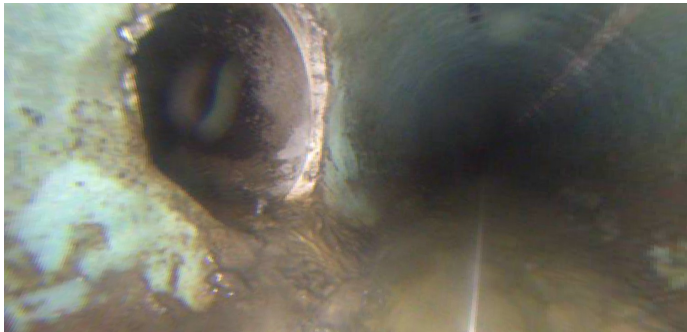
Code:	TF
Description:	Tap Factory
Distance (ft):	233.6
Structural Grade:	0
O&M Grade:	0
Clock Start/From:	3
Clock To:	
1st Value:	4.000
2nd Value:	
Value Percent:	
Continuous Index:	
Within 8" of Joint:	
Remarks:

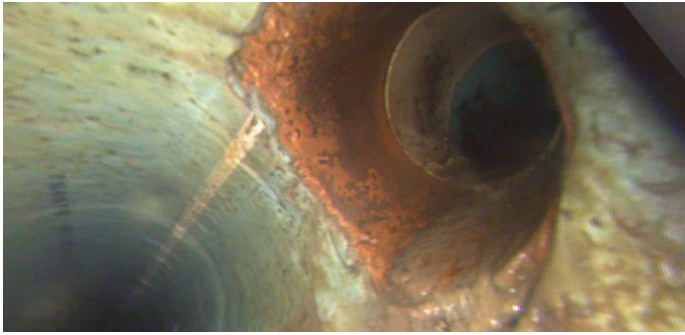
Code: **TF**
Description: **Tap Factory**

Distance (ft): **244.9**
Structural Grade: **0**
O&M Grade: **0**
Clock Start/From: **10**
Clock To:
1st Value: **4.000**
2nd Value:
Value Percent:
Continuous Index:
Within 8" of Joint:
Remarks:

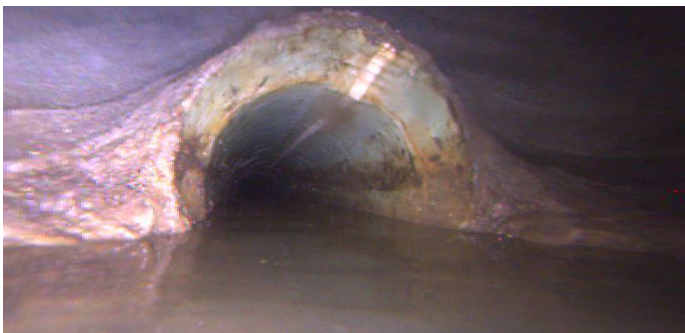
Code: **AMH**
Description: **Manhole**

Distance (ft): **295.6**
Structural Grade: **0**
O&M Grade: **0**
Clock Start/From:
Clock To:
1st Value:
2nd Value:
Value Percent:
Continuous Index:
Within 8" of Joint: **NO**
Remarks: **M-305-004**
