Profile/Photo Observation Report

Street:	FOXCROFT STREET	Flow Control:	Not Controlled
City:	Hobart, IN	Year Renewed:	
Location:	Yard	Tape/Media #:	
Purpose:	Routine Assessment	Dia/Height:	10"
Use:	Sanitary	Material:	XXX
Drain Area:	NA	Lining:	Cured in Place
Category:	NA		
Comment:	Debris on lenses

Location Details:		Direction of Survey:	Downstream
US MH:	M-305-013	DS MH:	M-305-012
		Total Length Surveyed (ft):	279.8

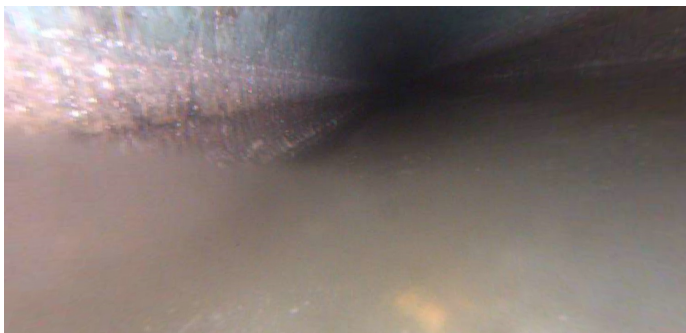
Code: **AMH**
Description: **Manhole**

Distance (ft): **.0**
Structural Grade: **0**
O&M Grade: **0**
Clock Start/From:
Clock To:
1st Value:
2nd Value:
Value Percent:
Continuous Index:
Within 8" of Joint: **NO**
Remarks: **M-305-013**

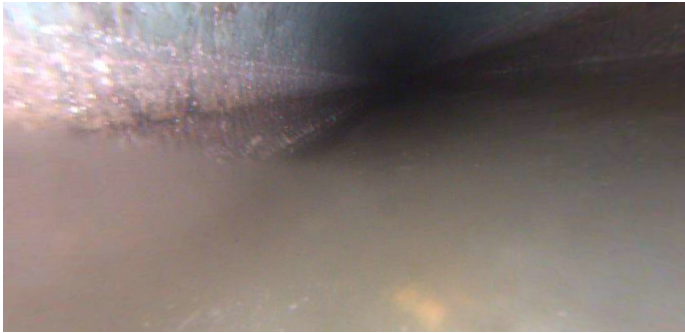
Code:	MWL
Description:	Water Level

Distance (ft):	.0
Structural Grade:	0
O&M Grade:	0
Clock Start/From:	
Clock To:	
1st Value:	
2nd Value:	
Value Percent:	5.000
Continuous Index:	
Within 8" of Joint:	NO
Remarks:
