Profile/Photo Observation Report

Street:	ALLEY BETWEEN WALNUT LN & CRO	Flow Control:	Not Controlled
City:	Hobart, IN	Year Renewed:	
Location:	Yard	Tape/Media #:	
Purpose:	Routine Assessment	Dia/Height:	10"
Use:	Sanitary	Material:	XXX
Drain Area:	NA	Lining:	Cured in Place
Category:	NA		
Comment:

Location Details:		Direction of Survey:	Downstream
US MH:	M-305-015	DS MH:	M-305-014
		Total Length Surveyed (ft):	274.8

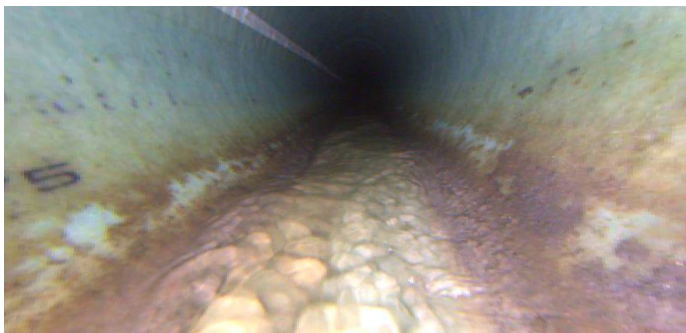
Code: **AMH**
Description: **Manhole**

Distance (ft): **.0**
Structural Grade: **0**
O&M Grade: **0**
Clock Start/From:
Clock To:
1st Value:
2nd Value:
Value Percent:
Continuous Index:
Within 8" of Joint: **NO**
Remarks: **M-305-015**

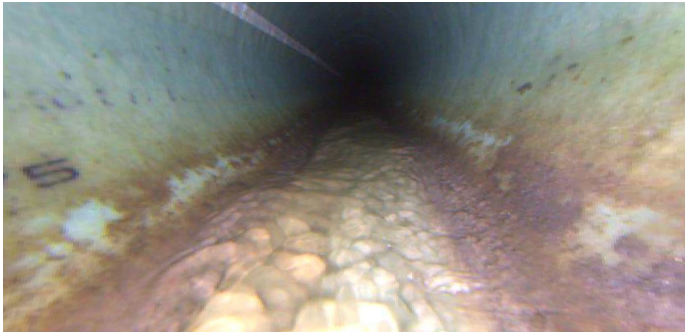
Code:	MWL
Description:	Water Level

Distance (ft):	.0
Structural Grade:	0
O&M Grade:	0
Clock Start/From:	
Clock To:	
1st Value:	
2nd Value:	
Value Percent:	5.000
Continuous Index:	
Within 8" of Joint:	NO
Remarks:

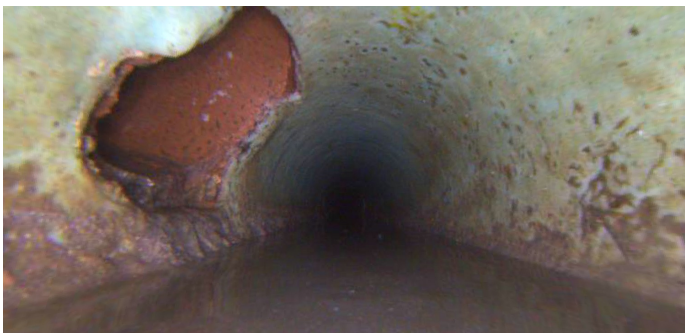
Code: **MWL**
Description: **Water Level**

Distance (ft): **51.3**
Structural Grade: **0**
O&M Grade: **0**
Clock Start/From:
Clock To:
1st Value:
2nd Value:
Value Percent: **30.000**
Continuous Index:
Within 8" of Joint: **NO**
Remarks:

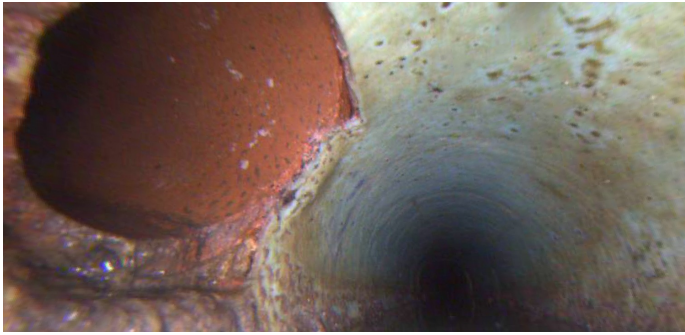
Code: **TB**
Description: **Tap Break-in**

Distance (ft): **51.6**
Structural Grade: **0**
O&M Grade: **0**
Clock Start/From: **10**
Clock To:
1st Value: **4.000**
2nd Value:
Value Percent:
Continuous Index:
Within 8" of Joint:
Remarks:

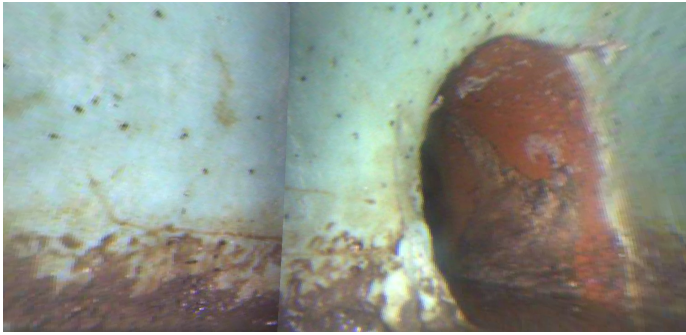
Code: **TB**
Description: **Tap Break-in**

Distance (ft): **57.9**
Structural Grade: **0**
O&M Grade: **0**
Clock Start/From: **3**
Clock To:
1st Value: **6.000**
2nd Value:
Value Percent:
Continuous Index:
Within 8" of Joint:
Remarks:

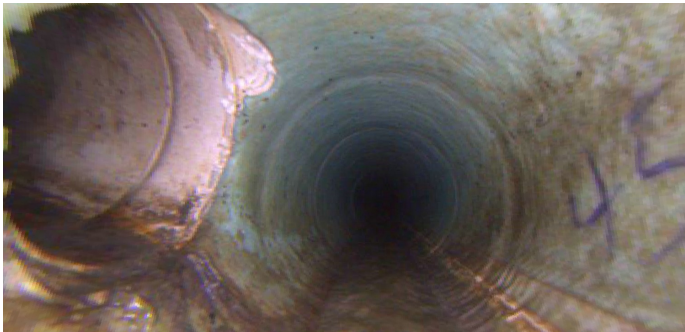
Code: **TB**
Description: **Tap Break-in**

Distance (ft): **150.2**
Structural Grade: **0**
O&M Grade: **0**
Clock Start/From: **9**
Clock To:
1st Value: **6.000**
2nd Value:
Value Percent:
Continuous Index:
Within 8" of Joint:
Remarks:

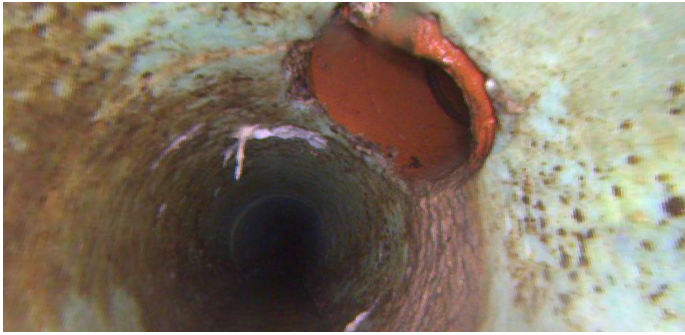
Code: **TB**
Description: **Tap Break-in**

Distance (ft): **195.7**
Structural Grade: **0**
O&M Grade: **0**
Clock Start/From: **1**
Clock To:
1st Value: **4.000**
2nd Value:
Value Percent:
Continuous Index:
Within 8" of Joint:
Remarks:

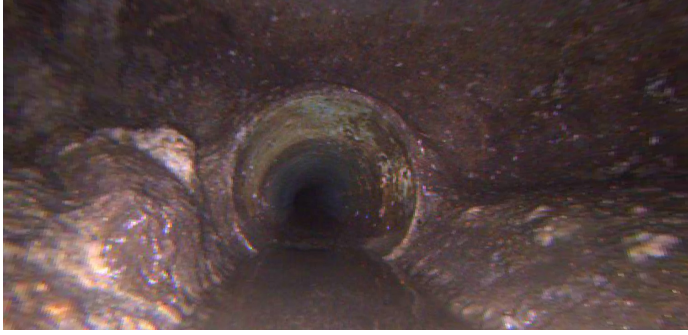
Code:	AMH
Description:	Manhole
Distance (ft):	274.8
Structural Grade:	0
O&M Grade:	0
Clock Start/From:	
Clock To:	
1st Value:	
2nd Value:	
Value Percent:	
Continuous Index:	
Within 8" of Joint:	NO
Remarks:	M-305-014
