## Profile/Photo Observation Report

Date:	<b>04/19/2018</b>	Weather:		Coding:	<b>PACP 6.0</b>
Pipe Length (ft):	<b>97.6</b>	Owner:	<b>NA</b>	Pre Clean:	<b>No Pre-Cleaning</b>
P.O.#:		Surveyor:	<b>Byrd Fitzgerald</b>	PSR:	<b>P-305-024-023</b>
Customer:		Clean Date:	<b>01/01/1900</b>	Shape:	<b>C</b>

Location Details:		Direction of Survey:	<b>Upstream</b>
US MH:	<b>M-305-024</b>	DS MH:	<b>M-305-023</b>
		Total Length Surveyed (ft):	<b>58.4</b>

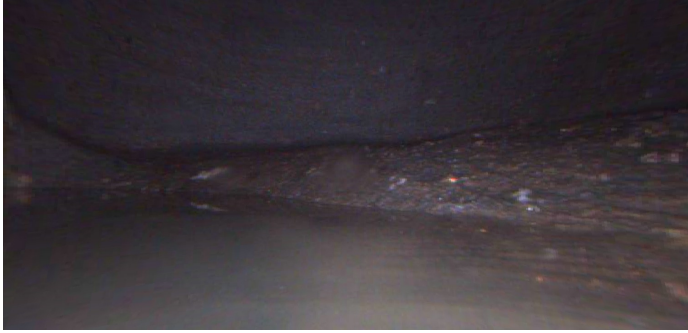
Code:	AMH
Description:	Manhole
Distance (ft):	58.4
Structural Grade:	0
O&M Grade:	0
Clock Start/From:	
Clock To:	
1st Value:	
2nd Value:	
Value Percent:	
Continuous Index:	
Within 8" of Joint:	NO
Remarks:	M-305-024
