Profile/Photo Observation Report

Date:	04/19/2018	Weather:		Coding:	PACP 6.0
Pipe Length (ft):	294.5	Owner:	NA	Pre Clean:	No Pre-Cleaning
P.O.#:		Surveyor:	Justin Gonzales	PSR:	P-305-027-026
Customer:		Clean Date:	01/01/1900	Shape:	C

Street:	ALLEY BETWEEN CROWSNEST DR &	Flow Control:	Not Controlled
City:	Hobart, IN	Year Renewed:	
Location:	Yard	Tape/Media #:	
Purpose:	Routine Assessment	Dia/Height:	10"
Use:	Sanitary	Material:	PVC
Drain Area:	NA	Lining:	Cured in Place
Category:	NA		
Comment:			
Location Details:		Direction of Survey:	Downstream
US MH:	M-305-027	DS MH:	M-305-026
		Total Length Surveyed (ft):	286.3

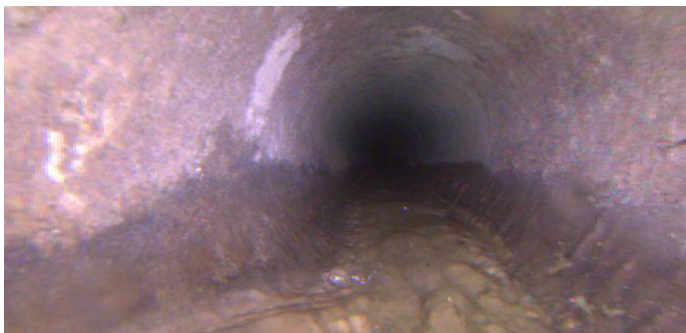
Code: **AMH**
Description: **Manhole**

Distance (ft): **.0**
Structural Grade: **0**
O&M Grade: **0**
Clock Start/From:
Clock To:
1st Value:
2nd Value:
Value Percent:
Continuous Index:
Within 8" of Joint: **NO**
Remarks: **M-305-027**

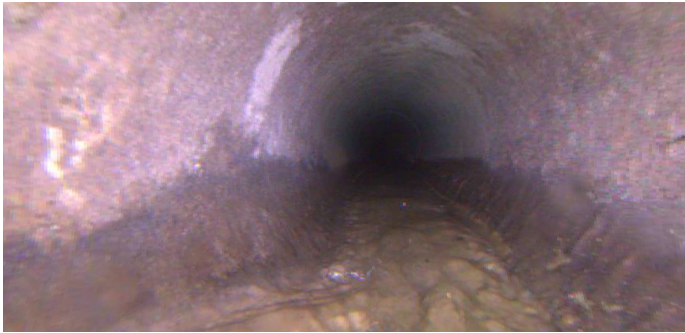
Code:	MWL
Description:	Water Level

Distance (ft):	.0
Structural Grade:	0
O&M Grade:	0
Clock Start/From:	
Clock To:	
1st Value:	
2nd Value:	
Value Percent:	5.000
Continuous Index:	
Within 8" of Joint:	NO
Remarks:

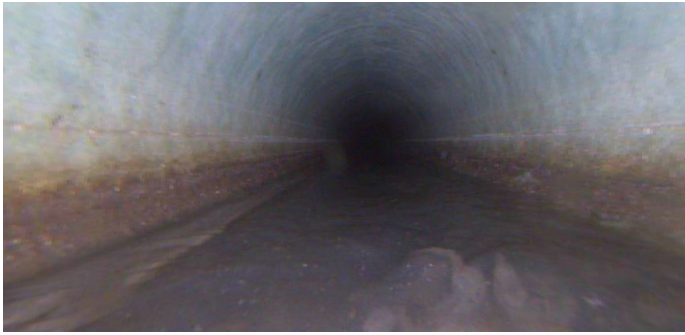
Code: **MWL**
Description: **Water Level**

Distance (ft): **27.1**
Structural Grade: **0**
O&M Grade: **0**
Clock Start/From:
Clock To:
1st Value:
2nd Value:
Value Percent: **15.000**
Continuous Index:
Within 8" of Joint: **NO**
Remarks:

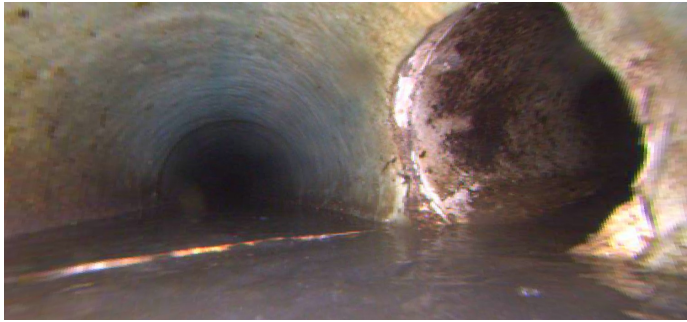
Code: **TFA**
Description: **Tap Factory Active**

Distance (ft): **52.2**
Structural Grade: **0**
O&M Grade: **0**
Clock Start/From: **3**
Clock To:
1st Value: **4.000**
2nd Value:
Value Percent:
Continuous Index:
Within 8" of Joint:
Remarks:

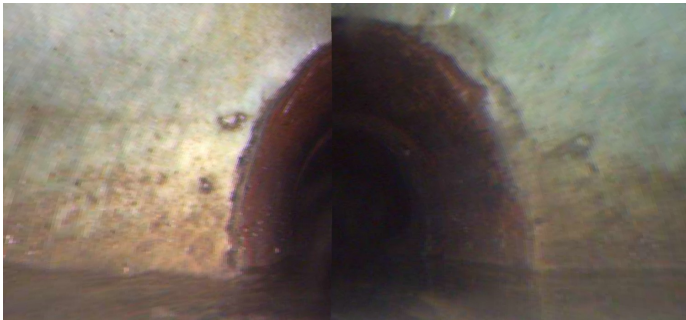
Code: **TFA**
Description: **Tap Factory Active**

Distance (ft): **130.6**
Structural Grade: **0**
O&M Grade: **0**
Clock Start/From: **3**
Clock To:
1st Value: **4.000**
2nd Value:
Value Percent:
Continuous Index:
Within 8" of Joint:
Remarks:

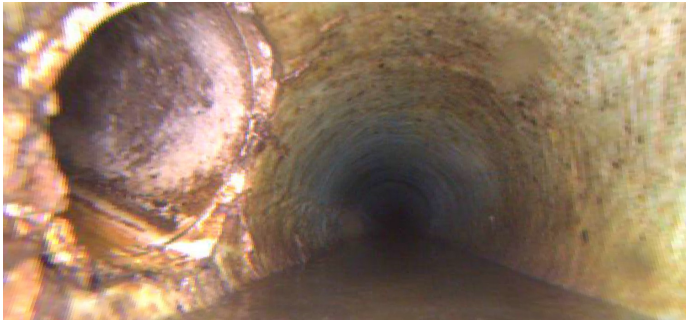
Code: **TF**
Description: **Tap Factory**

Distance (ft): **133.7**
Structural Grade: **0**
O&M Grade: **0**
Clock Start/From: **9**
Clock To:
1st Value: **4.000**
2nd Value:
Value Percent:
Continuous Index:
Within 8" of Joint:
Remarks:

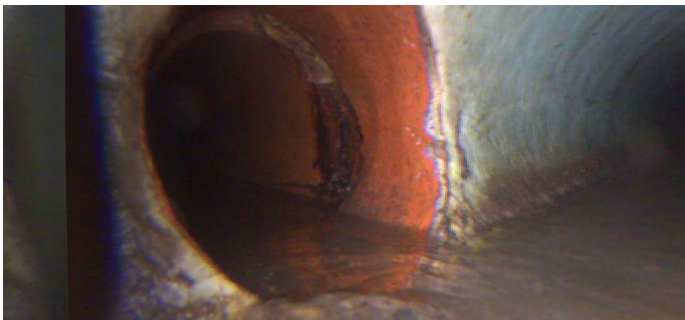
Code: **TF**
Description: **Tap Factory**

Distance (ft): **212.2**
Structural Grade: **0**
O&M Grade: **0**
Clock Start/From: **9**
Clock To:
1st Value: **4.000**
2nd Value:
Value Percent:
Continuous Index:
Within 8" of Joint:
Remarks:

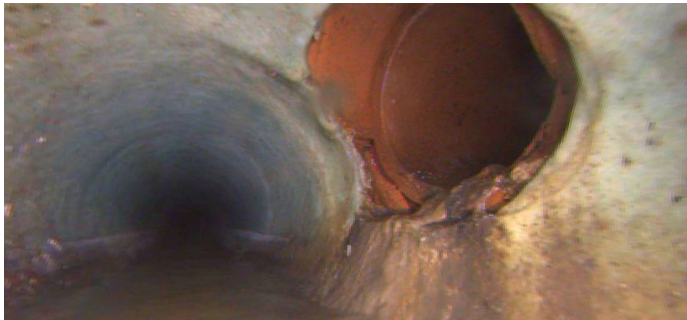
Code:	TF
Description:	Tap Factory
Distance (ft):	274.2
Structural Grade:	0
O&M Grade:	0
Clock Start/From:	3
Clock To:	
1st Value:	4.000
2nd Value:	
Value Percent:	
Continuous Index:	
Within 8" of Joint:	
Remarks:

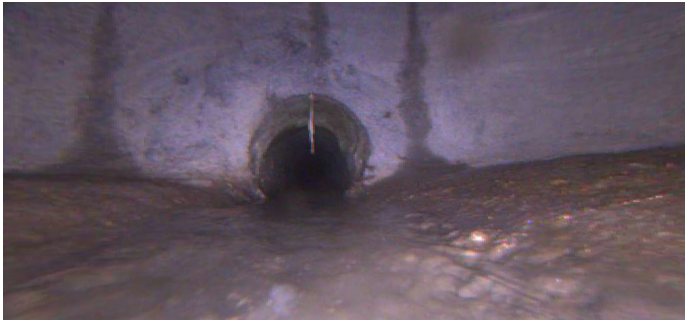
Code: **AMH**
Description: **Manhole**

Distance (ft): **286.3**
Structural Grade: **0**
O&M Grade: **0**
Clock Start/From:
Clock To:
1st Value:
2nd Value:
Value Percent:
Continuous Index:
Within 8" of Joint: **NO**
Remarks: **M-305-026**
