## Profile/Photo Observation Report

Date:	<b>04/18/2018</b>	Weather:		Coding:	<b>PACP 6.0</b>
Pipe Length (ft):	<b>378.8</b>	Owner:	<b>NA</b>	Pre Clean:	<b>No Pre-Cleaning</b>
P.O.#:		Surveyor:	<b>Byrd Fitzgerald</b>	PSR:	<b>P-305-032-031</b>
Customer:		Clean Date:	<b>01/01/1900</b>	Shape:	<b>C</b>

Street:	<b>ALLEY BETWEEN CROWSNEST DR &amp;</b>	Flow Control:	<b>Not Controlled</b>
City:	<b>Hobart, IN</b>	Year Renewed:	
Location:	<b>Yard</b>	Tape/Media #:	
Purpose:	<b>Routine Assessment</b>	Dia/Height:	<b>10"</b>
Use:	<b>Sanitary</b>	Material:	<b>XXX</b>
Drain Area:	<b>NA</b>	Lining:	<b>Cured in Place</b>
Category:	<b>NA</b>		
Comment:

Location Details:		Direction of Survey:	<b>Downstream</b>
US MH:	<b>M-305-032</b>	DS MH:	<b>M-305-031</b>
		Total Length Surveyed (ft):	<b>272.3</b>

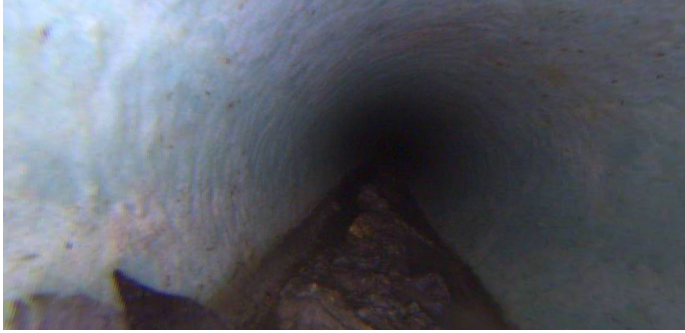
Code: **AMH**  
Description: **Manhole**

Distance (ft): **.0**  
Structural Grade: **0**  
O&M Grade: **0**  
Clock Start/From:  
Clock To:  
1st Value:  
2nd Value:  
Value Percent:  
Continuous Index:  
Within 8" of Joint: **NO**  
Remarks: **M-305-032**

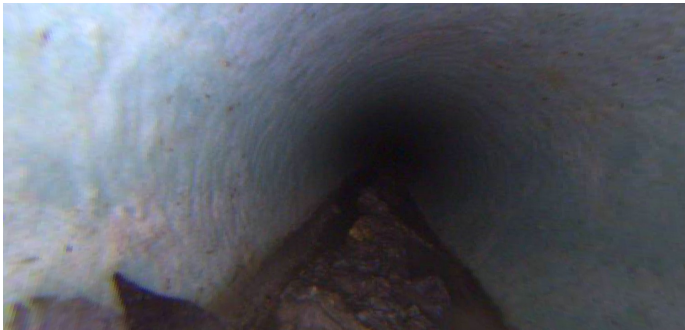
Code: **MWL**  
Description: **Water Level**

Distance (ft): **.0**  
Structural Grade: **0**  
O&M Grade: **0**  
Clock Start/From:  
Clock To:  
1st Value:  
2nd Value:  
Value Percent: **5.000**  
Continuous Index:  
Within 8" of Joint: **NO**  
Remarks:

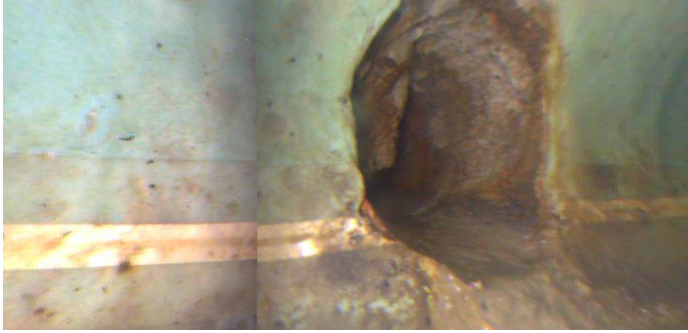
Code: **TB**  
Description: **Tap Break-in**

Distance (ft): **57.6**  
Structural Grade: **0**  
O&M Grade: **0**  
Clock Start/From: **3**  
Clock To:  
1st Value: **4.000**  
2nd Value:  
Value Percent:  
Continuous Index:  
Within 8" of Joint:  
Remarks:

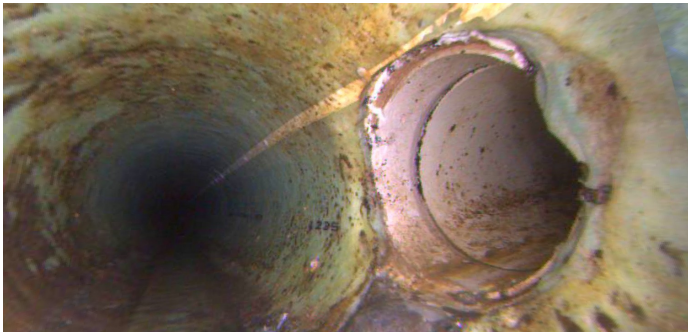
Code: **TB**  
Description: **Tap Break-in**

Distance (ft): **109.0**  
Structural Grade: **0**  
O&M Grade: **0**  
Clock Start/From: **3**  
Clock To:  
1st Value: **4.000**  
2nd Value:  
Value Percent:  
Continuous Index:  
Within 8" of Joint:  
Remarks:

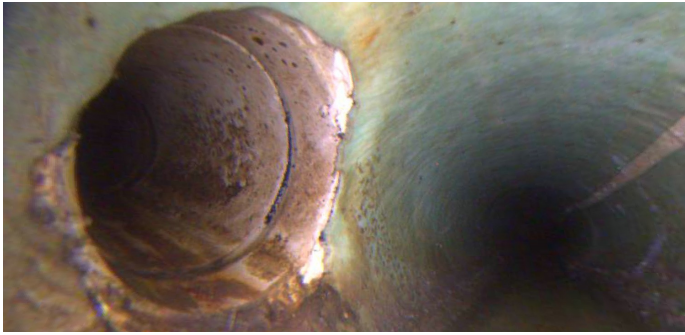
Code: **TB**  
Description: **Tap Break-in**

Distance (ft): **125.9**  
Structural Grade: **0**  
O&M Grade: **0**  
Clock Start/From: **9**  
Clock To:  
1st Value: **4.000**  
2nd Value:  
Value Percent:  
Continuous Index:  
Within 8" of Joint:  
Remarks:

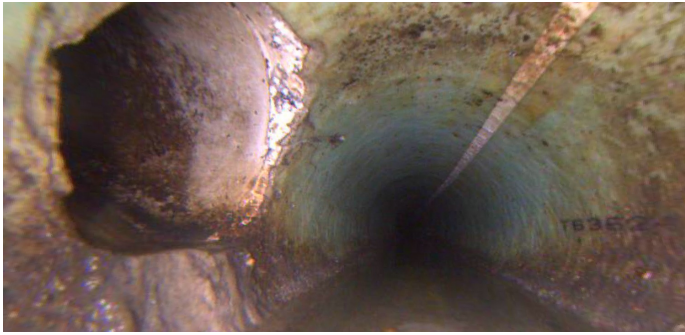
Code: **TBA**  
Description: **Tap Break-in Active**

Distance (ft): **203.0**  
Structural Grade: **0**  
O&M Grade: **0**  
Clock Start/From: **9**  
Clock To:  
1st Value: **4.000**  
2nd Value:  
Value Percent:  
Continuous Index:  
Within 8" of Joint:  
Remarks:

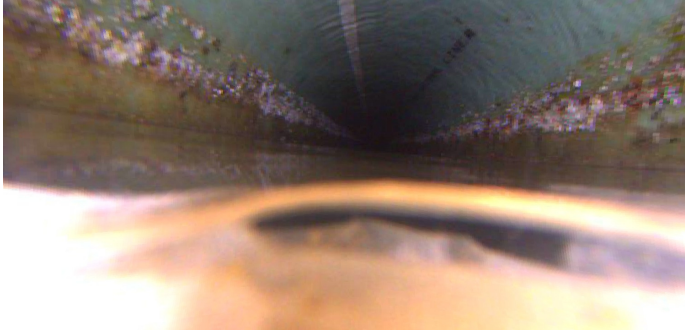
Code: **MWL**  
Description: **Water Level**

Distance (ft): **242.7**  
Structural Grade: **0**  
O&M Grade: **0**  
Clock Start/From:  
Clock To:  
1st Value:  
2nd Value:  
Value Percent: **25.000**  
Continuous Index:  
Within 8" of Joint: **NO**  
Remarks:

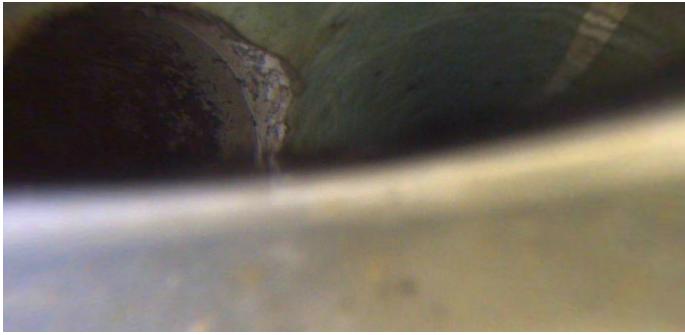
Code: **TBA**  
Description: **Tap Break-in Active**

Distance (ft): **262.3**  
Structural Grade: **0**  
O&M Grade: **0**  
Clock Start/From: **2**  
Clock To:  
1st Value: **4.000**  
2nd Value:  
Value Percent:  
Continuous Index:  
Within 8" of Joint:  
Remarks:

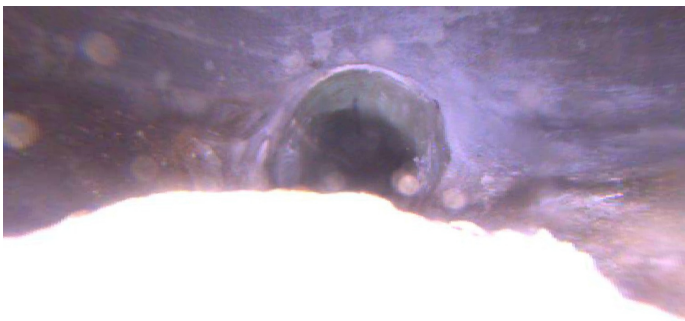
Code: **AMH**  
Description: **Manhole**

Distance (ft): **272.3**  
Structural Grade: **0**  
O&M Grade: **0**  
Clock Start/From:  
Clock To:  
1st Value:  
2nd Value:  
Value Percent:  
Continuous Index:  
Within 8" of Joint: **NO**  
Remarks: **M-305-031**
