Profile/Photo Observation Report

Street:	FOXCROFT STREET	Flow Control:	Not Controlled
City:	Hobart, IN	Year Renewed:	
Location:	Yard	Tape/Media #:	
Purpose:	Routine Assessment	Dia/Height:	10"
Use:	Sanitary	Material:	XXX
Drain Area:	NA	Lining:	Cured in Place
Category:	NA		
Comment:

Location Details:		Direction of Survey:	Downstream
US MH:	M-305-032	DS MH:	M-305-031
		Total Length Surveyed (ft):	272.3

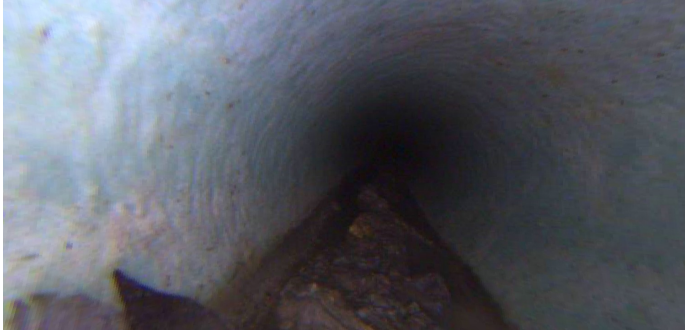
Code: **AMH**
Description: **Manhole**

Distance (ft): **.0**
Structural Grade: **0**
O&M Grade: **0**
Clock Start/From:
Clock To:
1st Value:
2nd Value:
Value Percent:
Continuous Index:
Within 8" of Joint: **NO**
Remarks: **M-305-032**

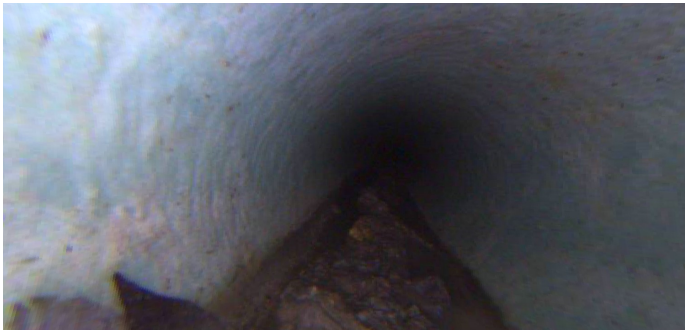
Code: **MWL**
Description: **Water Level**

Distance (ft): **.0**
Structural Grade: **0**
O&M Grade: **0**
Clock Start/From:
Clock To:
1st Value:
2nd Value:
Value Percent: **5.000**
Continuous Index:
Within 8" of Joint: **NO**
Remarks:

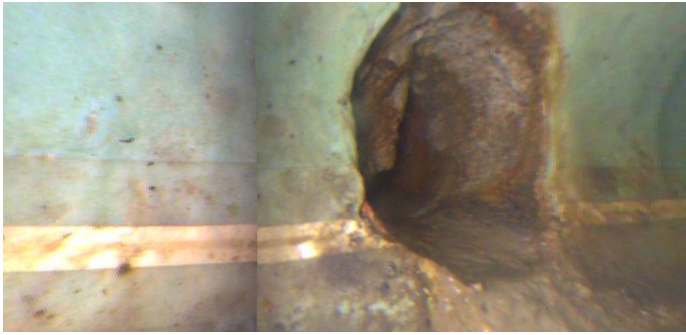
Code: **TB**
Description: **Tap Break-in**

Distance (ft): **57.6**
Structural Grade: **0**
O&M Grade: **0**
Clock Start/From: **3**
Clock To:
1st Value: **4.000**
2nd Value:
Value Percent:
Continuous Index:
Within 8" of Joint:
Remarks:

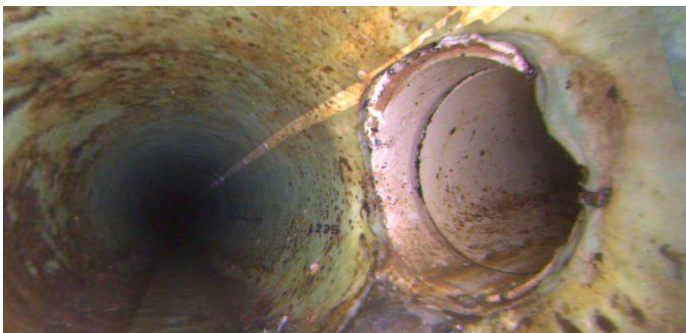
Code: **TB**
Description: **Tap Break-in**

Distance (ft): **109.0**
Structural Grade: **0**
O&M Grade: **0**
Clock Start/From: **3**
Clock To:
1st Value: **4.000**
2nd Value:
Value Percent:
Continuous Index:
Within 8" of Joint:
Remarks:

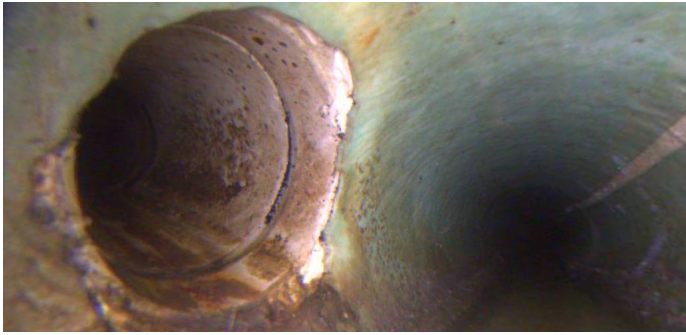
Code: **TB**
Description: **Tap Break-in**

Distance (ft): **125.9**
Structural Grade: **0**
O&M Grade: **0**
Clock Start/From: **9**
Clock To:
1st Value: **4.000**
2nd Value:
Value Percent:
Continuous Index:
Within 8" of Joint:
Remarks:

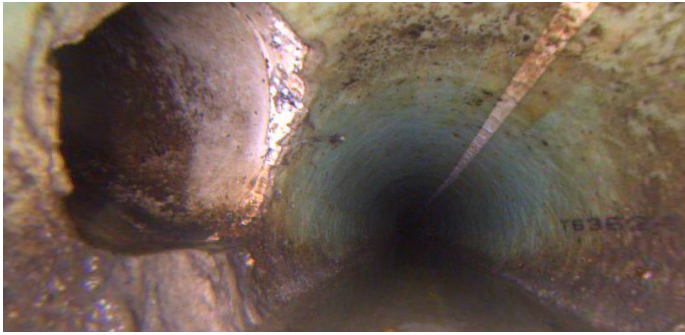
Code: **TBA**
Description: **Tap Break-in Active**

Distance (ft): **203.0**
Structural Grade: **0**
O&M Grade: **0**
Clock Start/From: **9**
Clock To:
1st Value: **4.000**
2nd Value:
Value Percent:
Continuous Index:
Within 8" of Joint:
Remarks:

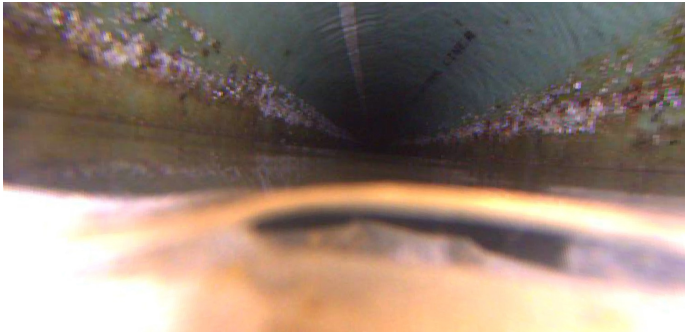
Code: **MWL**
Description: **Water Level**

Distance (ft): **242.7**
Structural Grade: **0**
O&M Grade: **0**
Clock Start/From:
Clock To:
1st Value:
2nd Value:
Value Percent: **25.000**
Continuous Index:
Within 8" of Joint: **NO**
Remarks:

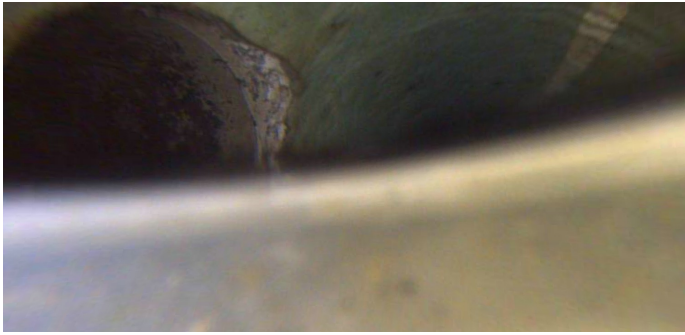
Code: **TBA**
Description: **Tap Break-in Active**

Distance (ft): **262.3**
Structural Grade: **0**
O&M Grade: **0**
Clock Start/From: **2**
Clock To:
1st Value: **4.000**
2nd Value:
Value Percent:
Continuous Index:
Within 8" of Joint:
Remarks:

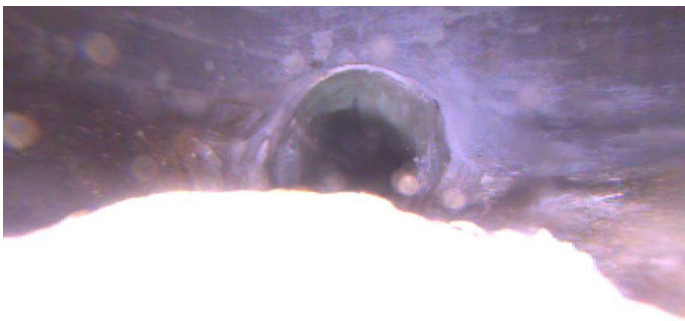
Code: **AMH**
Description: **Manhole**

Distance (ft): **272.3**
Structural Grade: **0**
O&M Grade: **0**
Clock Start/From:
Clock To:
1st Value:
2nd Value:
Value Percent:
Continuous Index:
Within 8" of Joint: **NO**
Remarks: **M-305-031**
