Profile/Photo Observation Report

Date:	04/18/2018	Weather:		Coding:	PACP 6.0
Pipe Length (ft):	321.1	Owner:	NA	Pre Clean:	No Pre-Cleaning
P.O.#:		Surveyor:	Byrd Fitzgerald	PSR:	P-305-033-034
Customer:		Clean Date:	01/01/1900	Shape:	C

Street:	OFF CRABAPPLE LN	Flow Control:	Not Controlled
City:	Hobart, IN	Year Renewed:	
Location:	Yard	Tape/Media #:	
Purpose:	Routine Assessment	Dia/Height:	8"
Use:	Sanitary	Material:	XXX
Drain Area:	NA	Lining:	Cured in Place
Category:	NA		
Comment:	Flow direction wrong		
Location Details:		Direction of Survey:	Downstream
US MH:	M-305-034	DS MH:	M-305-033
		Total Length Surveyed (ft):	320.1

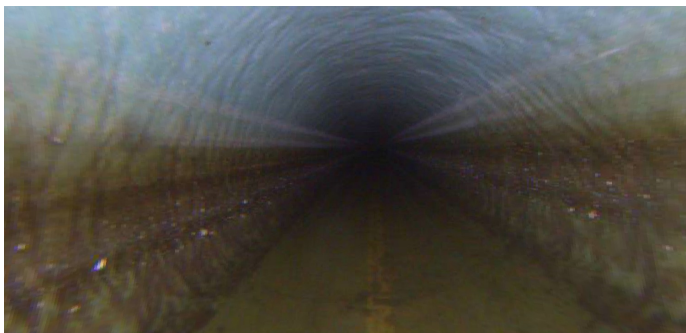
Code: **AMH**
Description: **Manhole**

Distance (ft): **.0**
Structural Grade: **0**
O&M Grade: **0**
Clock Start/From:
Clock To:
1st Value:
2nd Value:
Value Percent:
Continuous Index:
Within 8" of Joint: **NO**
Remarks: **M-305-034**

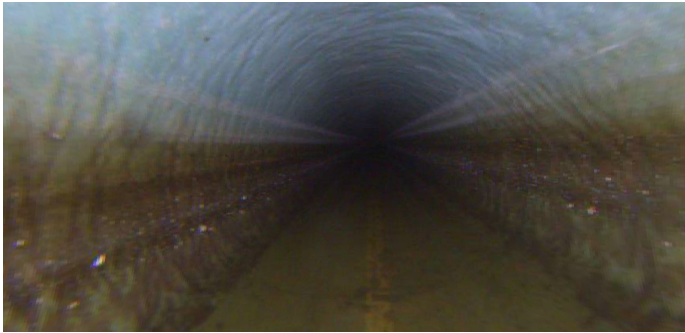
Code:	MWL
Description:	Water Level

Distance (ft):	.0
Structural Grade:	0
O&M Grade:	0
Clock Start/From:	
Clock To:	
1st Value:	
2nd Value:	
Value Percent:	5.000
Continuous Index:	
Within 8" of Joint:	NO
Remarks:

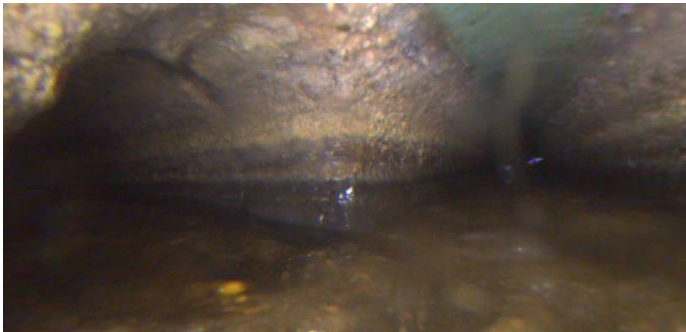
Code: **TFA**
Description: **Tap Factory Active**

Distance (ft): **108.3**
Structural Grade: **0**
O&M Grade: **0**
Clock Start/From: **3**
Clock To:
1st Value: **4.000**
2nd Value:
Value Percent:
Continuous Index:
Within 8" of Joint:
Remarks:

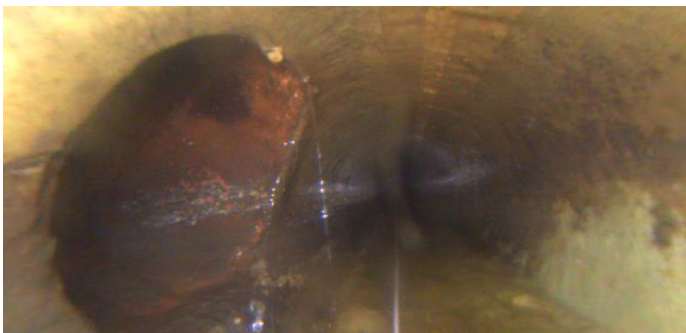
Code: **TFA**
Description: **Tap Factory Active**

Distance (ft): **263.9**
Structural Grade: **0**
O&M Grade: **0**
Clock Start/From: **3**
Clock To:
1st Value: **4.000**
2nd Value:
Value Percent:
Continuous Index:
Within 8" of Joint:
Remarks:
