Profile/Photo Observation Report

Date:	04/24/2018	Weather:		Coding:	PACP 6.0
Pipe Length (ft):	211.8	Owner:	NA	Pre Clean:	No Pre-Cleaning
P.O.#:		Surveyor:	Jen Costello	PSR:	P-305-042-043
Customer:		Clean Date:	01/01/1900	Shape:	C

Street:	CRESTWOOD DR	Flow Control:	Not Controlled
City:	Hobart, IN	Year Renewed:	
Location:	Yard	Tape/Media #:	
Purpose:	Routine Assessment	Dia/Height:	8"
Use:	Sanitary	Material:	PVC
Drain Area:	NA	Lining:	
Category:	NA		
Comment:

Location Details:		Direction of Survey:	Upstream
US MH:	M-305-042	DS MH:	M-305-043
		Total Length Surveyed (ft):	200.5

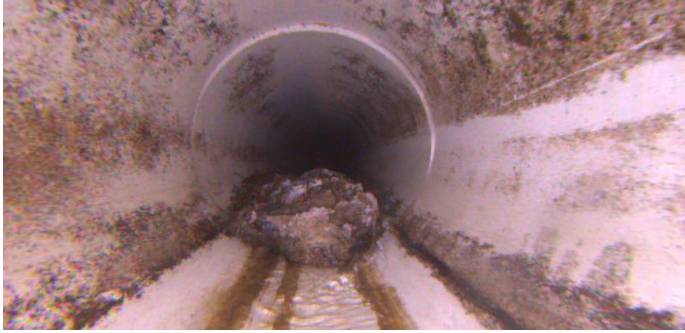
Code: **AMH**
Description: **Manhole**

Distance (ft): **.0**
Structural Grade: **0**
O&M Grade: **0**
Clock Start/From:
Clock To:
1st Value:
2nd Value:
Value Percent:
Continuous Index:
Within 8" of Joint: **NO**
Remarks: **M-305-043**

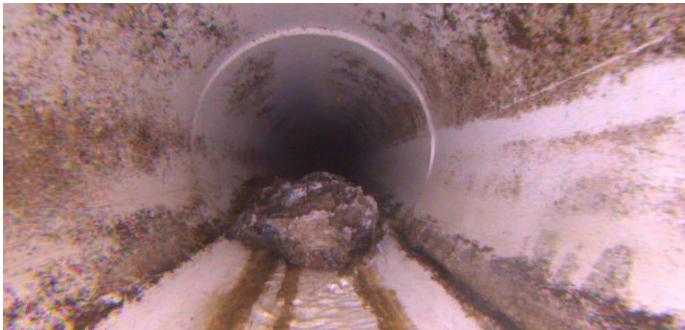
Code: **MWL**
Description: **Water Level**

Distance (ft): **.0**
Structural Grade: **0**
O&M Grade: **0**
Clock Start/From:
Clock To:
1st Value:
2nd Value:
Value Percent: **5.000**
Continuous Index:
Within 8" of Joint: **NO**
Remarks:

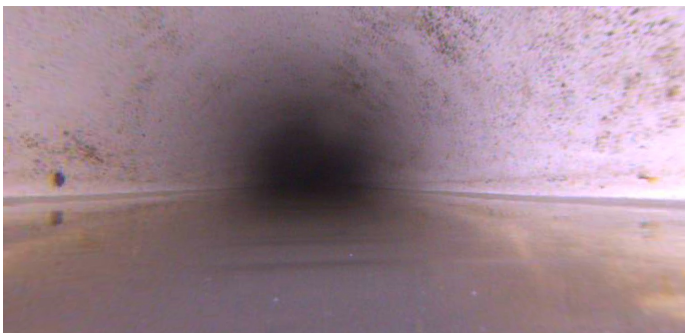
Code: **MWL**
Description: **Water Level**

Distance (ft): **5.3**
Structural Grade: **0**
O&M Grade: **0**
Clock Start/From:
Clock To:
1st Value:
2nd Value:
Value Percent: **40.000**
Continuous Index:
Within 8" of Joint: **NO**
Remarks:

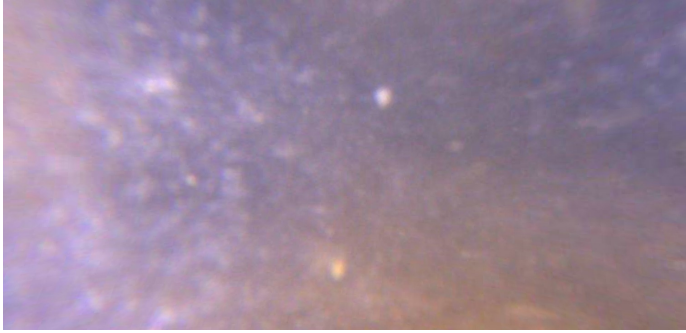
Code: **MWL**
Description: **Water Level**

Distance (ft): **13.0**
Structural Grade: **0**
O&M Grade: **0**
Clock Start/From:
Clock To:
1st Value:
2nd Value:
Value Percent: **100.000**
Continuous Index:
Within 8" of Joint: **NO**
Remarks:

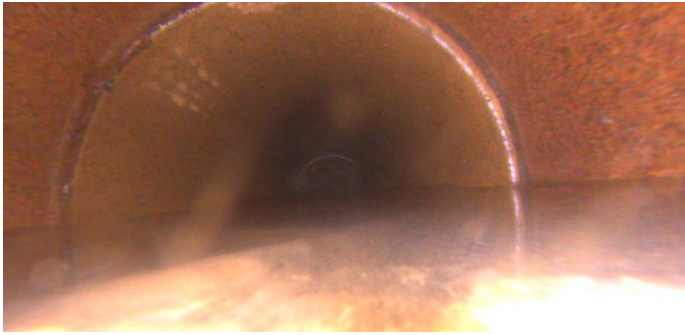
Code: **MMC**
Description: **Material Change**

Distance (ft): **14.9**
Structural Grade: **0**
O&M Grade: **0**
Clock Start/From:
Clock To:
1st Value:
2nd Value:
Value Percent:
Continuous Index:
Within 8" of Joint: **NO**
Remarks: **VCP**

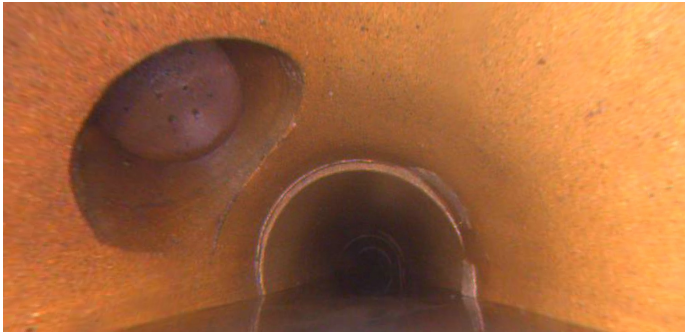
Code: **TF**
Description: **Tap Factory**

Distance (ft): **25.9**
Structural Grade: **0**
O&M Grade: **0**
Clock Start/From: **10**
Clock To:
1st Value: **4.000**
2nd Value:
Value Percent:
Continuous Index:
Within 8" of Joint:
Remarks:

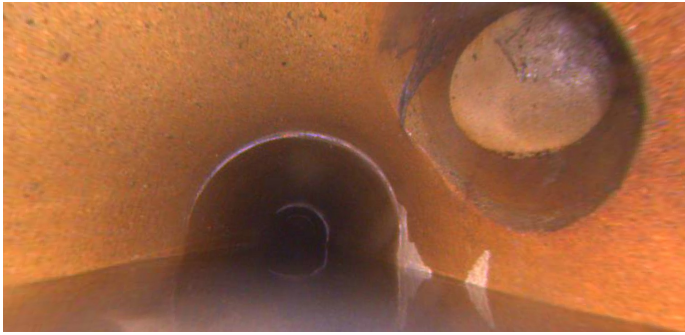
Code: **TFC**
Description: **Tap Factory Capped**

Distance (ft): **28.9**
Structural Grade: **0**
O&M Grade: **0**
Clock Start/From: **2**
Clock To:
1st Value: **4.000**
2nd Value:
Value Percent:
Continuous Index:
Within 8" of Joint:
Remarks:

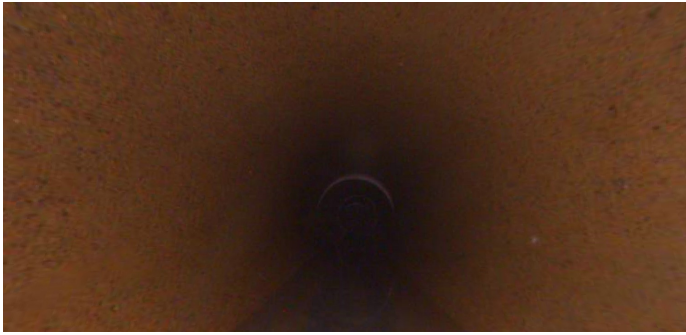
Code: **MMC**
Description: **Material Change**

Distance (ft): **100.7**
Structural Grade: **0**
O&M Grade: **0**
Clock Start/From:
Clock To:
1st Value:
2nd Value:
Value Percent:
Continuous Index:
Within 8" of Joint: **NO**
Remarks: **VCP**

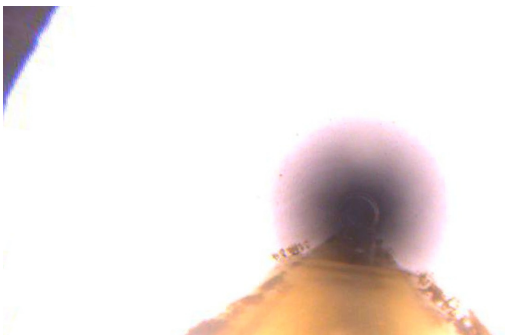
Code: **MMC**
Description: **Material Change**

Distance (ft): **120.8**
Structural Grade: **0**
O&M Grade: **0**
Clock Start/From:
Clock To:
1st Value:
2nd Value:
Value Percent:
Continuous Index:
Within 8" of Joint: **NO**
Remarks: **pvc**

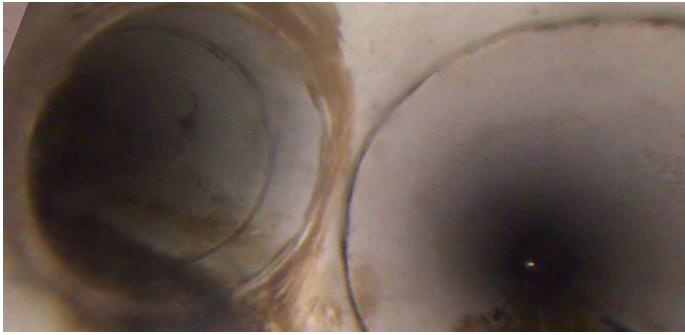
Code: **TFA**
Description: **Tap Factory Active**

Distance (ft): **127.1**
Structural Grade: **0**
O&M Grade: **0**
Clock Start/From: **3**
Clock To:
1st Value: **4.000**
2nd Value:
Value Percent:
Continuous Index:
Within 8" of Joint:
Remarks:

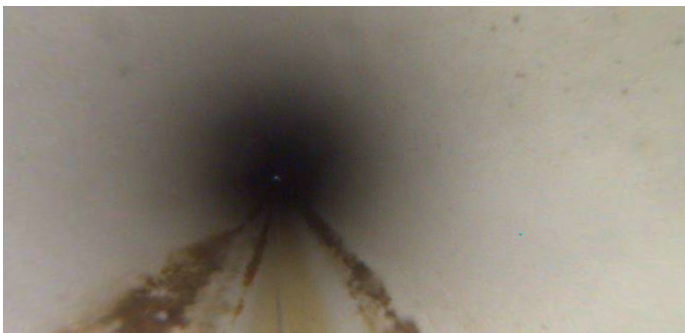
Code: **MGO**
Description: **General Observation**

Distance (ft): **135.3**
Structural Grade: **0**
O&M Grade: **0**
Clock Start/From:
Clock To:
1st Value:
2nd Value:
Value Percent:
Continuous Index:
Within 8" of Joint: **NO**
Remarks: **rear camera**

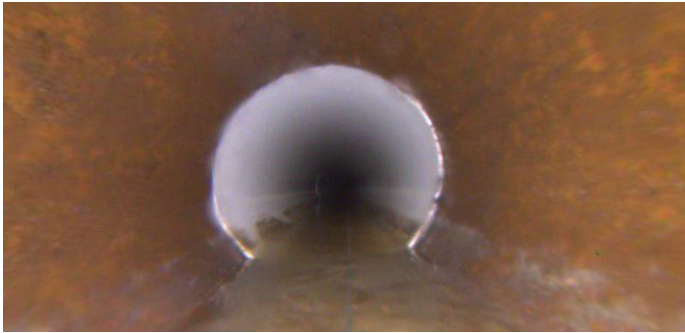
Code: **MMC**
Description: **Material Change**

Distance (ft): **158.8**
Structural Grade: **0**
O&M Grade: **0**
Clock Start/From:
Clock To:
1st Value:
2nd Value:
Value Percent:
Continuous Index:
Within 8" of Joint: **NO**
Remarks: **vcp**

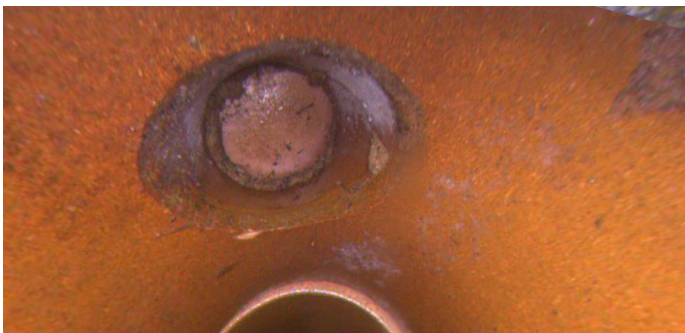
Code: **TFC**
Description: **Tap Factory Capped**

Distance (ft): **195.5**
Structural Grade: **0**
O&M Grade: **0**
Clock Start/From: **12**
Clock To:
1st Value: **4.000**
2nd Value:
Value Percent:
Continuous Index:
Within 8" of Joint:
Remarks:

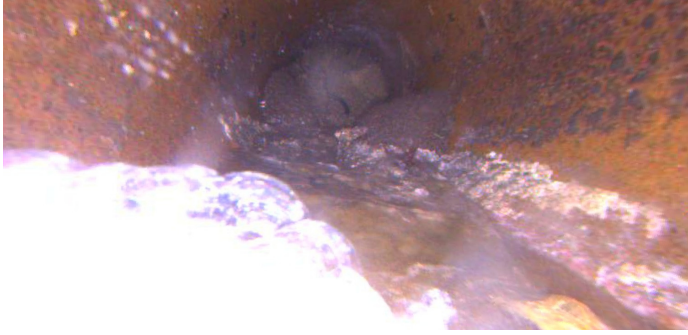
Code:	AMH
Description:	Manhole
Distance (ft):	200.5
Structural Grade:	0
O&M Grade:	0
Clock Start/From:	
Clock To:	
1st Value:	
2nd Value:	
Value Percent:	
Continuous Index:	
Within 8" of Joint:	NO
Remarks:	M-305-042
