## Profile/Photo Observation Report

Street:	<b>FOXCROFT STREET</b>	Flow Control:	<b>Not Controlled</b>
City:	<b>Hobart, IN</b>	Year Renewed:	
Location:	<b>Yard</b>	Tape/Media #:	
Purpose:	<b>Routine Assessment</b>	Dia/Height:	<b>8"</b>
Use:	<b>Sanitary</b>	Material:	<b>PVC</b>
Drain Area:	<b>NA</b>	Lining:	
Category:	<b>NA</b>		
Comment:

Location Details:		Direction of Survey:	<b>Upstream</b>
US MH:	<b>M-305-042</b>	DS MH:	<b>M-305-043</b>
		Total Length Surveyed (ft):	<b>200.5</b>

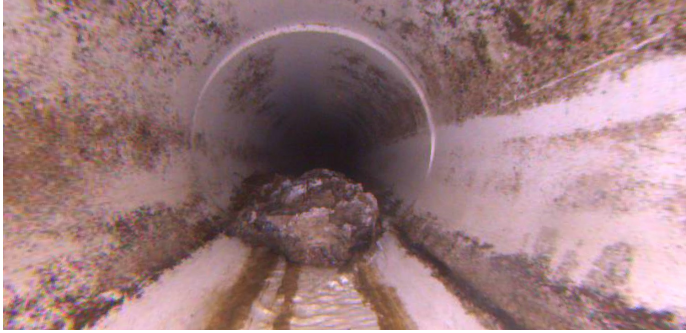
Code: **AMH**  
Description: **Manhole**

Distance (ft): **.0**  
Structural Grade: **0**  
O&M Grade: **0**  
Clock Start/From:  
Clock To:  
1st Value:  
2nd Value:  
Value Percent:  
Continuous Index:  
Within 8" of Joint: **NO**  
Remarks: **M-305-043**

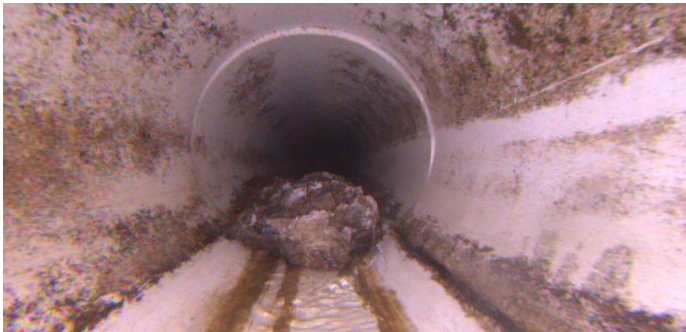
Code: **MWL**  
Description: **Water Level**

Distance (ft): **.0**  
Structural Grade: **0**  
O&M Grade: **0**  
Clock Start/From:  
Clock To:  
1st Value:  
2nd Value:  
Value Percent: **5.000**  
Continuous Index:  
Within 8" of Joint: **NO**  
Remarks:

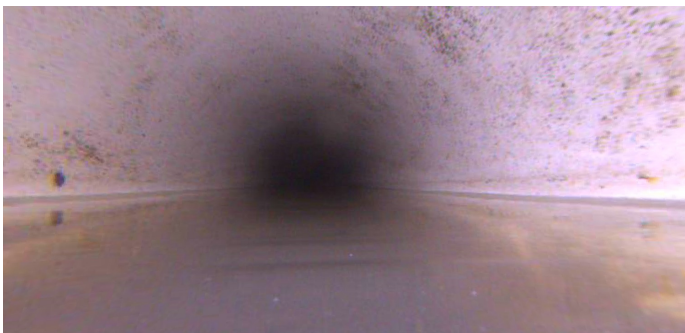
Code: **MWL**  
Description: **Water Level**

Distance (ft): **5.3**  
Structural Grade: **0**  
O&M Grade: **0**  
Clock Start/From:  
Clock To:  
1st Value:  
2nd Value:  
Value Percent: **40.000**  
Continuous Index:  
Within 8" of Joint: **NO**  
Remarks:

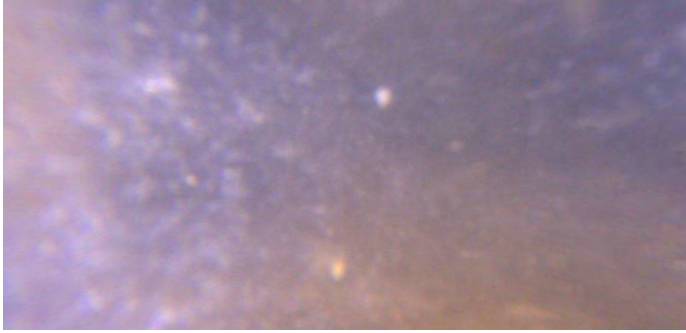
Code: **MWL**  
Description: **Water Level**

Distance (ft): **13.0**  
Structural Grade: **0**  
O&M Grade: **0**  
Clock Start/From:  
Clock To:  
1st Value:  
2nd Value:  
Value Percent: **100.000**  
Continuous Index:  
Within 8" of Joint: **NO**  
Remarks:

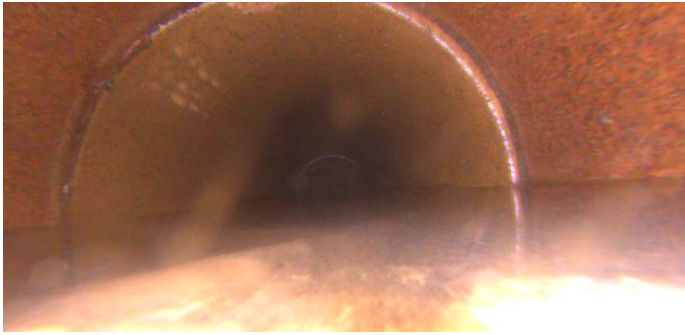
Code: **MMC**  
Description: **Material Change**

Distance (ft): **14.9**  
Structural Grade: **0**  
O&M Grade: **0**  
Clock Start/From:  
Clock To:  
1st Value:  
2nd Value:  
Value Percent:  
Continuous Index:  
Within 8" of Joint: **NO**  
Remarks: **VCP**

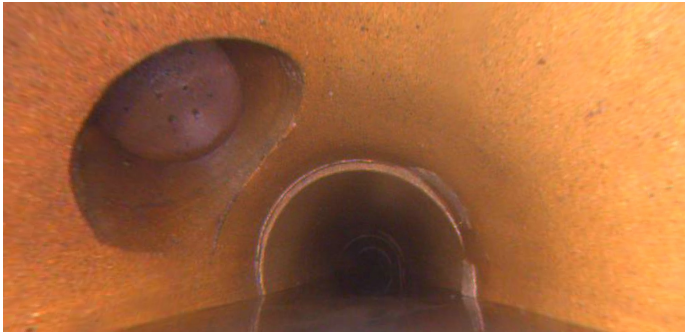
Code: **TF**  
Description: **Tap Factory**

Distance (ft): **25.9**  
Structural Grade: **0**  
O&M Grade: **0**  
Clock Start/From: **10**  
Clock To:  
1st Value: **4.000**  
2nd Value:  
Value Percent:  
Continuous Index:  
Within 8" of Joint:  
Remarks:

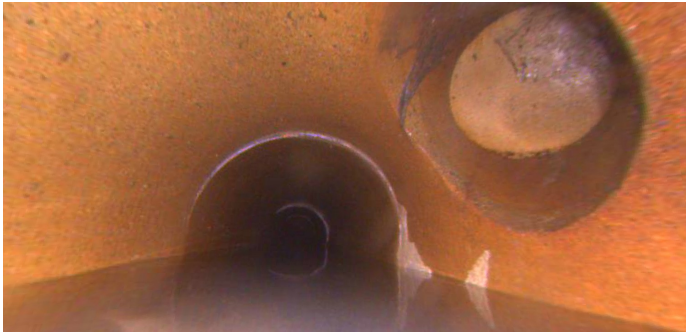
Code: **TFC**  
Description: **Tap Factory Capped**

Distance (ft): **28.9**  
Structural Grade: **0**  
O&M Grade: **0**  
Clock Start/From: **2**  
Clock To:  
1st Value: **4.000**  
2nd Value:  
Value Percent:  
Continuous Index:  
Within 8" of Joint:  
Remarks:

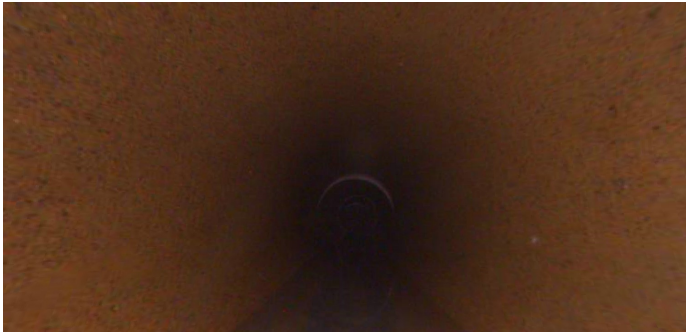
Code: **MMC**  
Description: **Material Change**

Distance (ft): **100.7**  
Structural Grade: **0**  
O&M Grade: **0**  
Clock Start/From:  
Clock To:  
1st Value:  
2nd Value:  
Value Percent:  
Continuous Index:  
Within 8" of Joint: **NO**  
Remarks: **VCP**

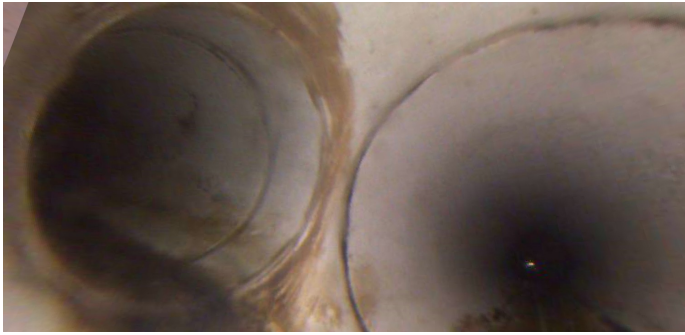
Code: **TFA**  
Description: **Tap Factory Active**

Distance (ft): **127.1**  
Structural Grade: **0**  
O&M Grade: **0**  
Clock Start/From: **3**  
Clock To:  
1st Value: **4.000**  
2nd Value:  
Value Percent:  
Continuous Index:  
Within 8" of Joint:  
Remarks:

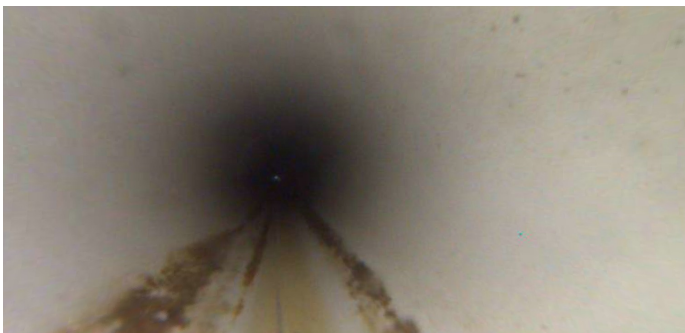
Code: **MGO**  
Description: **General Observation**

Distance (ft): **135.3**  
Structural Grade: **0**  
O&M Grade: **0**  
Clock Start/From:  
Clock To:  
1st Value:  
2nd Value:  
Value Percent:  
Continuous Index:  
Within 8" of Joint: **NO**  
Remarks: **rear camera**

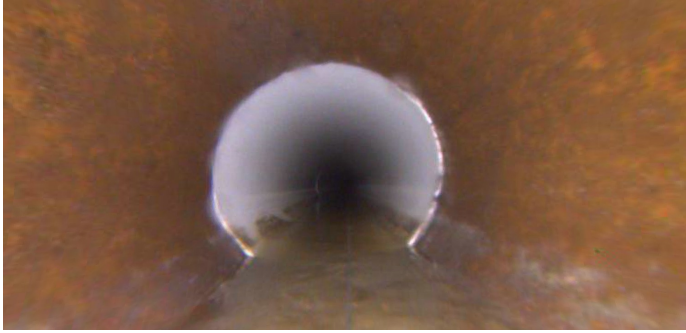
Code: **MMC**  
Description: **Material Change**

Distance (ft): **158.8**  
Structural Grade: **0**  
O&M Grade: **0**  
Clock Start/From:  
Clock To:  
1st Value:  
2nd Value:  
Value Percent:  
Continuous Index:  
Within 8" of Joint: **NO**  
Remarks: **vcp**

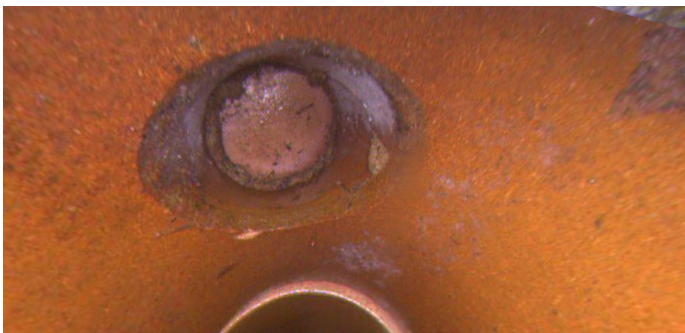
Code: **TFC**  
Description: **Tap Factory Capped**

Distance (ft): **195.5**  
Structural Grade: **0**  
O&M Grade: **0**  
Clock Start/From: **12**  
Clock To:  
1st Value: **4.000**  
2nd Value:  
Value Percent:  
Continuous Index:  
Within 8" of Joint:  
Remarks:

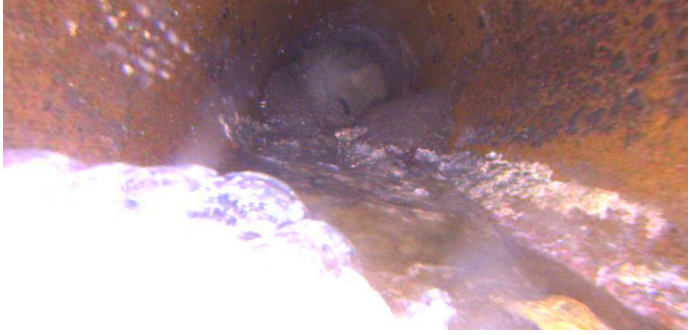
Code:	AMH
Description:	Manhole
Distance (ft):	200.5
Structural Grade:	0
O&M Grade:	0
Clock Start/From:	
Clock To:	
1st Value:	
2nd Value:	
Value Percent:	
Continuous Index:	
Within 8" of Joint:	NO
Remarks:	M-305-042
