Profile/Photo Observation Report

Date:	04/20/2018	Weather:		Coding:	PACP 6.0
Pipe Length (ft):	205.4	Owner:	NA	Pre Clean:	No Pre-Cleaning
P.O.#:		Surveyor:	Byrd Fitzgerald	PSR:	P-305-043-057
Customer:		Clean Date:	01/01/1900	Shape:	C

Street:	CRESTWOOD DR	Flow Control:	Not Controlled
City:	Hobart, IN	Year Renewed:	
Location:	Yard	Tape/Media #:	
Purpose:	Routine Assessment	Dia/Height:	10"
Use:	Sanitary	Material:	VCP
Drain Area:	NA	Lining:	
Category:	NA		
Comment:	P_C at 176 ft debris		
Location Details:		Direction of Survey:	Upstream
US MH:	M-305-043	DS MH:	M-305-057
		Total Length Surveyed (ft):	177.7

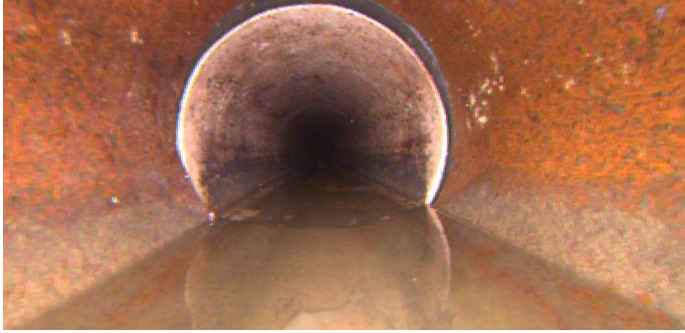
Code: **AMH**
Description: **Manhole**

Distance (ft): **.0**
Structural Grade: **0**
O&M Grade: **0**
Clock Start/From:
Clock To:
1st Value:
2nd Value:
Value Percent:
Continuous Index:
Within 8" of Joint: **NO**
Remarks: **M-305-057**

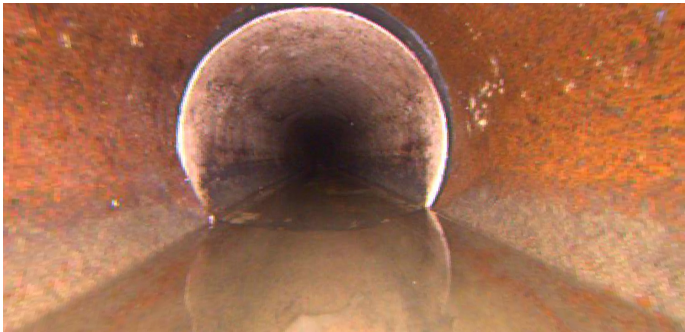
Code: **MWL**
Description: **Water Level**

Distance (ft): **.0**
Structural Grade: **0**
O&M Grade: **0**
Clock Start/From:
Clock To:
1st Value:
2nd Value:
Value Percent: **5.000**
Continuous Index:
Within 8" of Joint: **NO**
Remarks:

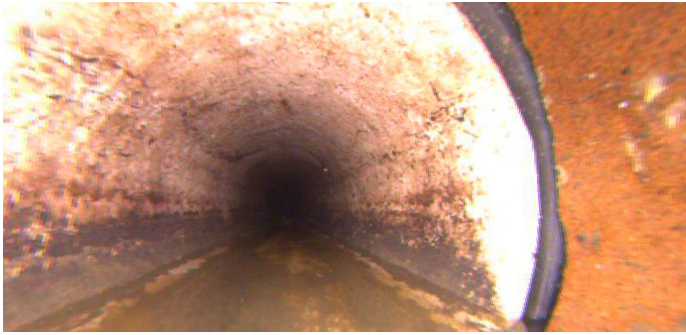
Code: **MMC**
Description: **Material Change**

Distance (ft): **1.9**
Structural Grade: **0**
O&M Grade: **0**
Clock Start/From:
Clock To:
1st Value:
2nd Value:
Value Percent:
Continuous Index:
Within 8" of Joint: **NO**
Remarks: **pvc**

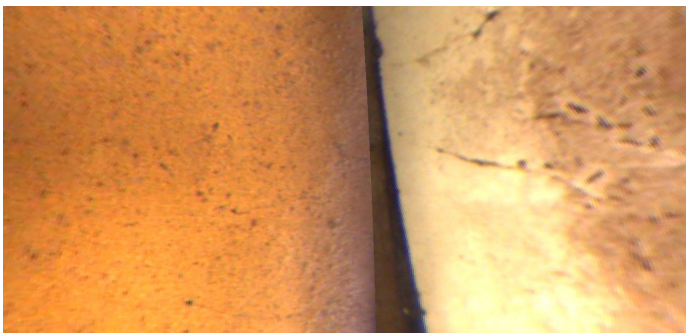
Code: **MMC**
Description: **Material Change**

Distance (ft): **8.2**
Structural Grade: **0**
O&M Grade: **0**
Clock Start/From:
Clock To:
1st Value:
2nd Value:
Value Percent:
Continuous Index:
Within 8" of Joint: **NO**
Remarks: **vcp**

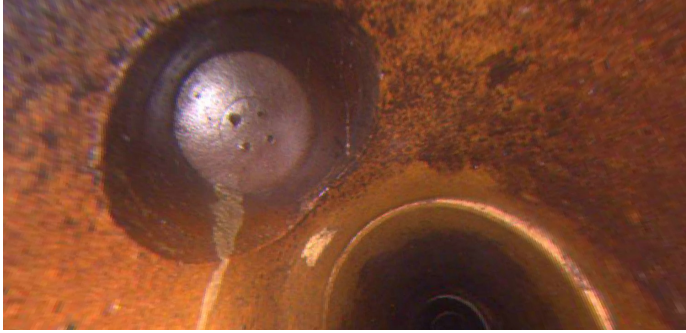
Code: **TFC**
Description: **Tap Factory Capped**

Distance (ft): **18.9**
Structural Grade: **0**
O&M Grade: **0**
Clock Start/From: **11**
Clock To:
1st Value: **4.000**
2nd Value:
Value Percent:
Continuous Index:
Within 8" of Joint: **YES**
Remarks:

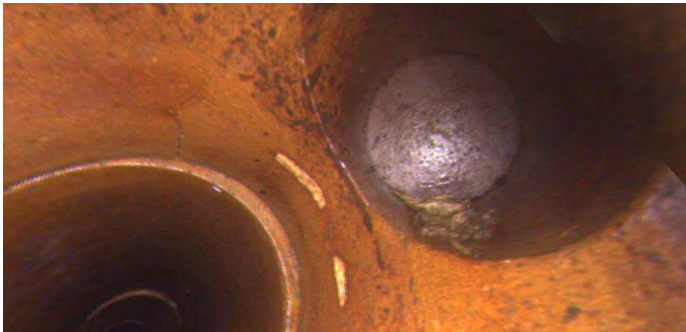
Code: **TFC**
Description: **Tap Factory Capped**

Distance (ft): **21.9**
Structural Grade: **0**
O&M Grade: **0**
Clock Start/From: **2**
Clock To:
1st Value: **4.000**
2nd Value:
Value Percent:
Continuous Index:
Within 8" of Joint: **YES**
Remarks:

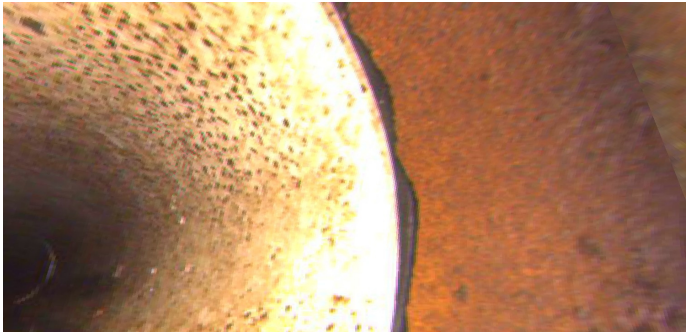
Code: **MMC**
Description: **Material Change**

Distance (ft): **34.1**
Structural Grade: **0**
O&M Grade: **0**
Clock Start/From:
Clock To:
1st Value:
2nd Value:
Value Percent:
Continuous Index:
Within 8" of Joint: **NO**
Remarks: **pvc**

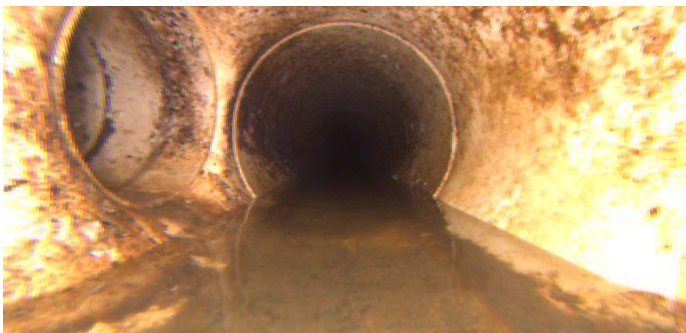
Code: **TF**
Description: **Tap Factory**

Distance (ft): **57.0**
Structural Grade: **0**
O&M Grade: **0**
Clock Start/From: **9**
Clock To:
1st Value: **6.000**
2nd Value:
Value Percent:
Continuous Index:
Within 8" of Joint: **YES**
Remarks:

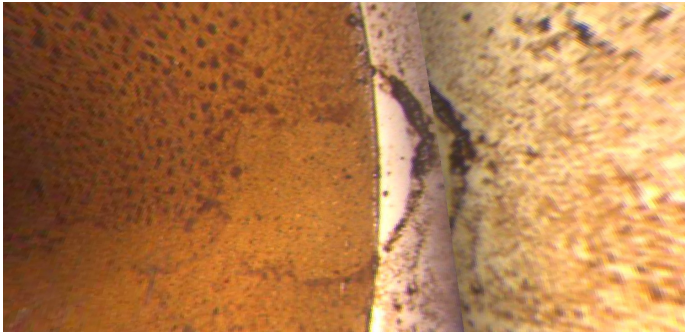
Code: **MMC**
Description: **Material Change**

Distance (ft): **78.8**
Structural Grade: **0**
O&M Grade: **0**
Clock Start/From:
Clock To:
1st Value:
2nd Value:
Value Percent:
Continuous Index:
Within 8" of Joint: **NO**
Remarks: **vcp**

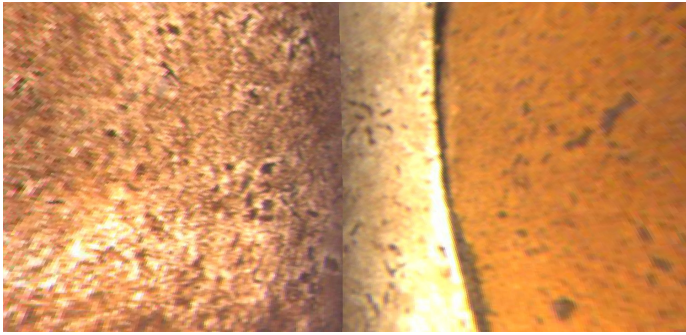
Code: **MMC**
Description: **Material Change**

Distance (ft): **110.8**
Structural Grade: **0**
O&M Grade: **0**
Clock Start/From:
Clock To:
1st Value:
2nd Value:
Value Percent:
Continuous Index:
Within 8" of Joint: **NO**
Remarks: **pvc**

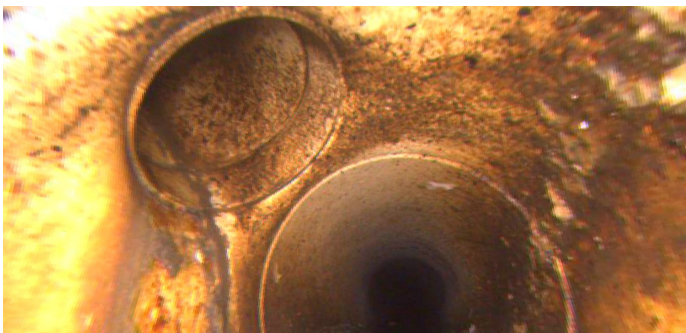
Code: **TF**
Description: **Tap Factory**

Distance (ft): **121.9**
Structural Grade: **0**
O&M Grade: **0**
Clock Start/From: **11**
Clock To:
1st Value: **4.000**
2nd Value:
Value Percent:
Continuous Index:
Within 8" of Joint: **YES**
Remarks:

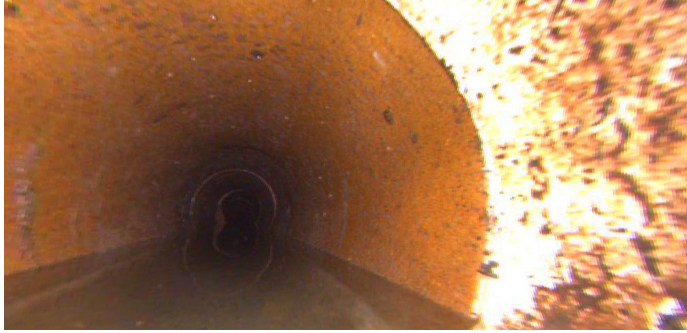
Code:	MMC
Description:	Material Change
Distance (ft):	149.3
Structural Grade:	0
O&M Grade:	0
Clock Start/From:	
Clock To:	
1st Value:	
2nd Value:	
Value Percent:	
Continuous Index:	
Within 8" of Joint:	NO
Remarks:	vcp
