## Profile/Photo Observation Report

Date:	<b>04/20/2018</b>	Weather:		Coding:	<b>PACP 6.0</b>
Pipe Length (ft):	<b>205.4</b>	Owner:	<b>NA</b>	Pre Clean:	<b>No Pre-Cleaning</b>
P.O.#:		Surveyor:	<b>Byrd Fitzgerald</b>	PSR:	<b>P-305-043-057</b>
Customer:		Clean Date:	<b>01/01/1900</b>	Shape:	<b>C</b>

Street:	<b>FOXCROFT STREET</b>	Flow Control:	<b>Not Controlled</b>
City:	<b>Hobart, IN</b>	Year Renewed:	
Location:	<b>Yard</b>	Tape/Media #:	
Purpose:	<b>Routine Assessment</b>	Dia/Height:	<b>10"</b>
Use:	<b>Sanitary</b>	Material:	<b>VCP</b>
Drain Area:	<b>NA</b>	Lining:	
Category:	<b>NA</b>		
Comment:	<b>P_C at 176 ft debris</b>		
Location Details:		Direction of Survey:	<b>Upstream</b>
US MH:	<b>M-305-043</b>	DS MH:	<b>M-305-057</b>
		Total Length Surveyed (ft):	<b>177.7</b>

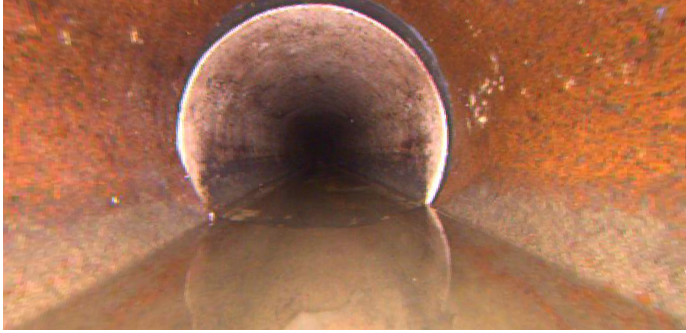
Code: **AMH**  
Description: **Manhole**

Distance (ft): **.0**  
Structural Grade: **0**  
O&M Grade: **0**  
Clock Start/From:  
Clock To:  
1st Value:  
2nd Value:  
Value Percent:  
Continuous Index:  
Within 8" of Joint: **NO**  
Remarks: **M-305-057**

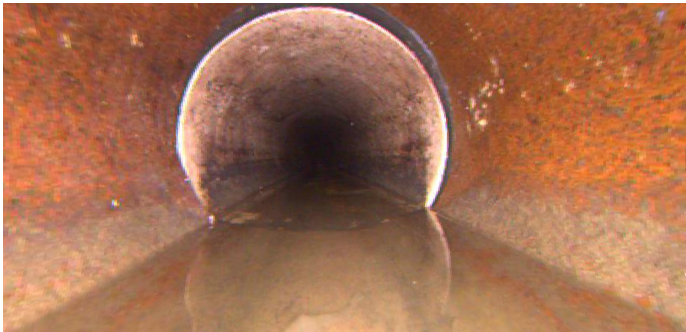
Code: **MWL**  
Description: **Water Level**

Distance (ft): **.0**  
Structural Grade: **0**  
O&M Grade: **0**  
Clock Start/From:  
Clock To:  
1st Value:  
2nd Value:  
Value Percent: **5.000**  
Continuous Index:  
Within 8" of Joint: **NO**  
Remarks:

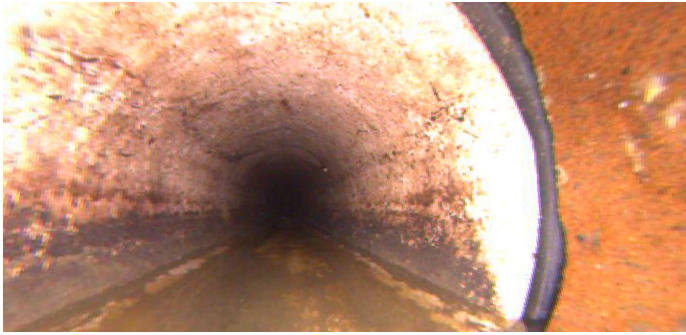
Code: **MMC**  
Description: **Material Change**

Distance (ft): **1.9**  
Structural Grade: **0**  
O&M Grade: **0**  
Clock Start/From:  
Clock To:  
1st Value:  
2nd Value:  
Value Percent:  
Continuous Index:  
Within 8" of Joint: **NO**  
Remarks: **pvc**

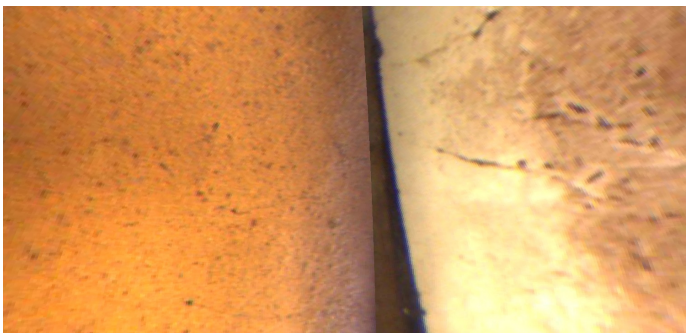
Code: **MMC**  
Description: **Material Change**

Distance (ft): **8.2**  
Structural Grade: **0**  
O&M Grade: **0**  
Clock Start/From:  
Clock To:  
1st Value:  
2nd Value:  
Value Percent:  
Continuous Index:  
Within 8" of Joint: **NO**  
Remarks: **vcp**

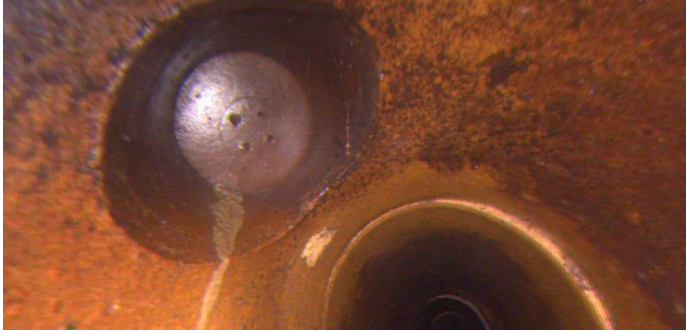
Code: **TFC**  
Description: **Tap Factory Capped**

Distance (ft): **18.9**  
Structural Grade: **0**  
O&M Grade: **0**  
Clock Start/From: **11**  
Clock To:  
1st Value: **4.000**  
2nd Value:  
Value Percent:  
Continuous Index:  
Within 8" of Joint: **YES**  
Remarks:

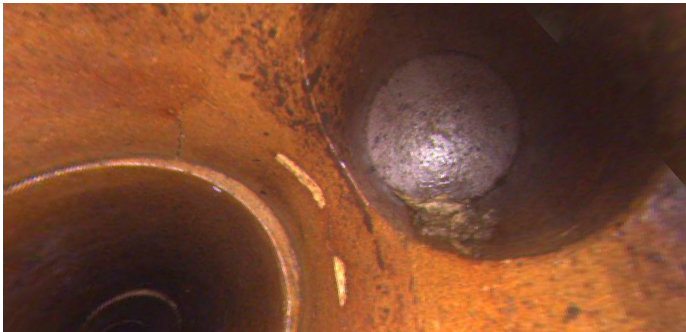
Code: **TFC**  
Description: **Tap Factory Capped**

Distance (ft): **21.9**  
Structural Grade: **0**  
O&M Grade: **0**  
Clock Start/From: **2**  
Clock To:  
1st Value: **4.000**  
2nd Value:  
Value Percent:  
Continuous Index:  
Within 8" of Joint: **YES**  
Remarks:

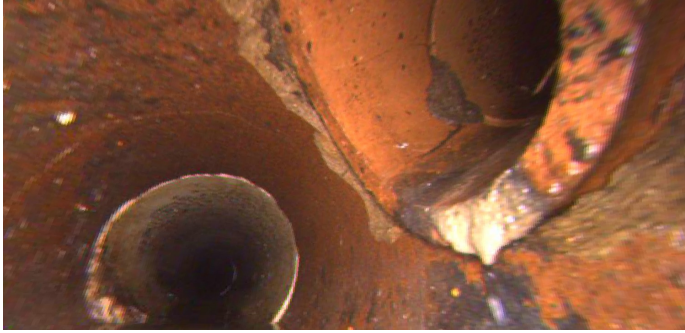
Code: **TB**  
Description: **Tap Break-in**

Distance (ft): **32.9**  
Structural Grade: **0**  
O&M Grade: **0**  
Clock Start/From: **2**  
Clock To:  
1st Value: **6.000**  
2nd Value:  
Value Percent:  
Continuous Index:  
Within 8" of Joint:  
Remarks:

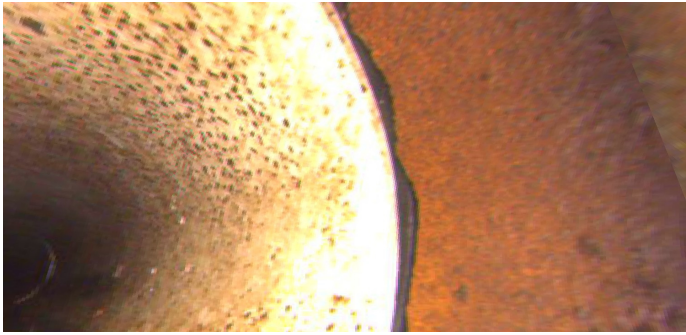
Code: **MMC**  
Description: **Material Change**

Distance (ft): **34.1**  
Structural Grade: **0**  
O&M Grade: **0**  
Clock Start/From:  
Clock To:  
1st Value:  
2nd Value:  
Value Percent:  
Continuous Index:  
Within 8" of Joint: **NO**  
Remarks: **pvc**

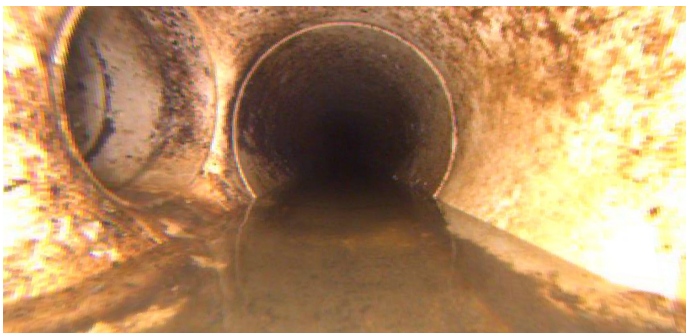
Code: **TF**  
Description: **Tap Factory**

Distance (ft): **57.0**  
Structural Grade: **0**  
O&M Grade: **0**  
Clock Start/From: **9**  
Clock To:  
1st Value: **6.000**  
2nd Value:  
Value Percent:  
Continuous Index:  
Within 8" of Joint: **YES**  
Remarks:

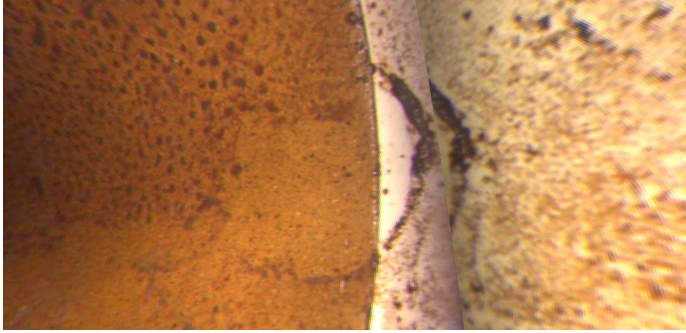
Code: **MMC**  
Description: **Material Change**

Distance (ft): **78.8**  
Structural Grade: **0**  
O&M Grade: **0**  
Clock Start/From:  
Clock To:  
1st Value:  
2nd Value:  
Value Percent:  
Continuous Index:  
Within 8" of Joint: **NO**  
Remarks: **vcp**

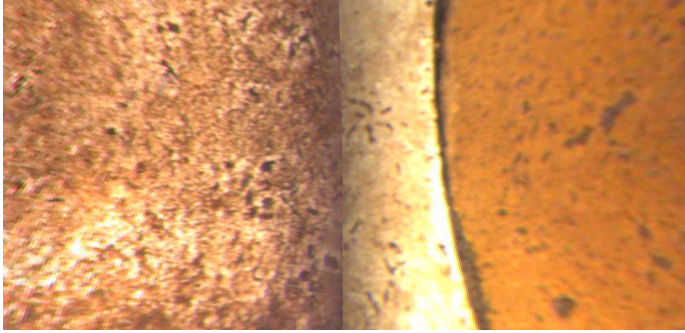
Code: **MMC**  
Description: **Material Change**

Distance (ft): **110.8**  
Structural Grade: **0**  
O&M Grade: **0**  
Clock Start/From:  
Clock To:  
1st Value:  
2nd Value:  
Value Percent:  
Continuous Index:  
Within 8" of Joint: **NO**  
Remarks: **pvc**

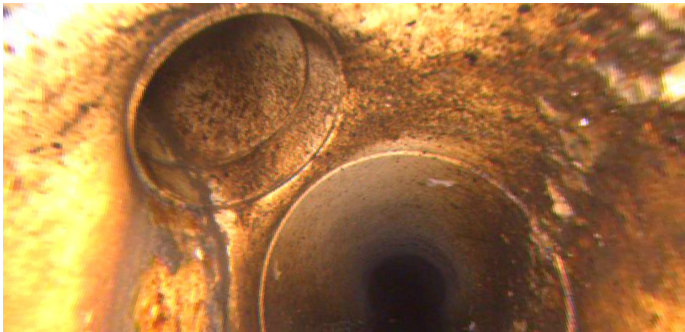
Code: **TF**  
Description: **Tap Factory**

Distance (ft): **121.9**  
Structural Grade: **0**  
O&M Grade: **0**  
Clock Start/From: **11**  
Clock To:  
1st Value: **4.000**  
2nd Value:  
Value Percent:  
Continuous Index:  
Within 8" of Joint: **YES**  
Remarks:

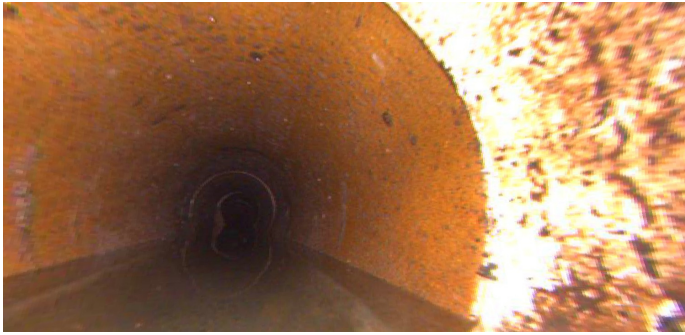
Code: **MMC**  
Description: **Material Change**

Distance (ft): **149.3**  
Structural Grade: **0**  
O&M Grade: **0**  
Clock Start/From:  
Clock To:  
1st Value:  
2nd Value:  
Value Percent:  
Continuous Index:  
Within 8" of Joint: **NO**  
Remarks: **vcp**
