Profile/Photo Observation Report

Date:	04/24/2018	Weather:		Coding:	PACP 6.0
Pipe Length (ft):	205.4	Owner:	NA	Pre Clean:	No Pre-Cleaning
P.O.#:		Surveyor:	Jen Costello	PSR:	P-305-043-057
Customer:		Clean Date:	01/01/1900	Shape:	C

Street:	FOXCROFT STREET	Flow Control:	Not Controlled
City:	Hobart, IN	Year Renewed:	
Location:	Yard	Tape/Media #:	
Purpose:	Routine Assessment	Dia/Height:	8"
Use:	Sanitary	Material:	VCP
Drain Area:	NA	Lining:	
Category:	NA		
Comment:	R_M at 32 ft debris

Location Details:		Direction of Survey:	Downstream
US MH:	M-305-043	DS MH:	M-305-057
		Total Length Surveyed (ft):	33.1

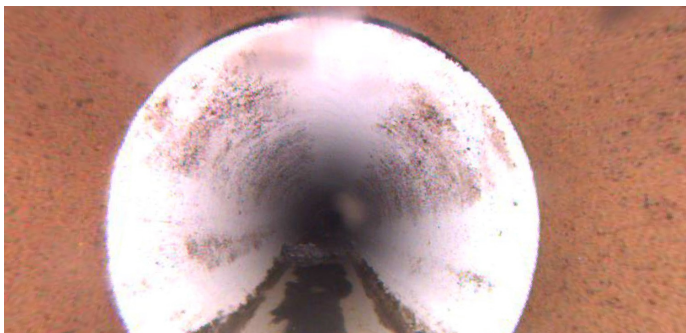
Code: **AMH**
Description: **Manhole**

Distance (ft): **.0**
Structural Grade: **0**
O&M Grade: **0**
Clock Start/From:
Clock To:
1st Value:
2nd Value:
Value Percent:
Continuous Index:
Within 8" of Joint: **NO**
Remarks: **M-305-043**

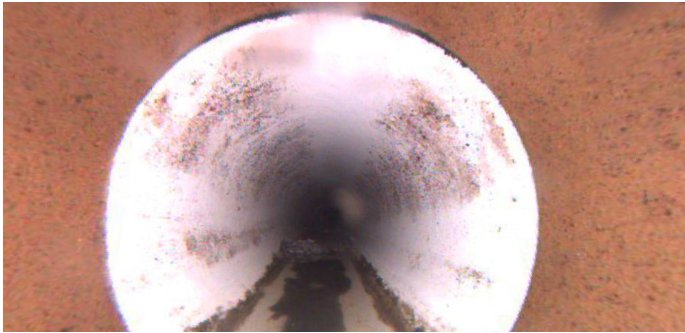
Code:	MWL
Description:	Water Level

Distance (ft):	.0
Structural Grade:	0
O&M Grade:	0
Clock Start/From:	
Clock To:	
1st Value:	
2nd Value:	
Value Percent:	5.000
Continuous Index:	
Within 8" of Joint:	NO
Remarks:
