Profile/Photo Observation Report

Date:	09/15/2022	Weather:		Coding:	PACP 7.0
Pipe Length (ft):	252.0	Owner:	City of Hobart	Pre Clean:	Heavy Cleaning
P.O.#:	YES502259	Surveyor:	S. Bucklin	PSR:	P-305-044-045
Customer:	City of Hobart	Clean Date:	08/14/2022	Shape:	C

Street:	West 3rd Street	Flow Control:	Not Controlled
City:	Hobart, IN	Year Renewed:	
Location:	Local rural streets with light traffic, t	Tape/Media #:	
Purpose:	Routine Assessment	Dia/Height:	15"
Use:	Sanitary Sewage Pipe	Material:	RCP
Drain Area:		Lining:	None
Category:	NA		
Comment:			
Location Details:		Direction of Survey:	Upstream
US MH:	M-305-044	DS MH:	M-405-045
		Total Length Surveyed (ft):	251.1

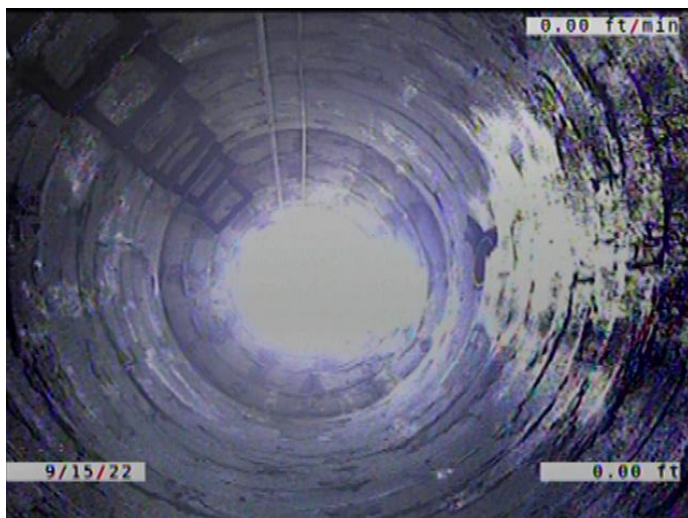
Code: **AMH**
 Description: **Manhole**

Distance (ft): **.0**
 Structural Grade: **0**
 O&M Grade: **0**
 Clock Start/From:
 Clock To:
 1st Value:
 2nd Value:
 Value Percent:
 Continuous Index:
 Within 8" of Joint: **NO**
 Remarks: **M-405-045**

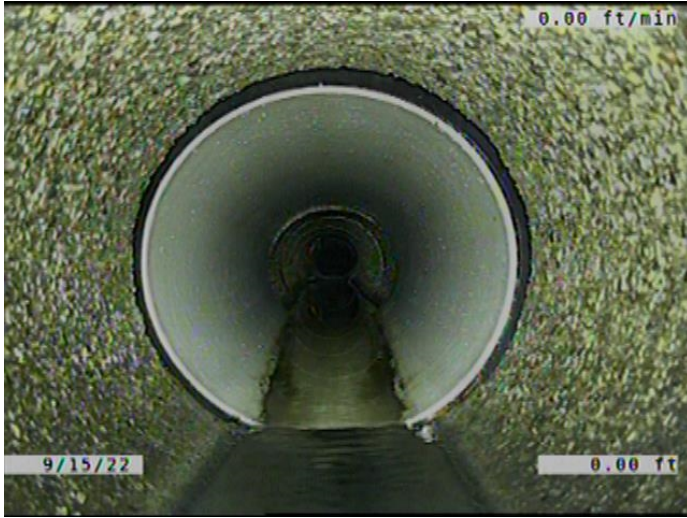
Code: **MWL**
Description: **Miscellaneous Water Level**

Distance (ft): **.0**
Structural Grade: **0**
O&M Grade: **0**
Clock Start/From:
Clock To:
1st Value:
2nd Value:
Value Percent: **5.000**
Continuous Index:
Within 8" of Joint: **NO**
Remarks:

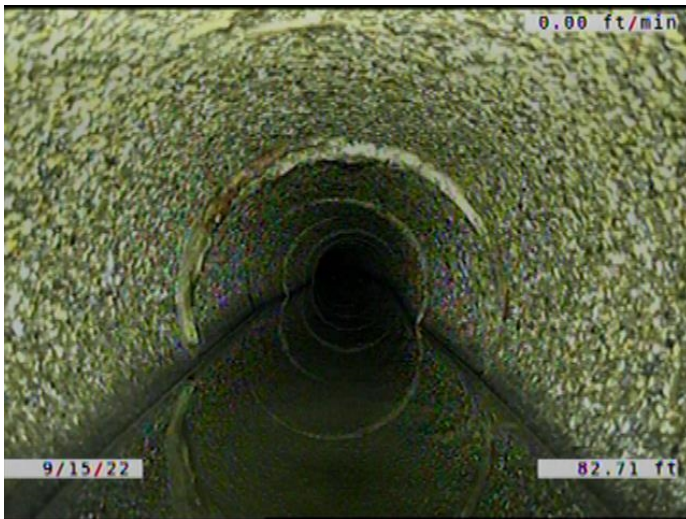
Code: **MWL**
Description: **Miscellaneous Water Level**

Distance (ft): **82.7**
Structural Grade: **0**
O&M Grade: **0**
Clock Start/From:
Clock To:
1st Value:
2nd Value:
Value Percent: **25.000**
Continuous Index:
Within 8" of Joint: **NO**
Remarks:

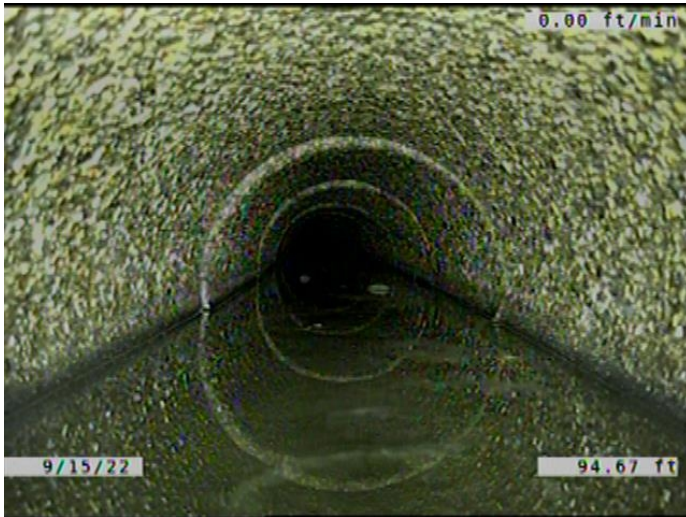
Code: **MWL**
Description: **Miscellaneous Water Level**

Distance (ft): **94.7**
Structural Grade: **0**
O&M Grade: **0**
Clock Start/From:
Clock To:
1st Value:
2nd Value:
Value Percent: **40.000**
Continuous Index:
Within 8" of Joint: **NO**
Remarks:

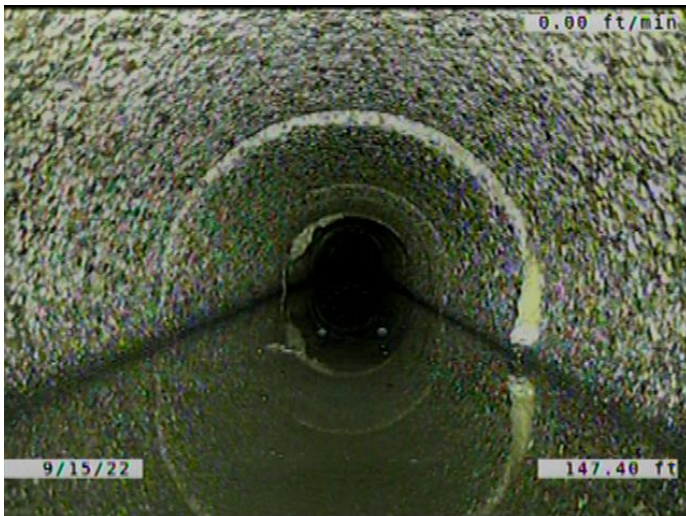
Code: **MWL**
Description: **Miscellaneous Water Level**

Distance (ft): **147.4**
Structural Grade: **0**
O&M Grade: **0**
Clock Start/From:
Clock To:
1st Value:
2nd Value:
Value Percent: **25.000**
Continuous Index:
Within 8" of Joint: **NO**
Remarks:

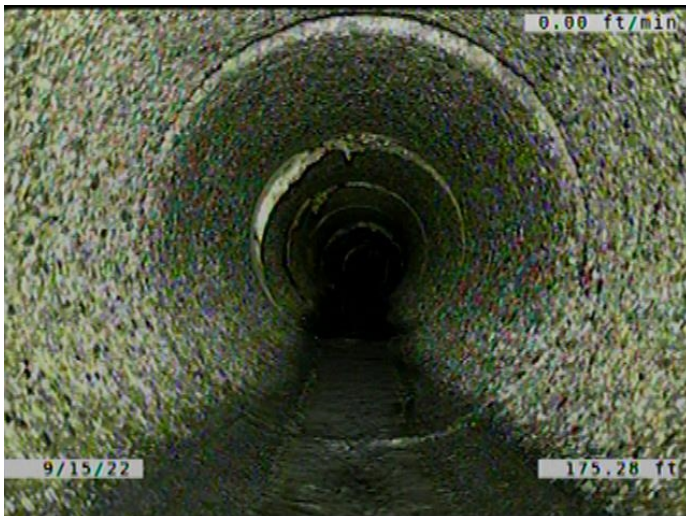
Code: **MWL**
 Description: **Miscellaneous Water Level**

Distance (ft): **175.3**
 Structural Grade: **0**
 O&M Grade: **0**
 Clock Start/From:
 Clock To:
 1st Value:
 2nd Value:
 Value Percent: **5.000**
 Continuous Index:
 Within 8" of Joint: **NO**
 Remarks:

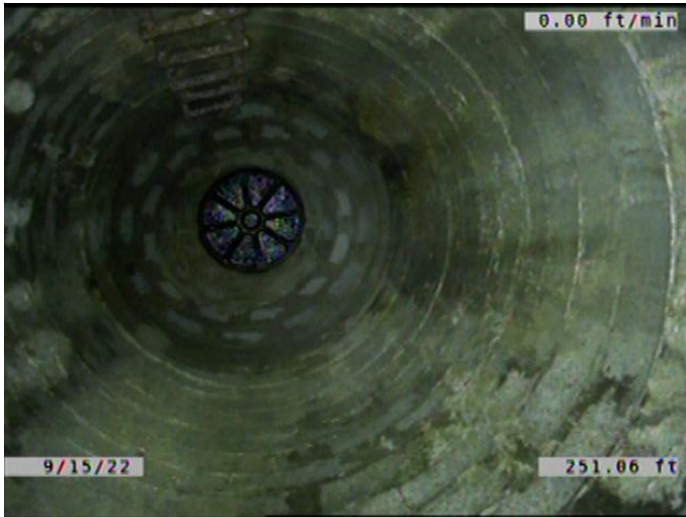
Code:	AMH
Description:	Manhole
Distance (ft):	251.1
Structural Grade:	0
O&M Grade:	0
Clock Start/From:	
Clock To:	
1st Value:	
2nd Value:	
Value Percent:	
Continuous Index:	
Within 8" of Joint:	NO
Remarks:	M-305-044
