## Profile/Photo Observation Report

Date:	<b>09/14/2022</b>	Weather:		Coding:	<b>PACP 7.0</b>
Pipe Length (ft):	<b>194.0</b>	Owner:	<b>City of Hobart</b>	Pre Clean:	<b>Heavy Cleaning</b>
P.O.#:	<b>YES502259</b>	Surveyor:	<b>S. Bucklin</b>	PSR:	<b>P-305-046-044</b>
Customer:	<b>City of Hobart</b>	Clean Date:	<b>08/13/2022</b>	Shape:	<b>C</b>

Street:	<b>West 3rd Street</b>	Flow Control:	<b>Not Controlled</b>
City:	<b>Hobart, IN</b>	Year Renewed:	
Location:	<b>Sidewalk</b>	Tape/Media #:	
Purpose:	<b>Routine Assessment</b>	Dia/Height:	<b>12"</b>
Use:	<b>Sanitary Sewage Pipe</b>	Material:	<b>VCP</b>
Drain Area:		Lining:	<b>None</b>
Category:	<b>NA</b>

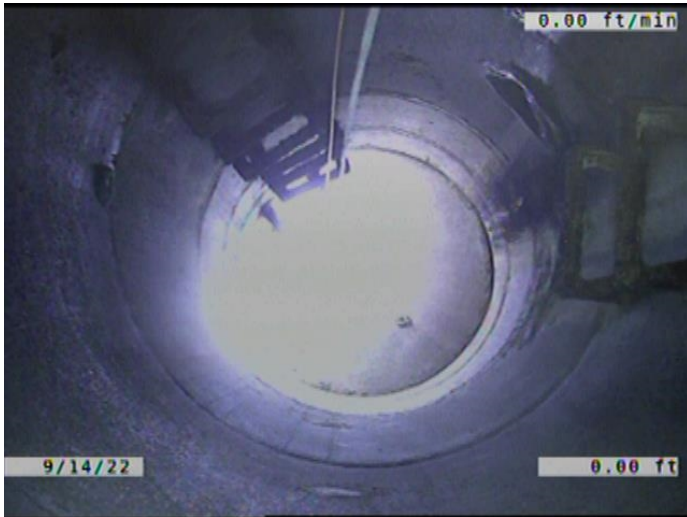
Code: **AMH**  
 Description: **Manhole**

Distance (ft): **.0**  
 Structural Grade: **0**  
 O&M Grade: **0**  
 Clock Start/From:  
 Clock To:  
 1st Value:  
 2nd Value:  
 Value Percent:  
 Continuous Index:  
 Within 8" of Joint: **NO**  
 Remarks: **M-305-046**

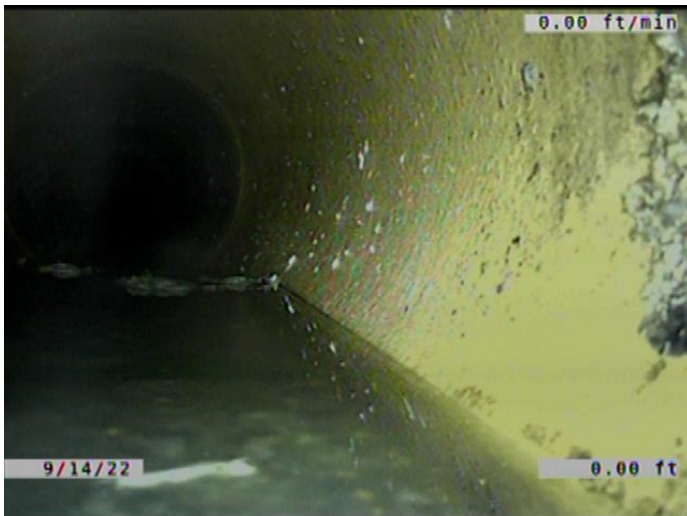
Code: **MWL**  
 Description: **Miscellaneous Water Level**

Distance (ft): **.0**  
 Structural Grade: **0**  
 O&M Grade: **0**  
 Clock Start/From:  
 Clock To:  
 1st Value:  
 2nd Value:  
 Value Percent: **15.000**  
 Continuous Index:  
 Within 8" of Joint: **NO**  
 Remarks:

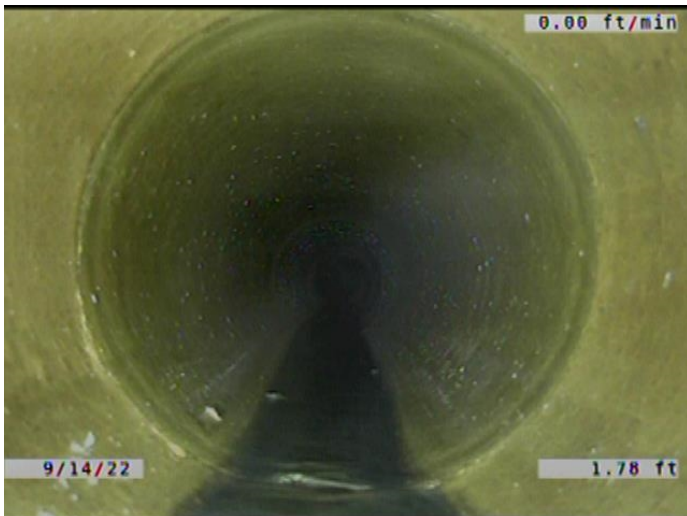
Code: **MWL**  
 Description: **Miscellaneous Water Level**

Distance (ft): **1.8**  
 Structural Grade: **0**  
 O&M Grade: **0**  
 Clock Start/From:  
 Clock To:  
 1st Value:  
 2nd Value:  
 Value Percent: **5.000**  
 Continuous Index:  
 Within 8" of Joint: **NO**  
 Remarks:

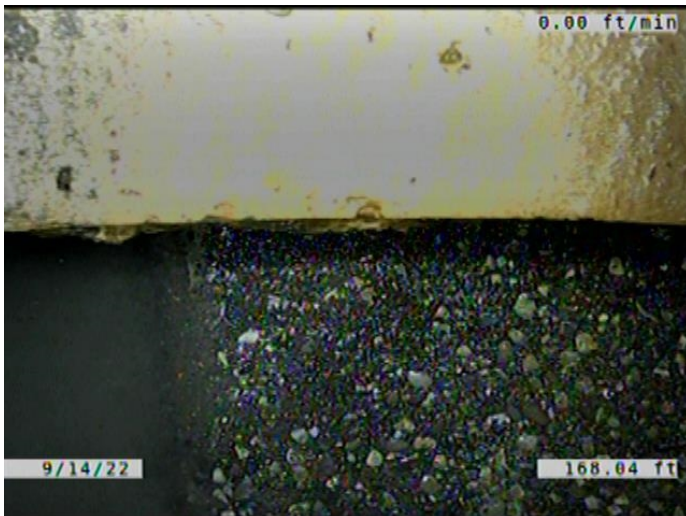
Code: **MSC**  
Description: **Miscellaneous Shape/Size Change**

Distance (ft): **168.0**  
Structural Grade: **0**  
O&M Grade: **0**  
Clock Start/From:  
Clock To:  
1st Value: **15.000**  
2nd Value:  
Value Percent:  
Continuous Index:  
Within 8" of Joint: **NO**  
Remarks:

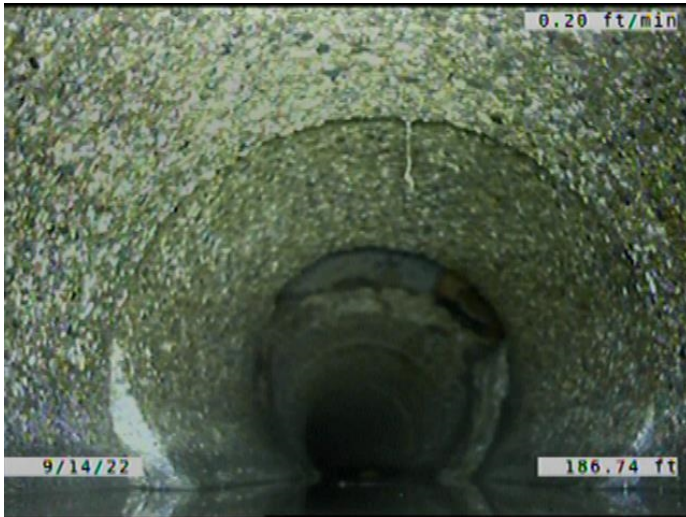
Code: **MWL**  
 Description: **Miscellaneous Water Level**

Distance (ft): **186.7**  
 Structural Grade: **0**  
 O&M Grade: **0**  
 Clock Start/From:  
 Clock To:  
 1st Value:  
 2nd Value:  
 Value Percent: **15.000**  
 Continuous Index:  
 Within 8" of Joint: **NO**  
 Remarks:

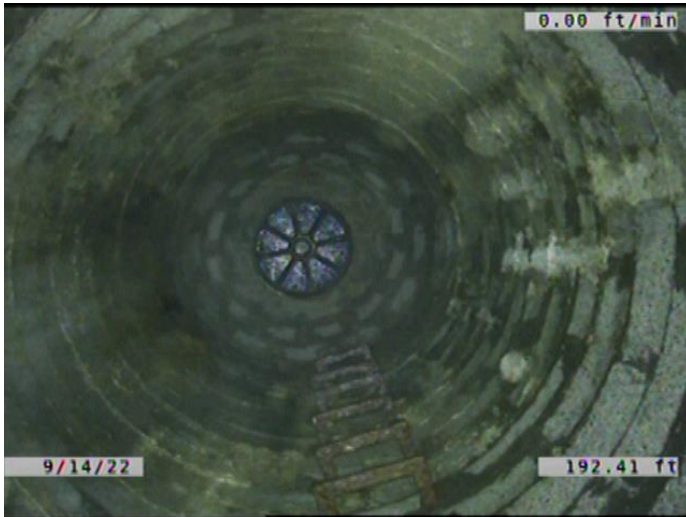
Code:	AMH
Description:	Manhole
Distance (ft):	192.4
Structural Grade:	0
O&M Grade:	0
Clock Start/From:	
Clock To:	
1st Value:	
2nd Value:	
Value Percent:	
Continuous Index:	
Within 8" of Joint:	NO
Remarks:	M-305-044
