## **Profile/Photo Observation Report**

Date: 11/04/2021 Weather: **PACP 7.0** Coding: Pipe Length (ft): 291.0 Owner: **City of Hobart** Pre Clean: **Heavy Cleaning** P.O.#: YES502259 S. Bucklin PSR: P-405-068-002 Surveyor:

Street: South Wabash Street Flow Control: Not Controlled
City: Hobart, IN Year Renewed:

US MH: M-404-002 DS MH: M-405-068 Total Length Surveyed (ft): 58.2

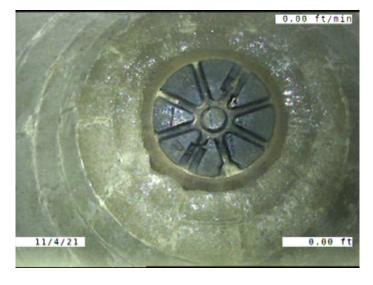
Code: Description:	AMH Manhole
Distance (ft):	.0
Structural Grade:	0
O&M Grade:	0
Clock Start/From:	
Clock To:	
1st Value:	
2nd Value:	
Value Percent:	
Continuous Index:	
Within 8" of Joint:	NO
Remarks:	M-404-002
