Profile/Photo Observation Report

Street:	FOXCROFT STREET	Flow Control:	Not Controlled
City:	Hobart, IN	Year Renewed:	
Location:	Light Highway	Tape/Media #:	
Purpose:	Routine Assessment	Dia/Height:	12"
Use:	Sanitary	Material:	VCP
Drain Area:	NA	Lining:	
Category:	NA		
Comment:	P_C at 94 ft lateral .		
Location Details:		Direction of Survey:	Upstream
US MH:	M-404-004	DS MH:	M-404-002
		Total Length Surveyed (ft):	95.3

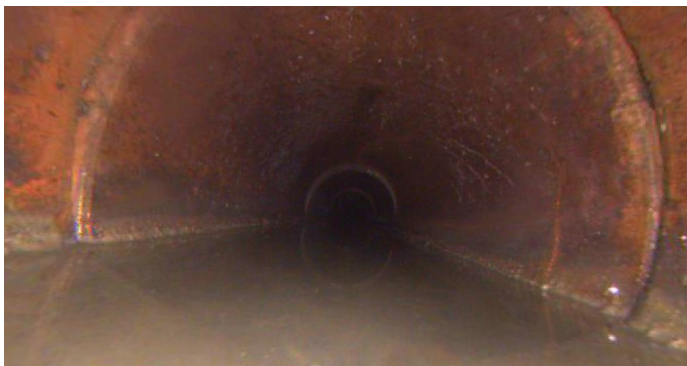
Code: **AMH**
 Description: **Manhole**

Distance (ft): **.0**
 Structural Grade: **0**
 O&M Grade: **0**
 Clock Start/From:
 Clock To:
 1st Value:
 2nd Value:
 Value Percent:
 Continuous Index:
 Within 8" of Joint: **NO**
 Remarks: **M-404-002**

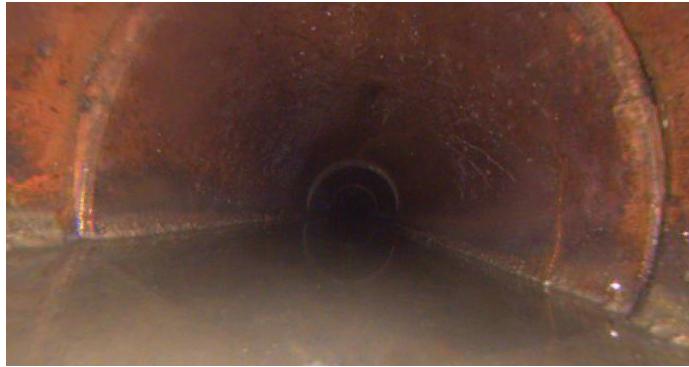
Code: **MWL**
Description: **Water Level**

Distance (ft): **.0**
Structural Grade: **0**
O&M Grade: **0**
Clock Start/From:
Clock To:
1st Value:
2nd Value:
Value Percent: **10.000**
Continuous Index:
Within 8" of Joint: **NO**
Remarks:

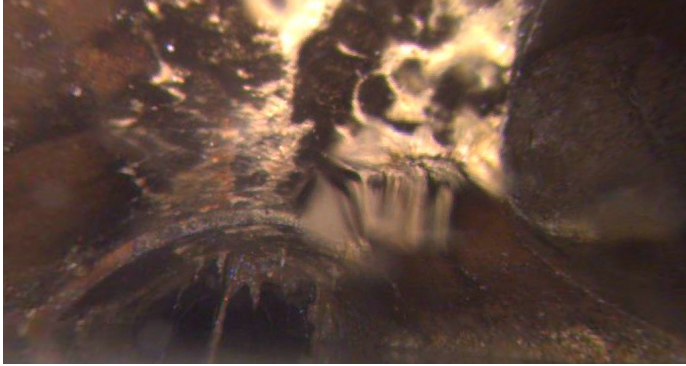
Code: **TFC**
Description: **Tap Factory Capped**

Distance (ft): **93.5**
Structural Grade: **0**
O&M Grade: **0**
Clock Start/From: **2**
Clock To:
1st Value: **4.000**
2nd Value:
Value Percent:
Continuous Index:
Within 8" of Joint:
Remarks:
