Profile/Photo Observation Report

Date:	11/06/2021	Weather:		Coding:	PACP 7.0
Pipe Length (ft):	353.7	Owner:	City of Hobart	Pre Clean:	Heavy Cleaning
P.O.#:	YES502259	Surveyor:	S. Bucklin	PSR:	P-404-004-002
Customer:	City of Hobart	Clean Date:	11/06/2021	Shape:	C

Street:	North Wabash Street	Flow Control:	Not Controlled
City:	Hobart, IN	Year Renewed:	
Location:	Alley	Tape/Media #:	
Purpose:	Routine Assessment	Dia/Height:	12"
Use:	Sanitary Sewage Pipe	Material:	VCP
Drain Area:		Lining:	None
Category:	NA		
Comment:			
Location Details:		Direction of Survey:	Downstream
US MH:	M-404-004	DS MH:	M-404-002
		Total Length Surveyed (ft):	353.7

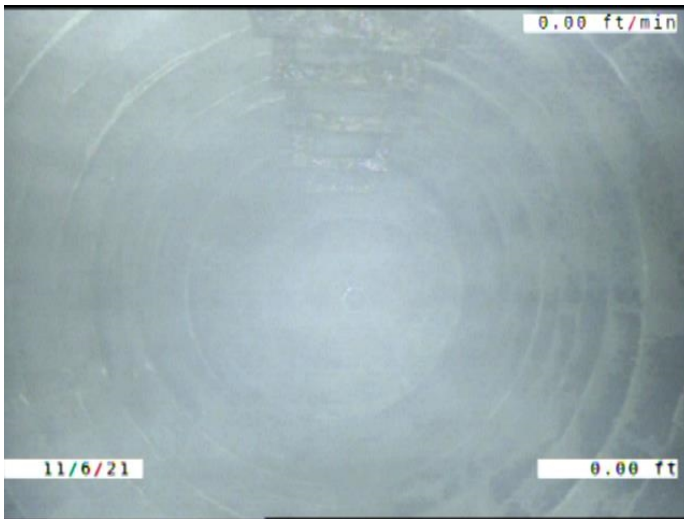
Code: **AMH**
 Description: **Manhole**

Distance (ft): **.0**
 Structural Grade: **0**
 O&M Grade: **0**
 Clock Start/From:
 Clock To:
 1st Value:
 2nd Value:
 Value Percent:
 Continuous Index:
 Within 8" of Joint: **NO**
 Remarks: **M-404-004**

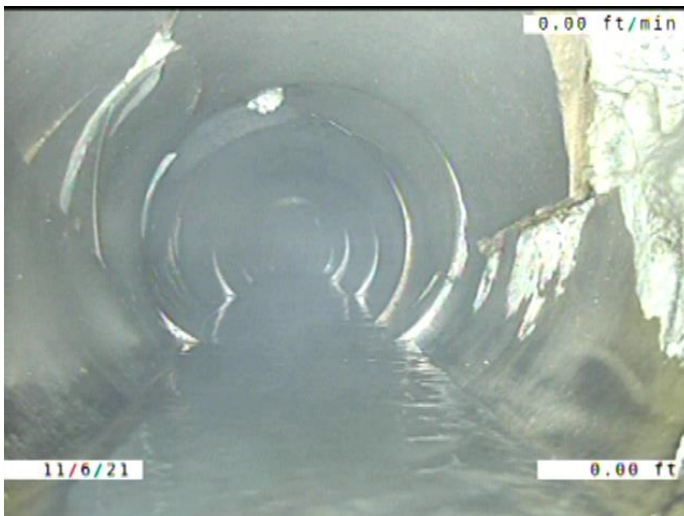
Code: **MWL**
 Description: **Miscellaneous Water Level**

Distance (ft): **.0**
 Structural Grade: **0**
 O&M Grade: **0**
 Clock Start/From:
 Clock To:
 1st Value:
 2nd Value:
 Value Percent: **5.000**
 Continuous Index:
 Within 8" of Joint: **NO**
 Remarks:

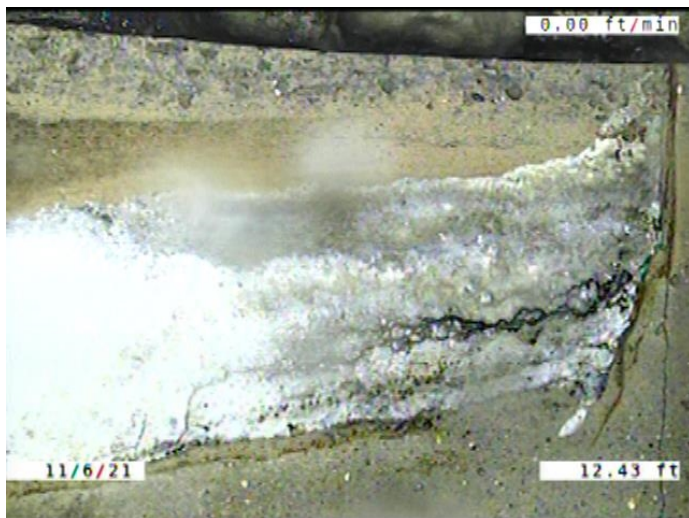
Code: **DAE**
 Description: **Deposits Attached Encrustation**

Distance (ft): **12.4**
 Structural Grade: **0**
 O&M Grade: **2**
 Clock Start/From: **8**
 Clock To: **10**
 1st Value:
 2nd Value:
 Value Percent: **5.000**
 Continuous Index:
 Within 8" of Joint: **YES**
 Remarks:

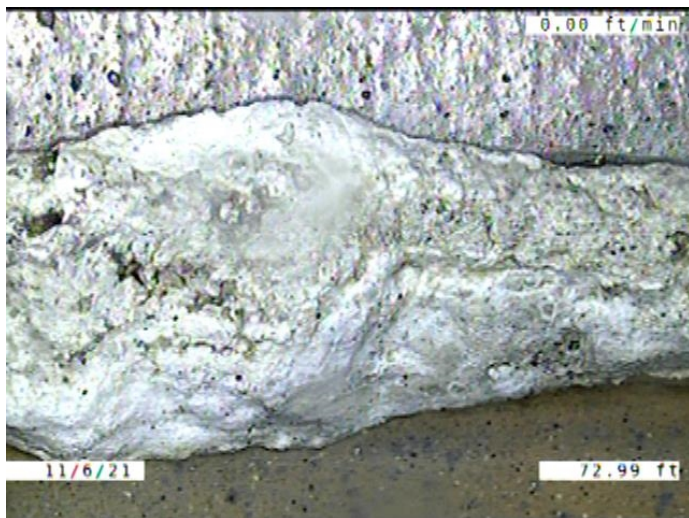
Code: **DAE**
 Description: **Deposits Attached Encrustation**

Distance (ft): **73.0**
 Structural Grade: **0**
 O&M Grade: **2**
 Clock Start/From: **9**
 Clock To: **3**
 1st Value:
 2nd Value:
 Value Percent: **5.000**
 Continuous Index:
 Within 8" of Joint: **YES**
 Remarks:

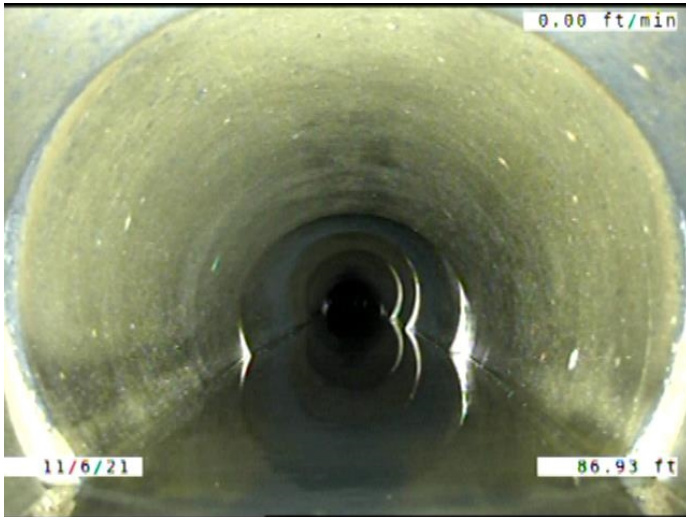
Code: **MWLS**
 Description: **Miscellaneous Water Level Sag**

Distance (ft): **86.9**
 Structural Grade: **2**
 O&M Grade: **0**
 Clock Start/From:
 Clock To:
 1st Value:
 2nd Value:
 Value Percent: **20.000**
 Continuous Index: **S03**
 Within 8" of Joint: **NO**
 Remarks:

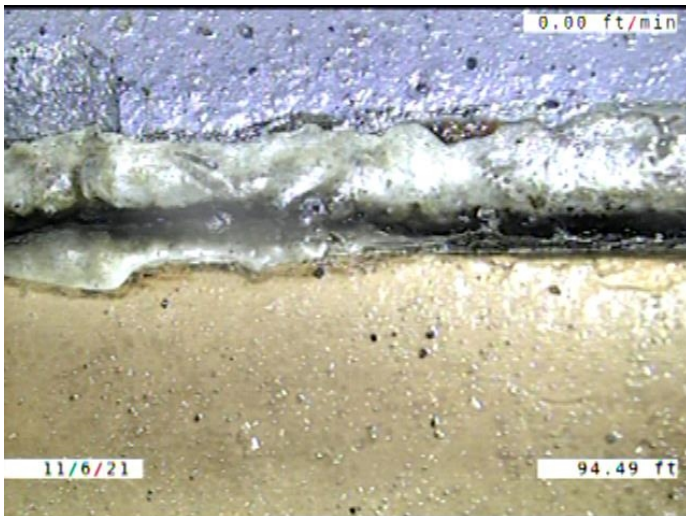
Code: **DAE**
 Description: **Deposits Attached Encrustation**

Distance (ft): **94.5**
 Structural Grade: **0**
 O&M Grade: **2**
 Clock Start/From: **8**
 Clock To: **3**
 1st Value:
 2nd Value:
 Value Percent: **5.000**
 Continuous Index:
 Within 8" of Joint: **YES**
 Remarks:

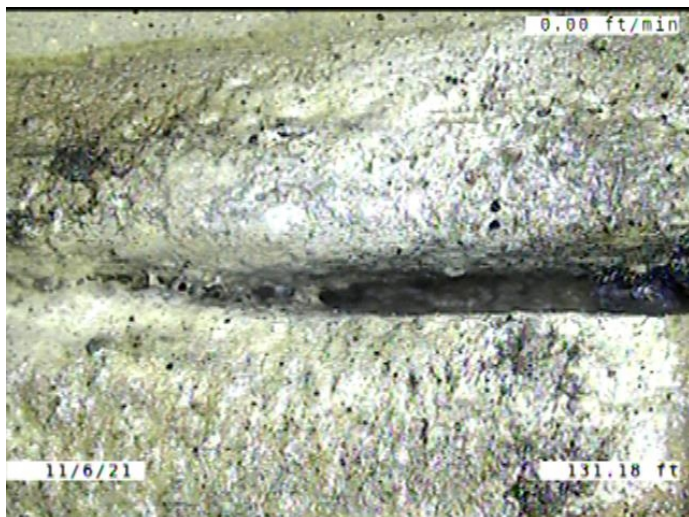
Code: **DAE**
 Description: **Deposits Attached Encrustation**

Distance (ft): **131.2**
 Structural Grade: **0**
 O&M Grade: **2**
 Clock Start/From: **12**
 Clock To: **3**
 1st Value:
 2nd Value:
 Value Percent: **5.000**
 Continuous Index:
 Within 8" of Joint: **YES**
 Remarks:

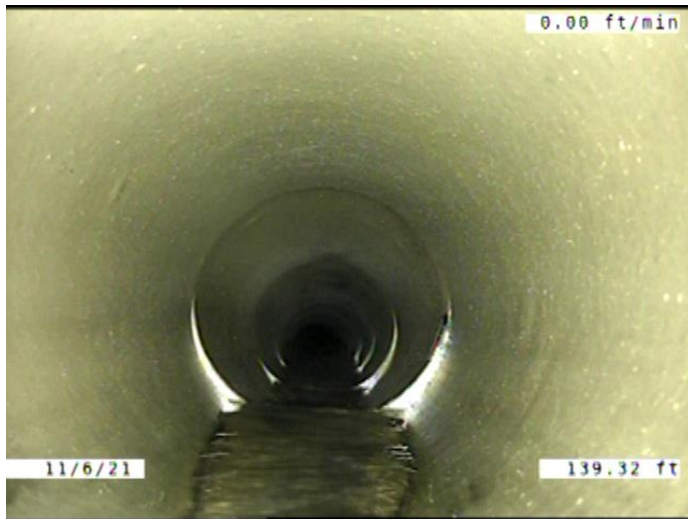
Code: **MWLS**
 Description: **Miscellaneous Water Level Sag**

Distance (ft): **139.3**
 Structural Grade: **2**
 O&M Grade: **0**
 Clock Start/From:
 Clock To:
 1st Value:
 2nd Value:
 Value Percent: **10.000**
 Continuous Index: **F04**
 Within 8" of Joint: **NO**
 Remarks:

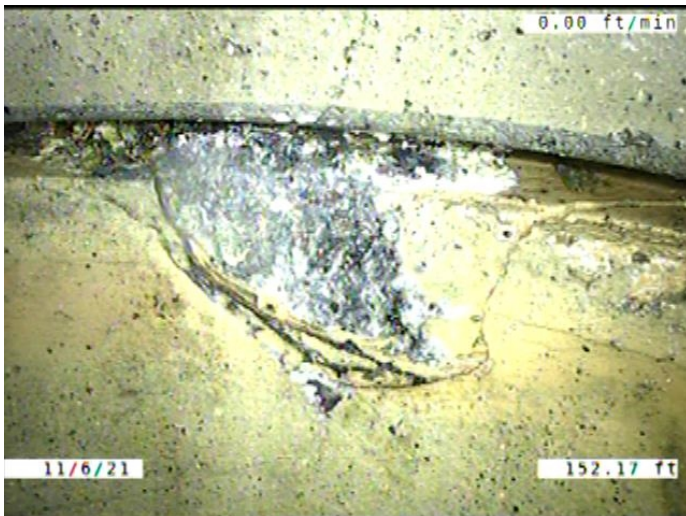
Code: **DAE**
Description: **Deposits Attached Encrustation**

Distance (ft): **152.2**
Structural Grade: **0**
O&M Grade: **2**
Clock Start/From: **2**
Clock To: **3**
1st Value:
2nd Value:
Value Percent: **5.000**
Continuous Index:
Within 8" of Joint: **YES**
Remarks:

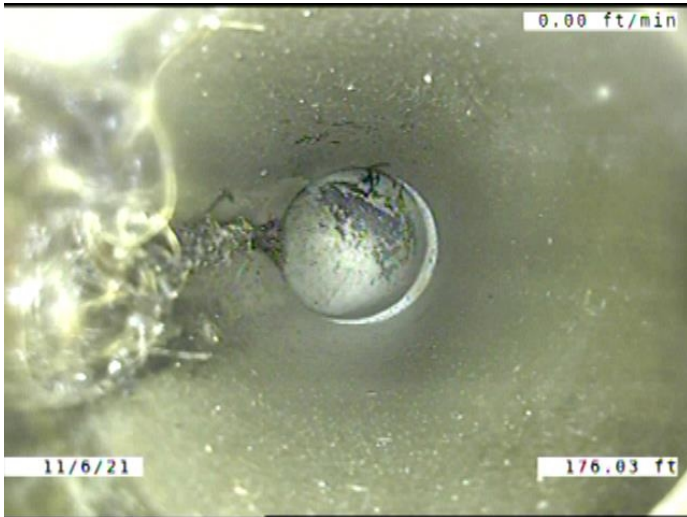
Code: **TBI**
Description: **Tap Break-in Intruding**

Distance (ft): **176.0**
Structural Grade: **0**
O&M Grade: **2**
Clock Start/From: **11**
Clock To:
1st Value: **4.000**
2nd Value: **1.000**
Value Percent:
Continuous Index:
Within 8" of Joint: **YES**
Remarks: **GROWING DOWN THE TAP INTO THE MAIN. CONSTANTLY RUNNING WAT**

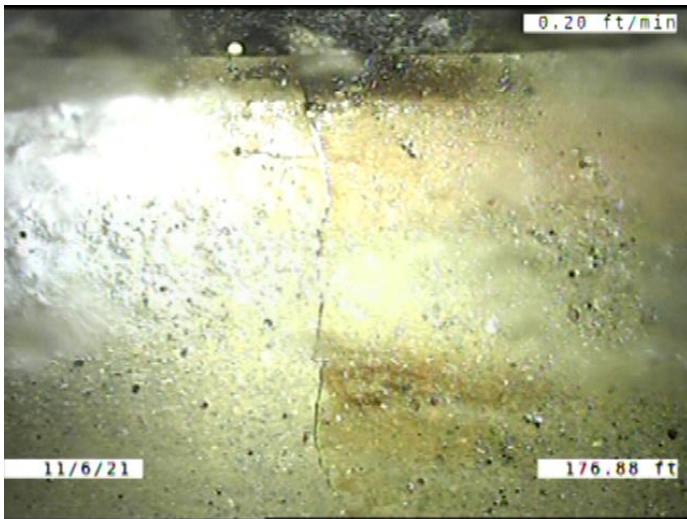
Code: **CL**
Description: **Crack Longitudinal**

Distance (ft): **176.9**
Structural Grade: **2**
O&M Grade: **0**
Clock Start/From: **1**
Clock To:
1st Value:
2nd Value:
Value Percent:
Continuous Index:
Within 8" of Joint: **YES**
Remarks:

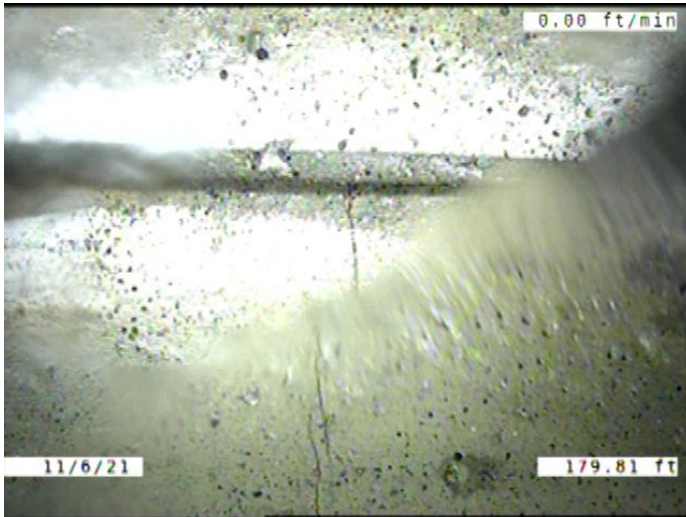
Code: **CL**
Description: **Crack Longitudinal**

Distance (ft): **179.8**
Structural Grade: **2**
O&M Grade: **0**
Clock Start/From: **12**
Clock To:
1st Value:
2nd Value:
Value Percent:
Continuous Index:
Within 8" of Joint: **YES**
Remarks:

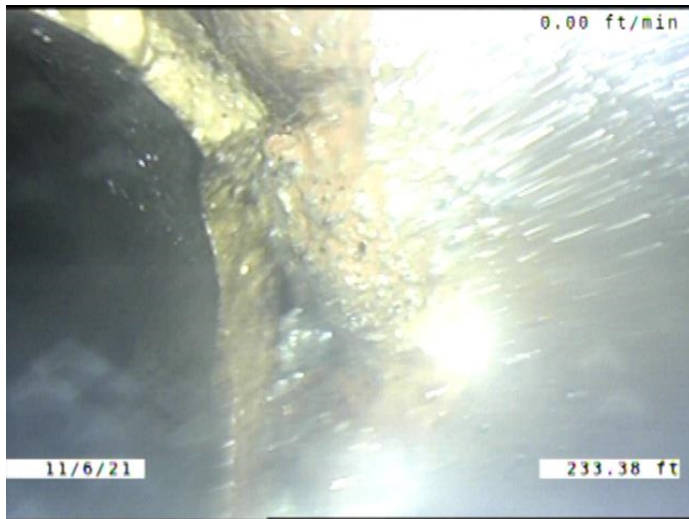
Code:	TFC
Description:	Tap Factory Capped
Distance (ft):	232.5
Structural Grade:	0
O&M Grade:	0
Clock Start/From:	1
Clock To:	
1st Value:	4.000
2nd Value:	
Value Percent:	
Continuous Index:	
Within 8" of Joint:	YES
Remarks:

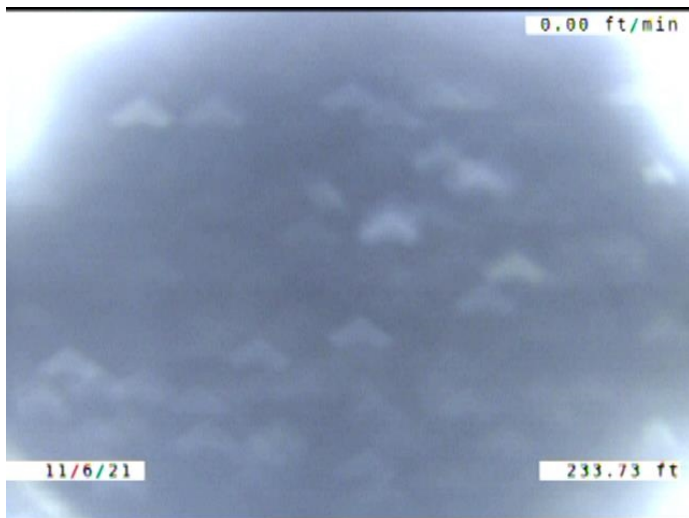
Code: **B**
Description: **Broken**

Distance (ft): **233.4**
Structural Grade: **4**
O&M Grade: **0**
Clock Start/From: **11**
Clock To: **1**
1st Value:
2nd Value:
Value Percent:
Continuous Index:
Within 8" of Joint: **YES**
Remarks: **Visible through water**

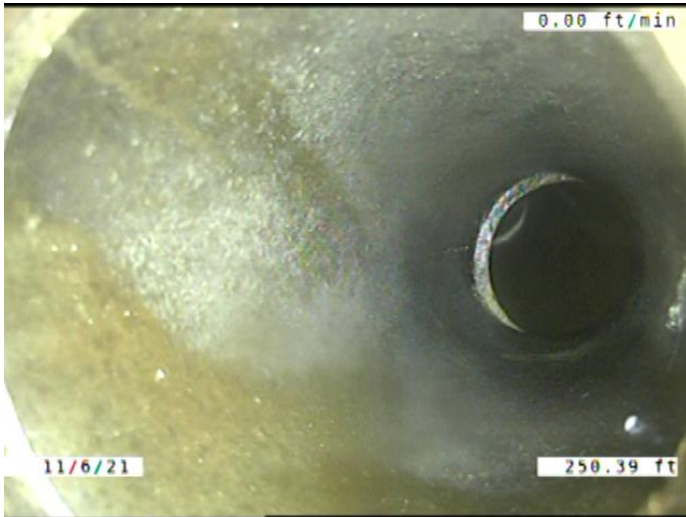
Code: **B**
Description: **Broken**

Distance (ft): **250.1**
Structural Grade: **4**
O&M Grade: **0**
Clock Start/From: **9**
Clock To: **2**
1st Value:
2nd Value:
Value Percent:
Continuous Index: **S09**
Within 8" of Joint: **YES**
Remarks:

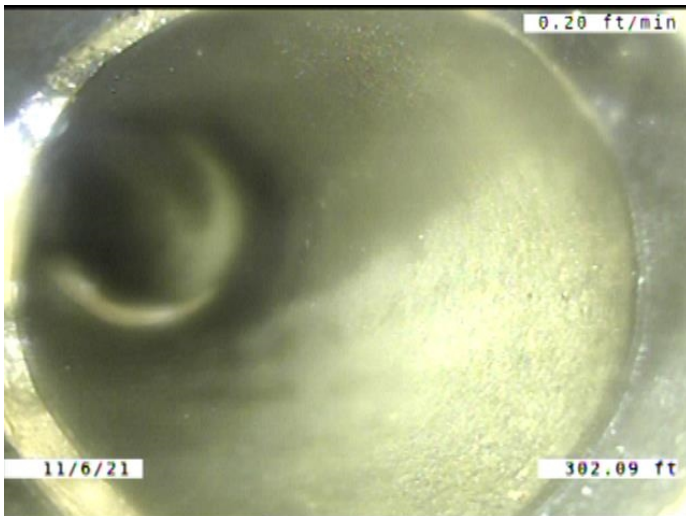
Code: **BSV**
Description: **Broken Soil Visible**

Distance (ft): **301.5**
Structural Grade: **5**
O&M Grade: **0**
Clock Start/From: **9**
Clock To: **3**
1st Value:
2nd Value:
Value Percent:
Continuous Index:
Within 8" of Joint: **YES**
Remarks:

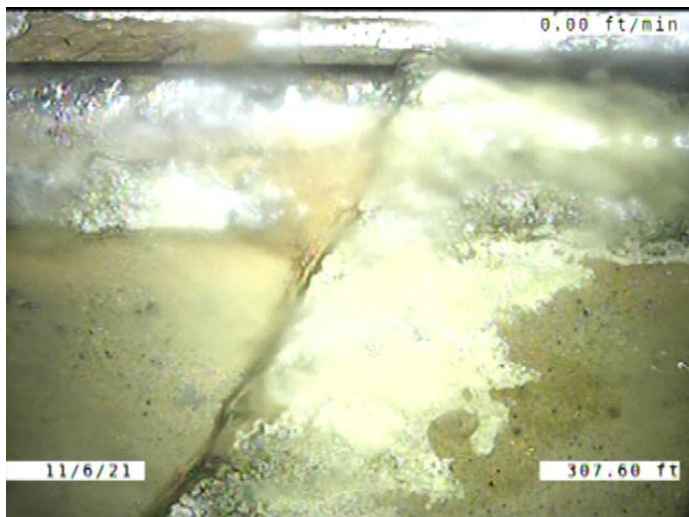
Code: **TBI**
Description: **Tap Break-in Intruding**

Distance (ft): **302.1**
Structural Grade: **0**
O&M Grade: **2**
Clock Start/From: **11**
Clock To:
1st Value: **4.000**
2nd Value: **1.000**
Value Percent:
Continuous Index:
Within 8" of Joint: **YES**
Remarks: **CONSTANTLY RUNNING WATER.**

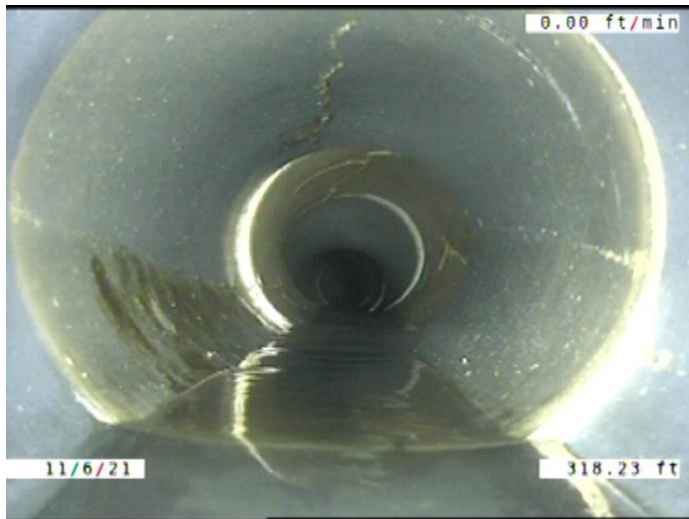
Code: **TBI**
 Description: **Tap Break-in Intruding**

Distance (ft): **314.5**
 Structural Grade: **0**
 O&M Grade: **2**
 Clock Start/From: **12**
 Clock To:
 1st Value: **4.000**
 2nd Value: **1.000**
 Value Percent:
 Continuous Index:
 Within 8" of Joint: **YES**
 Remarks: **CONSTANTLY RUNNING WATER.**

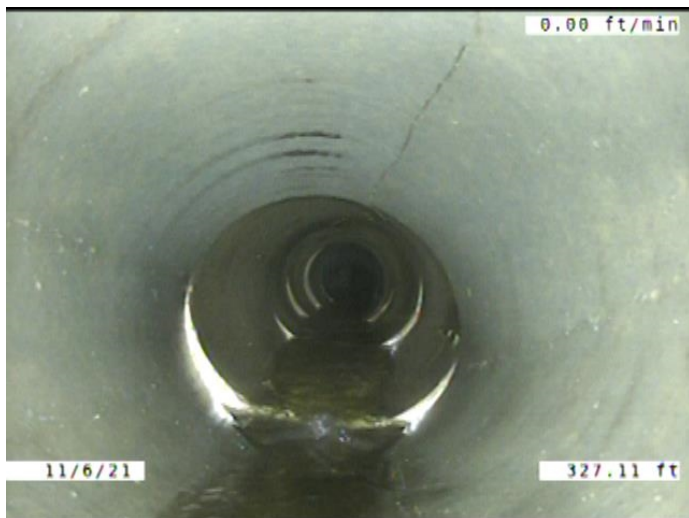
Code: **MWLS**
 Description: **Miscellaneous Water Level Sag**

Distance (ft): **318.2**
 Structural Grade: **3**
 O&M Grade: **0**
 Clock Start/From:
 Clock To:
 1st Value:
 2nd Value:
 Value Percent: **35.000**
 Continuous Index: **F10**
 Within 8" of Joint: **NO**
 Remarks:

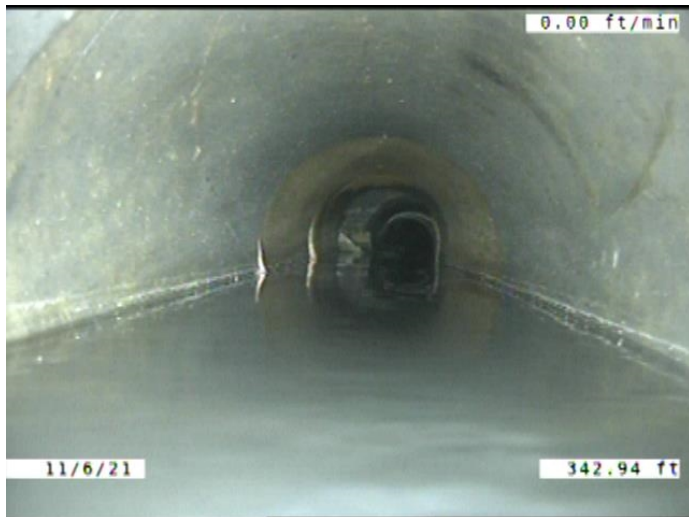
Code: **LD**
 Description: **Line Down**

Distance (ft): **327.1**
 Structural Grade: **0**
 O&M Grade: **1**
 Clock Start/From:
 Clock To:
 1st Value:
 2nd Value:
 Value Percent: **5.000**
 Continuous Index:
 Within 8" of Joint: **NO**
 Remarks:

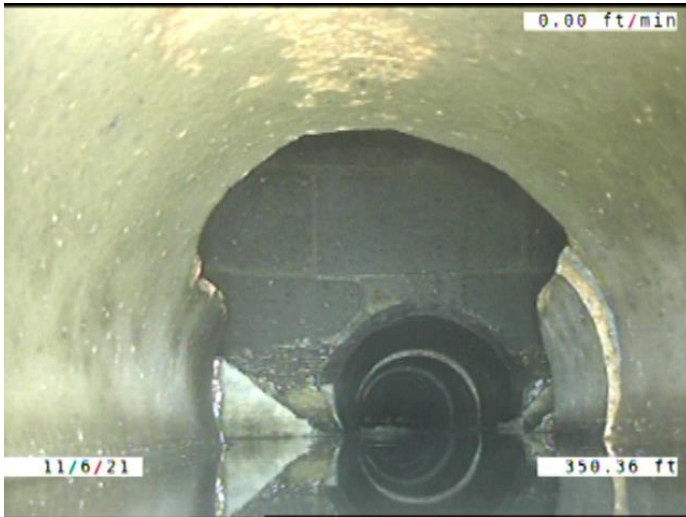
Code:	SSS
Description:	Surface Damage Surface Spalling
Distance (ft):	350.4
Structural Grade:	2
O&M Grade:	0
Clock Start/From:	10
Clock To:	1
1st Value:	
2nd Value:	
Value Percent:	
Continuous Index:	
Within 8" of Joint:	YES
Remarks:

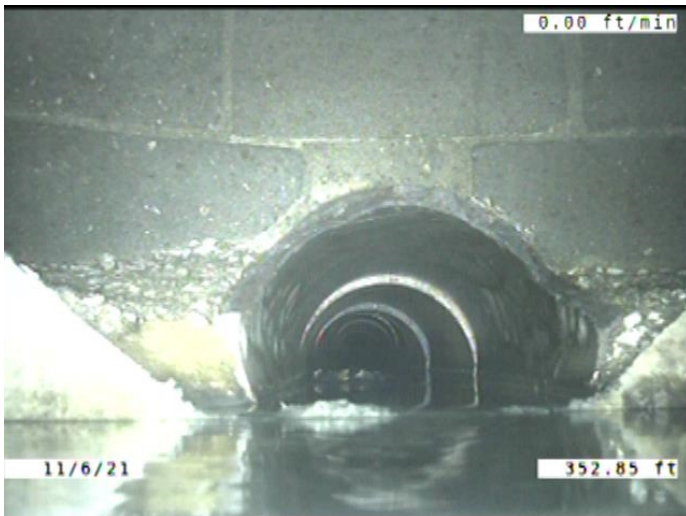
Code: **DAE**
Description: **Deposits Attached Encrustation**

Distance (ft): **350.4**
Structural Grade: **0**
O&M Grade: **2**
Clock Start/From: **9**
Clock To: **3**
1st Value:
2nd Value:
Value Percent: **5.000**
Continuous Index: **F12**
Within 8" of Joint: **YES**
Remarks:
