Profile/Photo Observation Report

Date:	11/06/2021	Weather:		Coding:	PACP 7.0
Pipe Length (ft):	353.7	Owner:	City of Hobart	Pre Clean:	Heavy Cleaning
P.O.#:	YES502259	Surveyor:	S. Bucklin	PSR:	P-404-004-002
Customer:	City of Hobart	Clean Date:	11/06/2021	Shape:	C

Street:	North Wabash Street	Flow Control:	Not Controlled
City:	Hobart, IN	Year Renewed:	
Location:	Alley	Tape/Media #:	
Purpose:	Routine Assessment	Dia/Height:	12"
Use:	Sanitary Sewage Pipe	Material:	VCP
Drain Area:		Lining:	None
Category:	NA		
Comment:			
Location Details:		Direction of Survey:	Downstream
US MH:	M-404-004	DS MH:	M-404-002
		Total Length Surveyed (ft):	353.7

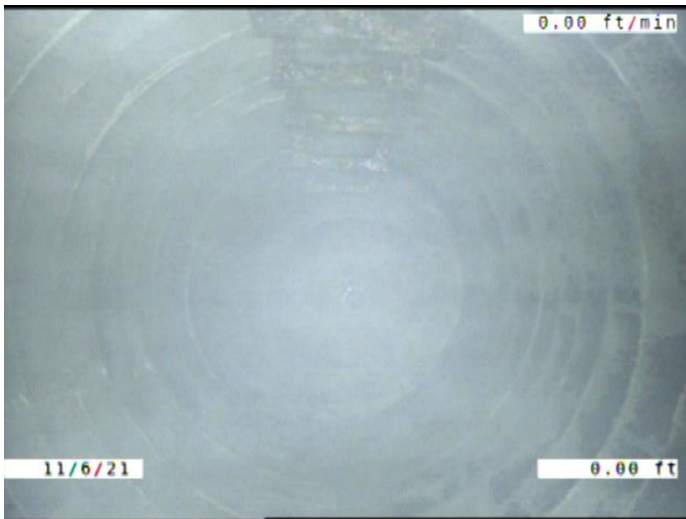
Code: **AMH**
 Description: **Manhole**

Distance (ft): **.0**
 Structural Grade: **0**
 O&M Grade: **0**
 Clock Start/From:
 Clock To:
 1st Value:
 2nd Value:
 Value Percent:
 Continuous Index:
 Within 8" of Joint: **NO**
 Remarks: **M-404-004**

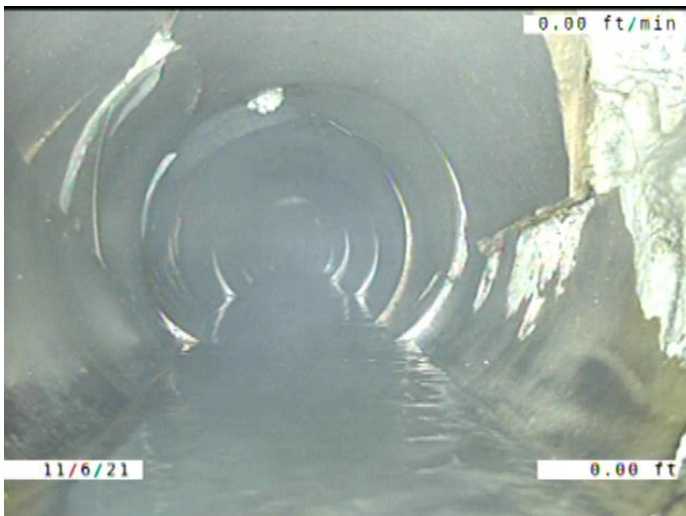
Code: **MWL**
 Description: **Miscellaneous Water Level**

Distance (ft): **.0**
 Structural Grade: **0**
 O&M Grade: **0**
 Clock Start/From:
 Clock To:
 1st Value:
 2nd Value:
 Value Percent: **5.000**
 Continuous Index:
 Within 8" of Joint: **NO**
 Remarks:

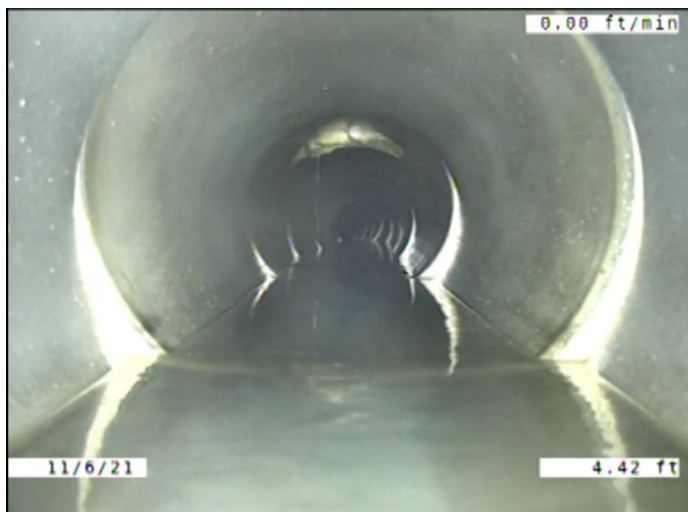
Code:	B
Description:	Broken
Distance (ft):	4.4
Structural Grade:	4
O&M Grade:	0
Clock Start/From:	12
Clock To:	12
1st Value:	
2nd Value:	
Value Percent:	
Continuous Index:	F01
Within 8" of Joint:	YES
Remarks:

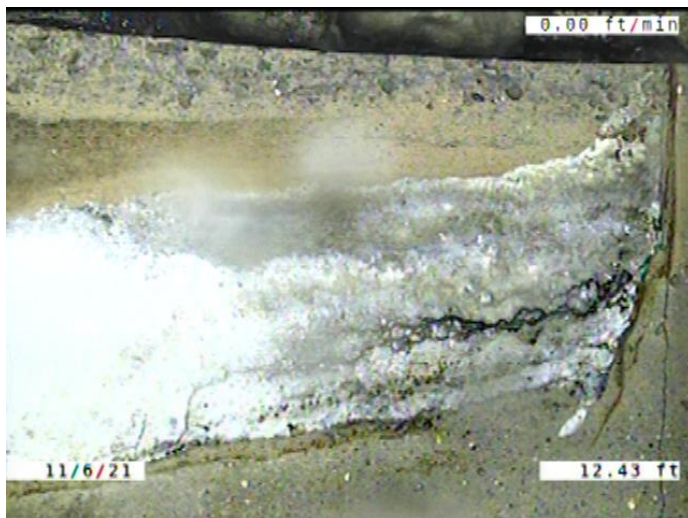
Code: **DAE**
 Description: **Deposits Attached Encrustation**

Distance (ft): **12.4**
 Structural Grade: **0**
 O&M Grade: **2**
 Clock Start/From: **8**
 Clock To: **10**
 1st Value:
 2nd Value:
 Value Percent: **5.000**
 Continuous Index:
 Within 8" of Joint: **YES**
 Remarks:

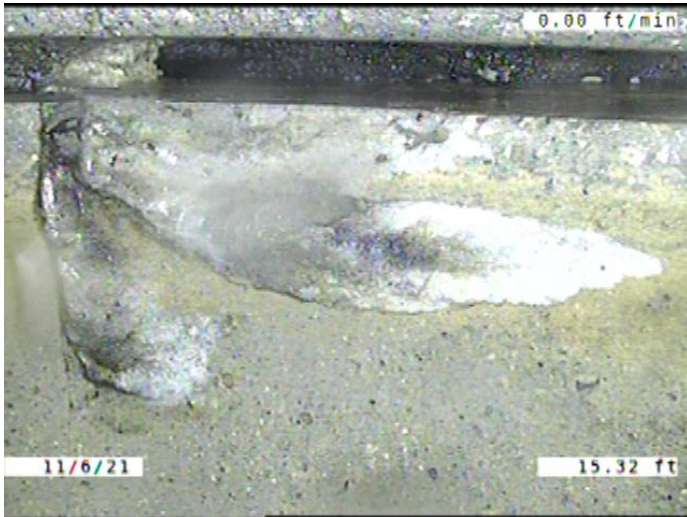
Code: **DAE**
 Description: **Deposits Attached Encrustation**

Distance (ft): **15.3**
 Structural Grade: **0**
 O&M Grade: **2**
 Clock Start/From: **2**
 Clock To: **3**
 1st Value:
 2nd Value:
 Value Percent: **5.000**
 Continuous Index:
 Within 8" of Joint: **YES**
 Remarks:

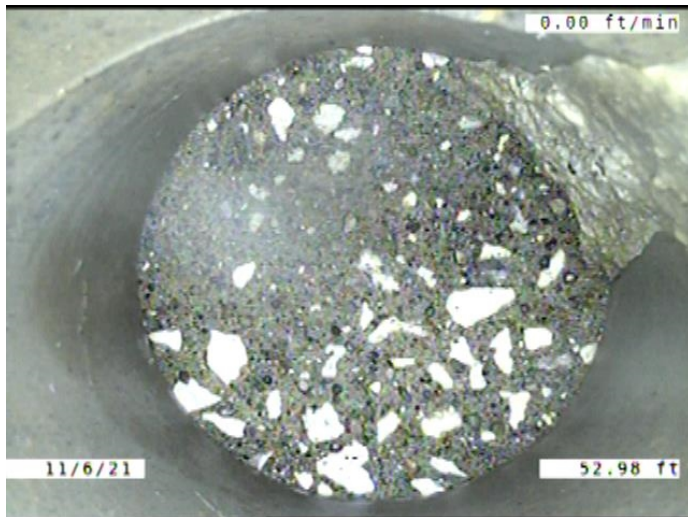
Code: **TFC**
 Description: **Tap Factory Capped**

Distance (ft): **53.0**
 Structural Grade: **0**
 O&M Grade: **0**
 Clock Start/From: **1**
 Clock To:
 1st Value: **4.000**
 2nd Value:
 Value Percent:
 Continuous Index:
 Within 8" of Joint: **YES**
 Remarks: **ENCRUSTATION AROUND THE CAP**

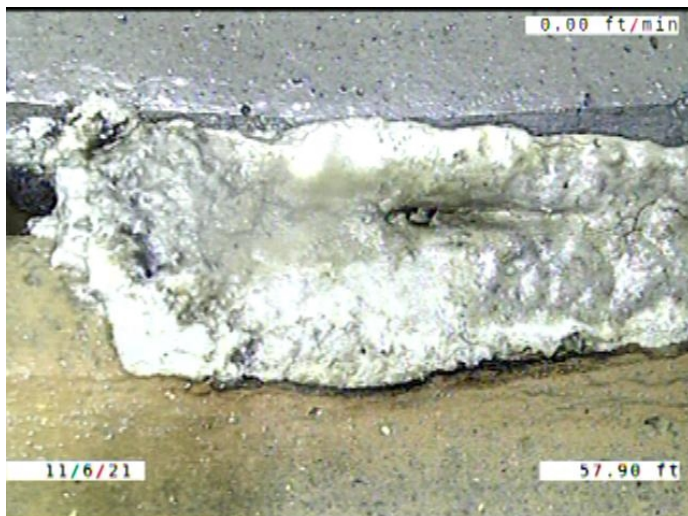
Code: **DAE**
 Description: **Deposits Attached Encrustation**

Distance (ft): **57.9**
 Structural Grade: **0**
 O&M Grade: **2**
 Clock Start/From: **9**
 Clock To: **11**
 1st Value:
 2nd Value:
 Value Percent: **5.000**
 Continuous Index:
 Within 8" of Joint: **YES**
 Remarks:

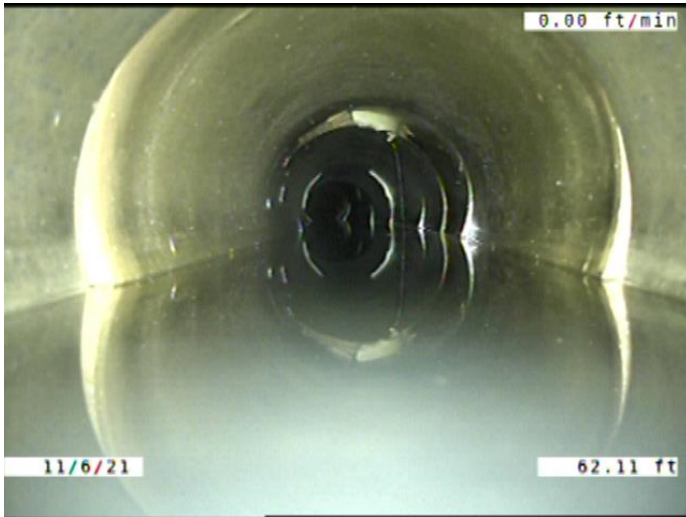
Code: **MWLS**
Description: **Miscellaneous Water Level Sag**

Distance (ft): **62.1**
Structural Grade: **2**
O&M Grade: **0**
Clock Start/From:
Clock To:
1st Value:
2nd Value:
Value Percent: **10.000**
Continuous Index: **S02**
Within 8" of Joint: **NO**
Remarks:

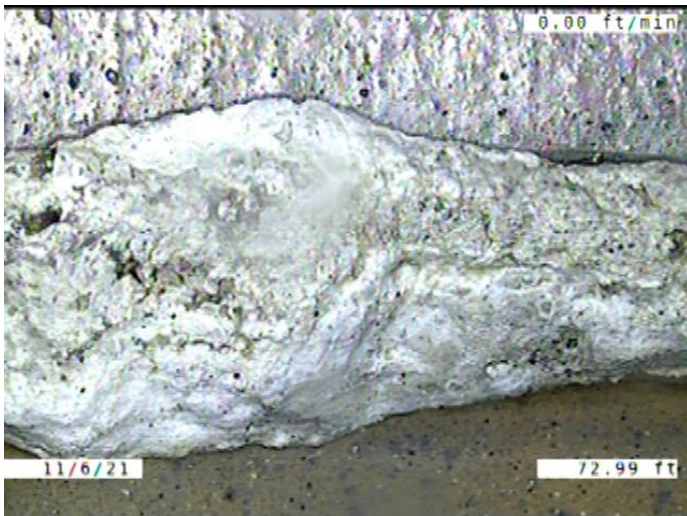
Code: **DAE**
 Description: **Deposits Attached Encrustation**

Distance (ft): **73.0**
 Structural Grade: **0**
 O&M Grade: **2**
 Clock Start/From: **9**
 Clock To: **3**
 1st Value:
 2nd Value:
 Value Percent: **5.000**
 Continuous Index:
 Within 8" of Joint: **YES**
 Remarks:

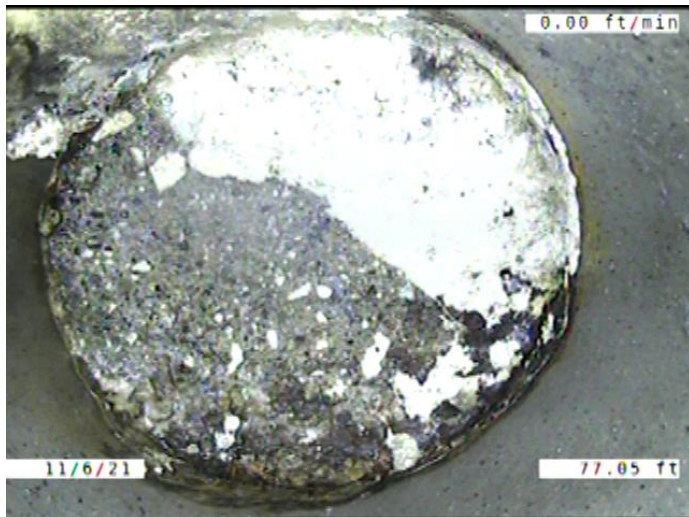
Code:	TFC
Description:	Tap Factory Capped
Distance (ft):	77.0
Structural Grade:	0
O&M Grade:	0
Clock Start/From:	11
Clock To:	
1st Value:	4.000
2nd Value:	
Value Percent:	
Continuous Index:	
Within 8" of Joint:	YES
Remarks:	ENCrustATION AROUND THE CAP

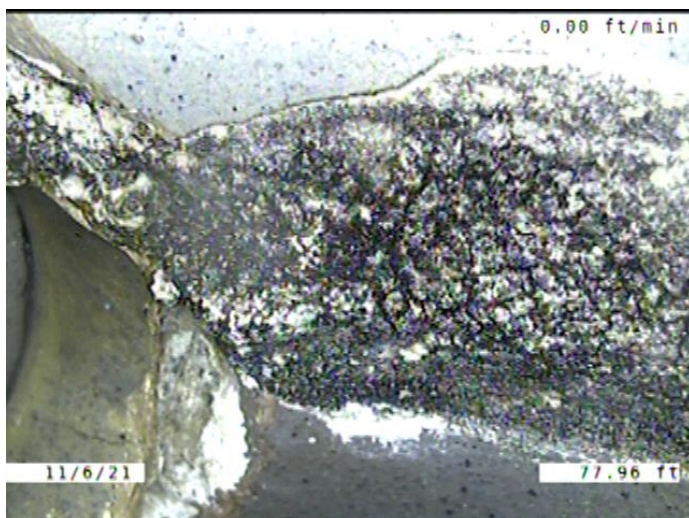
Code:	DAE
Description:	Deposits Attached Encrustation
Distance (ft):	78.0
Structural Grade:	0
O&M Grade:	2
Clock Start/From:	8
Clock To:	3
1st Value:	
2nd Value:	
Value Percent:	5.000
Continuous Index:	
Within 8" of Joint:	YES
Remarks:

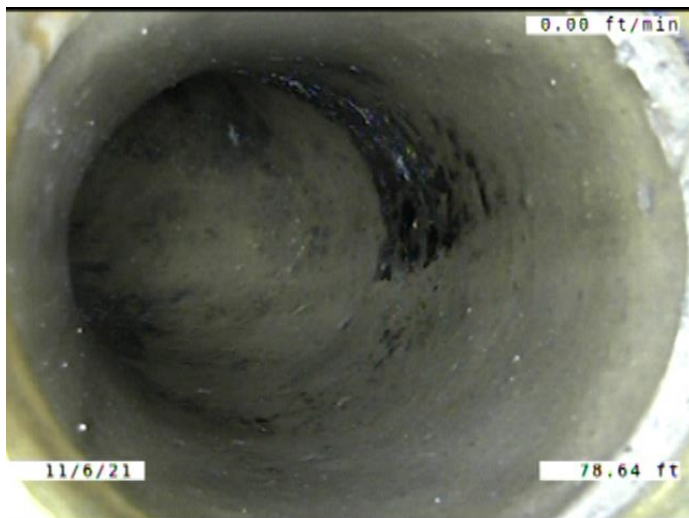
Code: **TB**
Description: **Tap Break-in/Hammer**

Distance (ft): **78.6**
Structural Grade: **0**
O&M Grade: **0**
Clock Start/From: **11**
Clock To:
1st Value: **4.000**
2nd Value:
Value Percent:
Continuous Index:
Within 8" of Joint: **YES**
Remarks:

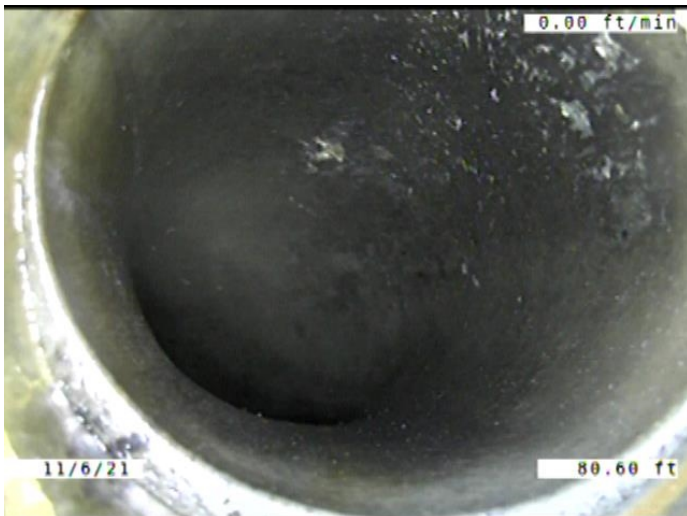
Code: **TB**
Description: **Tap Break-in/Hammer**

Distance (ft): **80.6**
Structural Grade: **0**
O&M Grade: **0**
Clock Start/From: **11**
Clock To:
1st Value: **4.000**
2nd Value:
Value Percent:
Continuous Index:
Within 8" of Joint: **YES**
Remarks:

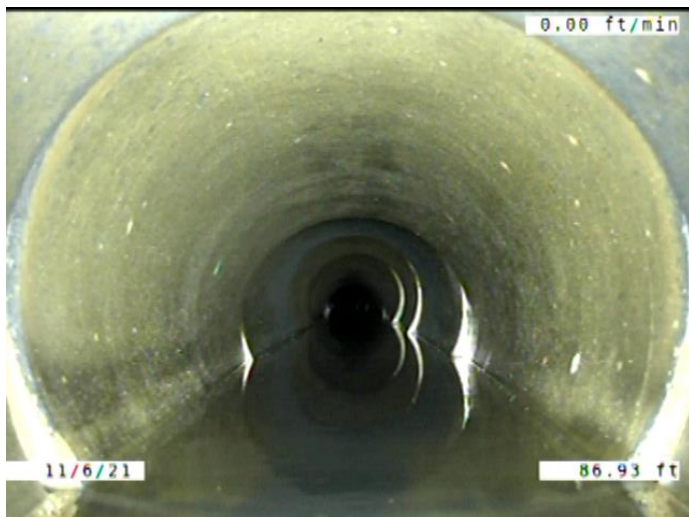
Code: **MWLS**
 Description: **Miscellaneous Water Level Sag**

Distance (ft): **86.9**
 Structural Grade: **2**
 O&M Grade: **0**
 Clock Start/From:
 Clock To:
 1st Value:
 2nd Value:
 Value Percent: **20.000**
 Continuous Index: **S03**
 Within 8" of Joint: **NO**
 Remarks:

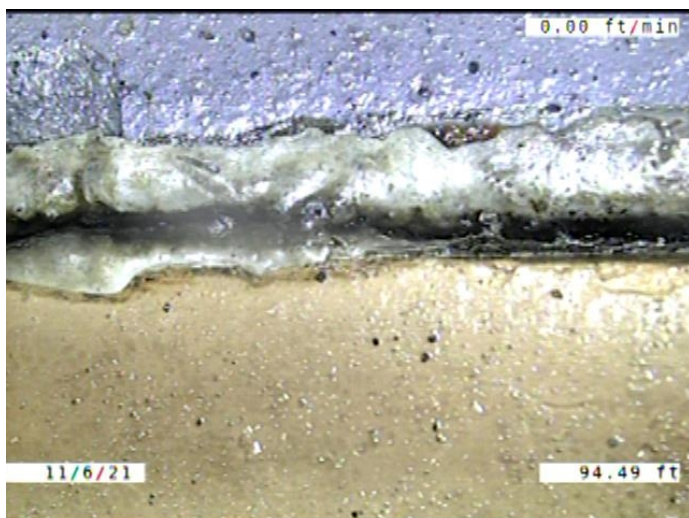
Code: **DAE**
 Description: **Deposits Attached Encrustation**

Distance (ft): **94.5**
 Structural Grade: **0**
 O&M Grade: **2**
 Clock Start/From: **8**
 Clock To: **3**
 1st Value:
 2nd Value:
 Value Percent: **5.000**
 Continuous Index:
 Within 8" of Joint: **YES**
 Remarks:

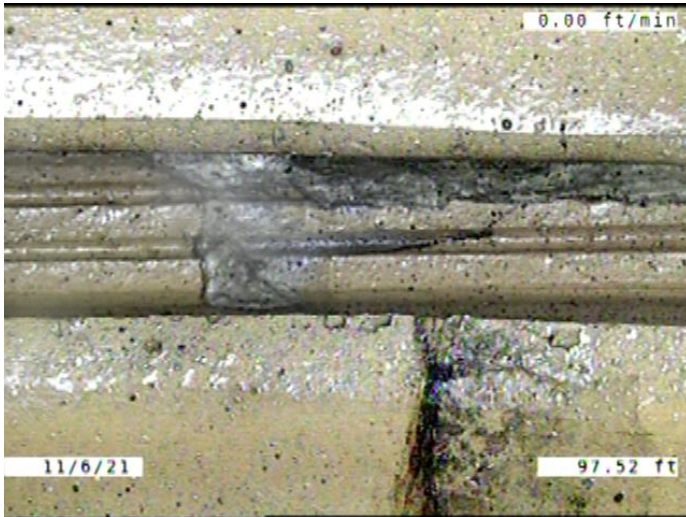
Code: **DAE**
 Description: **Deposits Attached Encrustation**

Distance (ft): **97.5**
 Structural Grade: **0**
 O&M Grade: **2**
 Clock Start/From: **12**
 Clock To: **2**
 1st Value:
 2nd Value:
 Value Percent: **5.000**
 Continuous Index:
 Within 8" of Joint: **YES**
 Remarks:

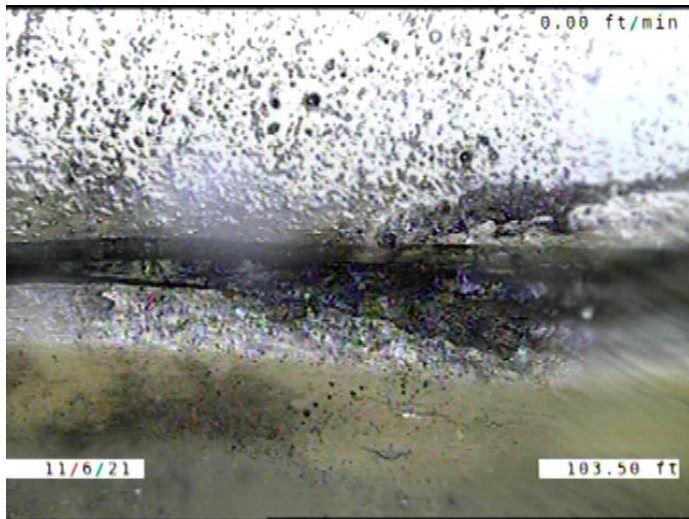
Code: **DAE**
 Description: **Deposits Attached Encrustation**

Distance (ft): **103.5**
 Structural Grade: **0**
 O&M Grade: **2**
 Clock Start/From: **12**
 Clock To: **2**
 1st Value:
 2nd Value:
 Value Percent: **5.000**
 Continuous Index:
 Within 8" of Joint: **YES**
 Remarks:

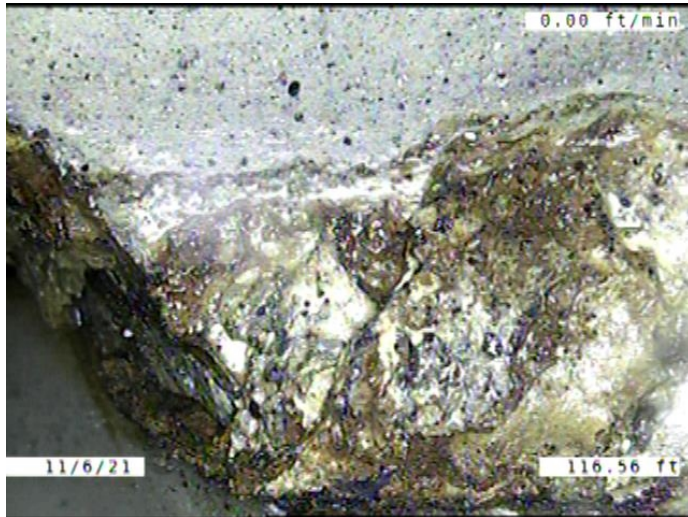
Code: **DAE**
 Description: **Deposits Attached Encrustation**

Distance (ft): **116.6**
 Structural Grade: **0**
 O&M Grade: **2**
 Clock Start/From: **1**
 Clock To: **3**
 1st Value:
 2nd Value:
 Value Percent: **5.000**
 Continuous Index:
 Within 8" of Joint: **YES**
 Remarks:

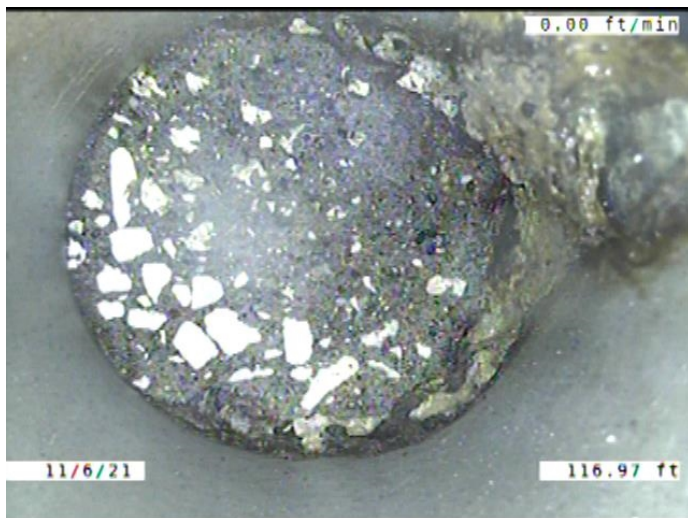
Code: **TFC**
 Description: **Tap Factory Capped**

Distance (ft): **117.0**
 Structural Grade: **0**
 O&M Grade: **0**
 Clock Start/From: **2**
 Clock To:
 1st Value: **4.000**
 2nd Value:
 Value Percent:
 Continuous Index:
 Within 8" of Joint: **YES**
 Remarks: **ENCrustation AROND THE CAP**

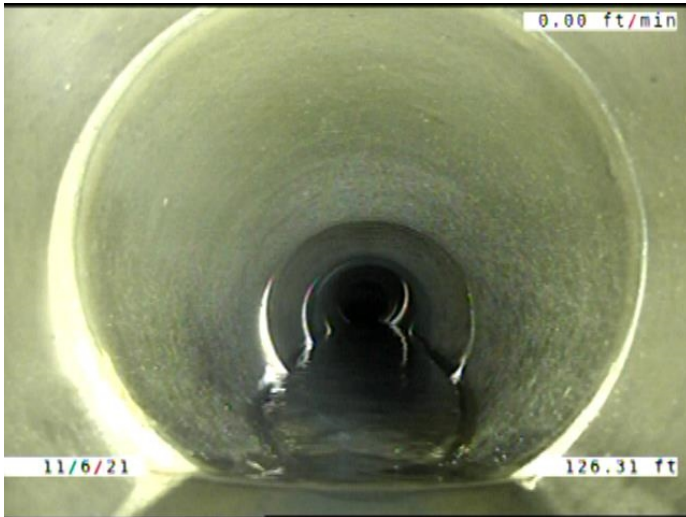
Code: **MWLS**
Description: **Miscellaneous Water Level Sag**

Distance (ft): **126.3**
Structural Grade: **2**
O&M Grade: **0**
Clock Start/From:
Clock To:
1st Value:
2nd Value:
Value Percent: **20.000**
Continuous Index: **F03**
Within 8" of Joint: **NO**
Remarks:

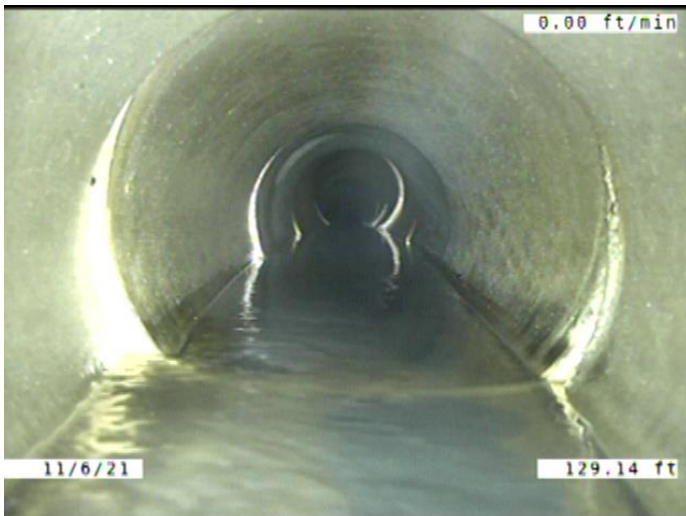
Code: **MWLS**
Description: **Miscellaneous Water Level Sag**

Distance (ft): **129.1**
Structural Grade: **2**
O&M Grade: **0**
Clock Start/From:
Clock To:
1st Value:
2nd Value:
Value Percent: **10.000**
Continuous Index: **S04**
Within 8" of Joint: **NO**
Remarks:

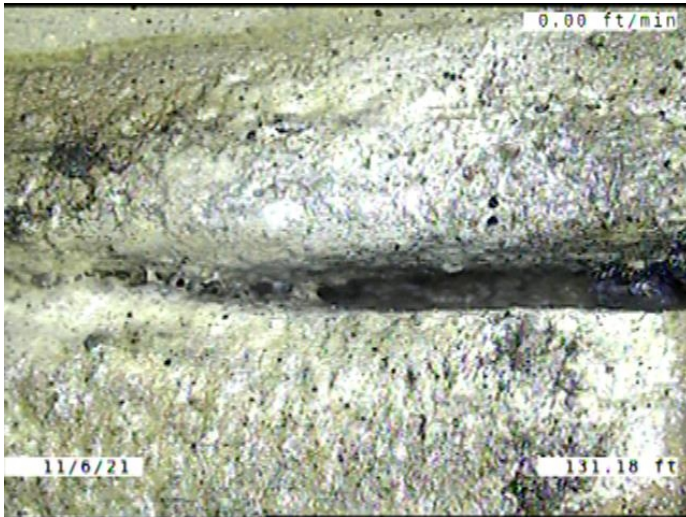
Code: **DAE**
 Description: **Deposits Attached Encrustation**

Distance (ft): **131.2**
 Structural Grade: **0**
 O&M Grade: **2**
 Clock Start/From: **12**
 Clock To: **3**
 1st Value:
 2nd Value:
 Value Percent: **5.000**
 Continuous Index:
 Within 8" of Joint: **YES**
 Remarks:

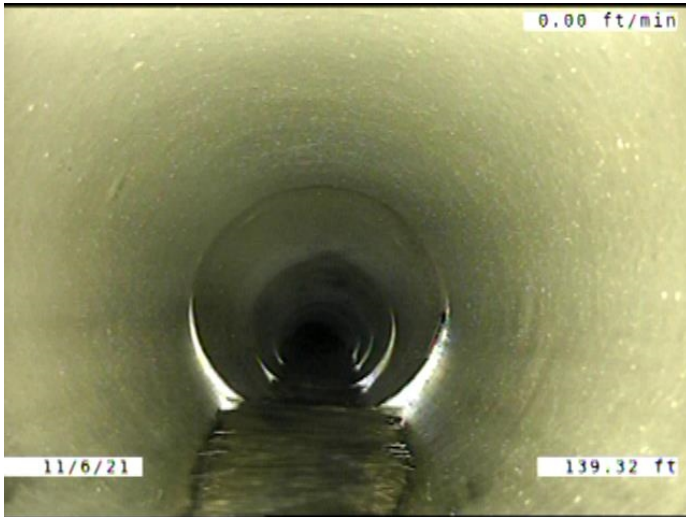
Code: **MWLS**
 Description: **Miscellaneous Water Level Sag**

Distance (ft): **139.3**
 Structural Grade: **2**
 O&M Grade: **0**
 Clock Start/From:
 Clock To:
 1st Value:
 2nd Value:
 Value Percent: **10.000**
 Continuous Index: **F04**
 Within 8" of Joint: **NO**
 Remarks:

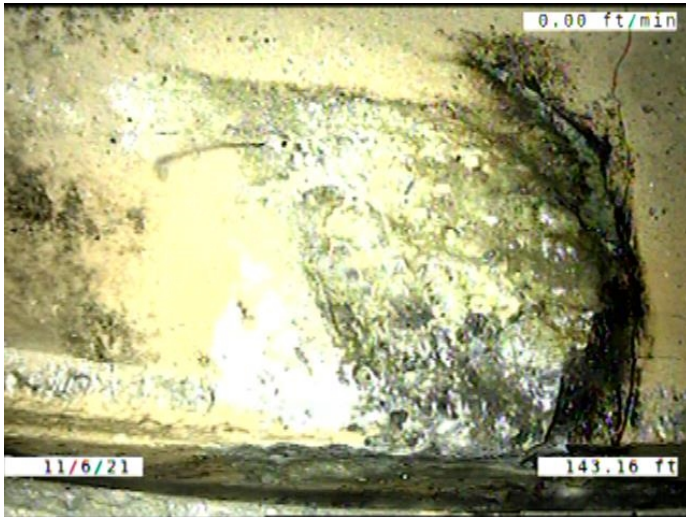
Code: **DAE**
 Description: **Deposits Attached Encrustation**

Distance (ft): **143.2**
 Structural Grade: **0**
 O&M Grade: **2**
 Clock Start/From: **3**
 Clock To: **4**
 1st Value:
 2nd Value:
 Value Percent: **5.000**
 Continuous Index:
 Within 8" of Joint: **YES**
 Remarks:

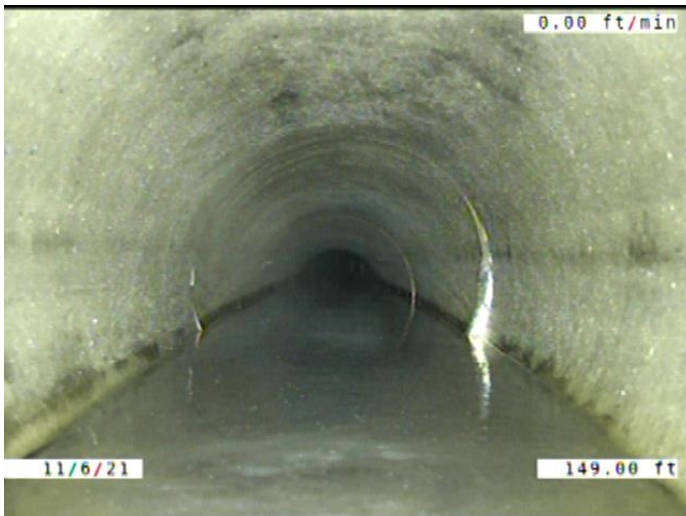
Code: **MWLS**
 Description: **Miscellaneous Water Level Sag**

Distance (ft): **149.0**
 Structural Grade: **3**
 O&M Grade: **0**
 Clock Start/From:
 Clock To:
 1st Value:
 2nd Value:
 Value Percent: **35.000**
 Continuous Index: **S05**
 Within 8" of Joint: **NO**
 Remarks:

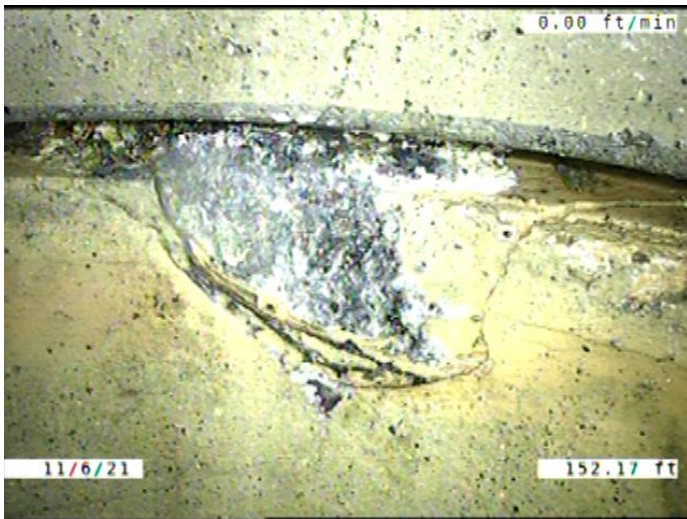
Code: **DAE**
Description: **Deposits Attached Encrustation**

Distance (ft): **152.2**
Structural Grade: **0**
O&M Grade: **2**
Clock Start/From: **2**
Clock To: **3**
1st Value:
2nd Value:
Value Percent: **5.000**
Continuous Index:
Within 8" of Joint: **YES**
Remarks:

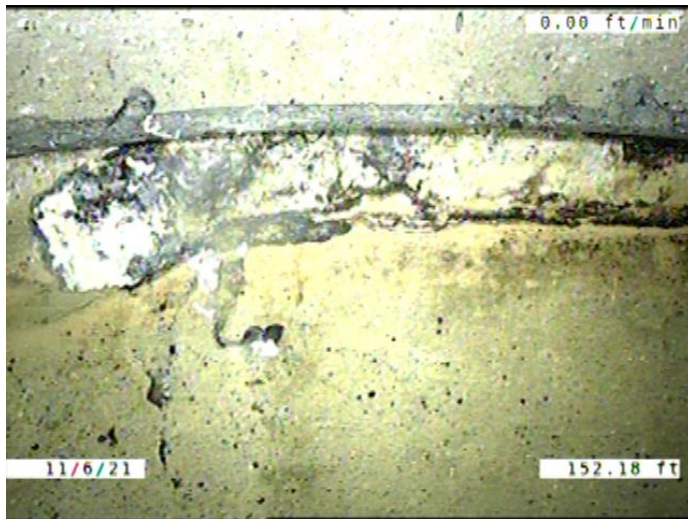
Code: **DAE**
 Description: **Deposits Attached Encrustation**

Distance (ft): **152.2**
 Structural Grade: **0**
 O&M Grade: **2**
 Clock Start/From: **9**
 Clock To: **11**
 1st Value:
 2nd Value:
 Value Percent: **5.000**
 Continuous Index:
 Within 8" of Joint: **YES**
 Remarks:

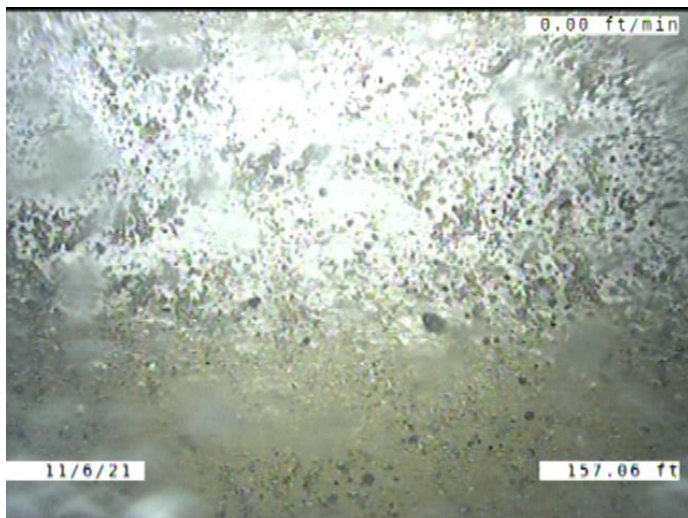
Code: **MCU**
 Description: **Miscellaneous Camera Underwater**

Distance (ft): **157.1**
 Structural Grade: **0**
 O&M Grade: **4**
 Clock Start/From:
 Clock To:
 1st Value:
 2nd Value:
 Value Percent:
 Continuous Index: **S06**
 Within 8" of Joint: **NO**
 Remarks:

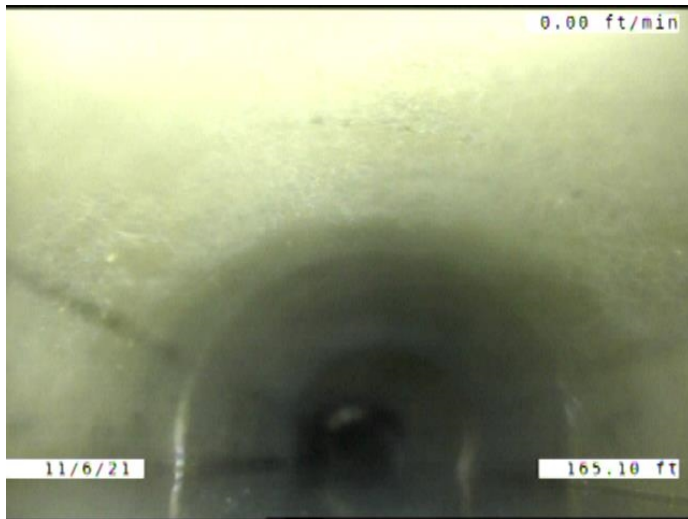
Code: **MCU**
 Description: **Miscellaneous Camera Underwater**

Distance (ft): **165.1**
 Structural Grade: **0**
 O&M Grade: **4**
 Clock Start/From:
 Clock To:
 1st Value:
 2nd Value:
 Value Percent:
 Continuous Index: **F06**
 Within 8" of Joint: **NO**
 Remarks:

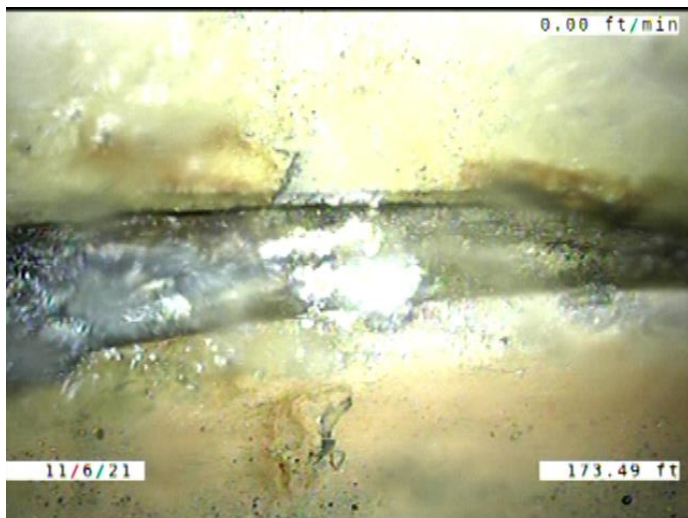
Code: **DAE**
 Description: **Deposits Attached Encrustation**

Distance (ft): **173.5**
 Structural Grade: **0**
 O&M Grade: **2**
 Clock Start/From: **9**
 Clock To: **11**
 1st Value:
 2nd Value:
 Value Percent: **5.000**
 Continuous Index:
 Within 8" of Joint: **YES**
 Remarks:

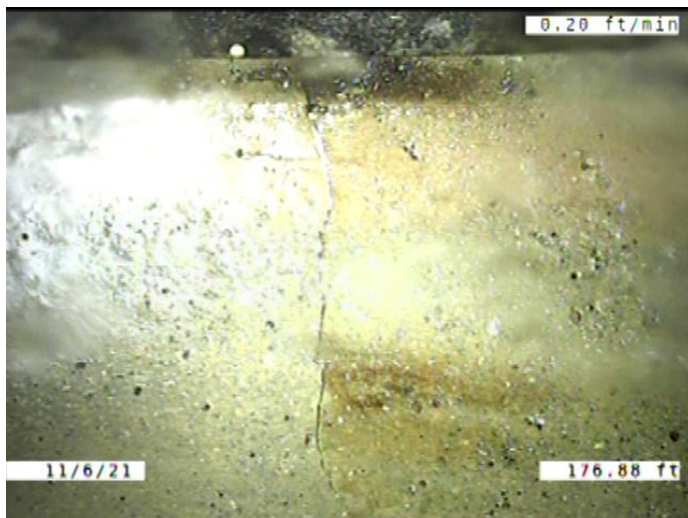
Code:	CL
Description:	Crack Longitudinal
Distance (ft):	176.9
Structural Grade:	2
O&M Grade:	0
Clock Start/From:	1
Clock To:	
1st Value:	
2nd Value:	
Value Percent:	
Continuous Index:	
Within 8" of Joint:	YES
Remarks:

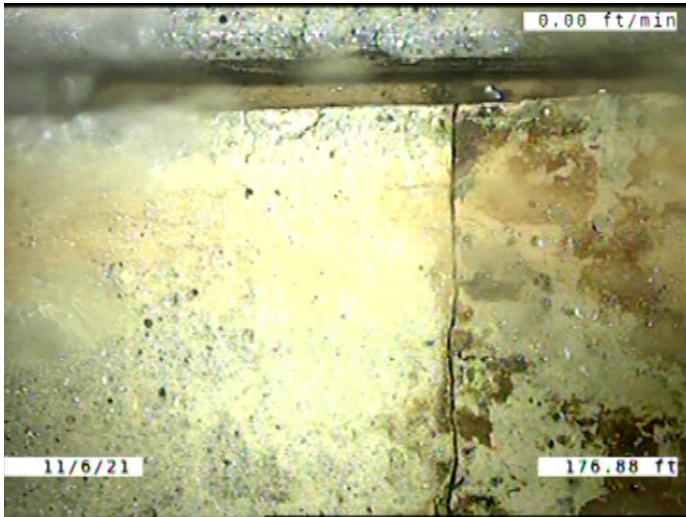
Code: **CL**
Description: **Crack Longitudinal**

Distance (ft): **176.9**
Structural Grade: **2**
O&M Grade: **0**
Clock Start/From: **2**
Clock To:
1st Value:
2nd Value:
Value Percent:
Continuous Index:
Within 8" of Joint: **YES**
Remarks:

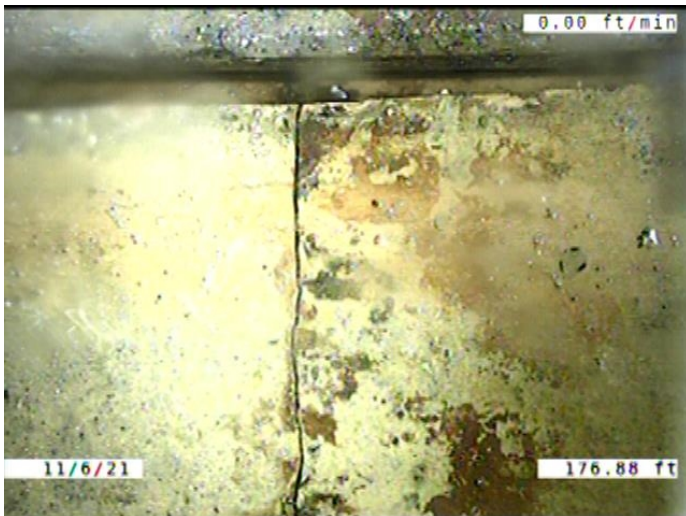
Code: **ISB**
Description: **Infiltration Stain Barrel**

Distance (ft): **176.9**
Structural Grade: **0**
O&M Grade: **1**
Clock Start/From: **1**
Clock To: **3**
1st Value:
2nd Value:
Value Percent:
Continuous Index:
Within 8" of Joint: **YES**
Remarks:

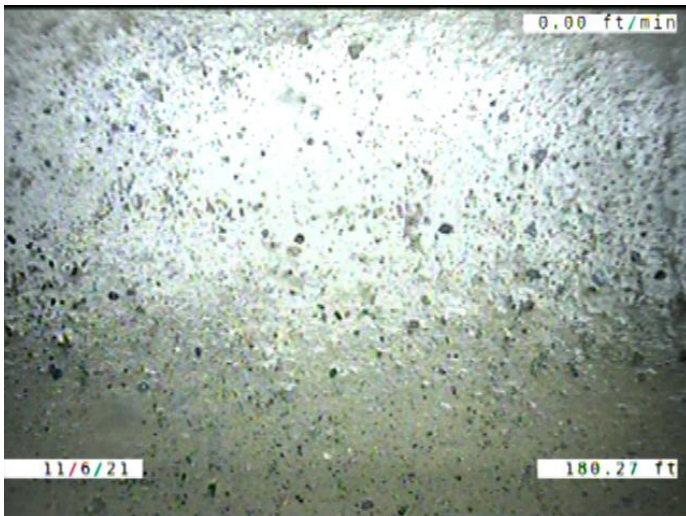
Code: **CL**
Description: **Crack Longitudinal**

Distance (ft): **179.8**
Structural Grade: **2**
O&M Grade: **0**
Clock Start/From: **12**
Clock To:
1st Value:
2nd Value:
Value Percent:
Continuous Index:
Within 8" of Joint: **YES**
Remarks:

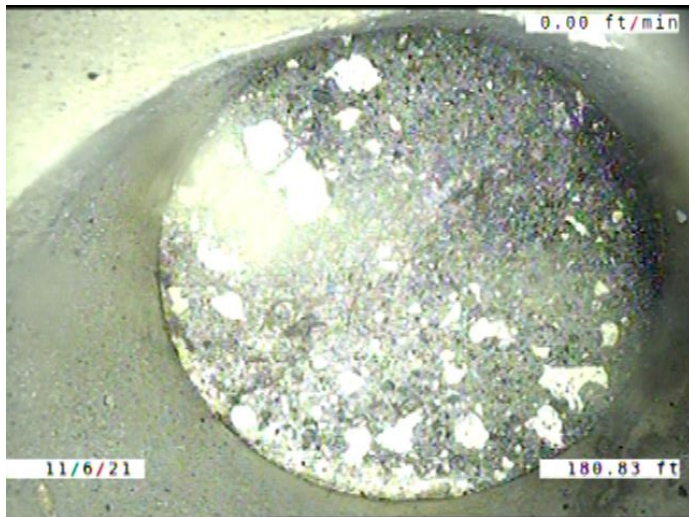
Code: **MCU**
Description: **Miscellaneous Camera Underwater**

Distance (ft): **180.3**
Structural Grade: **0**
O&M Grade: **4**
Clock Start/From:
Clock To:
1st Value:
2nd Value:
Value Percent:
Continuous Index:
Within 8" of Joint: **NO**
Remarks: **Out at 180.7**

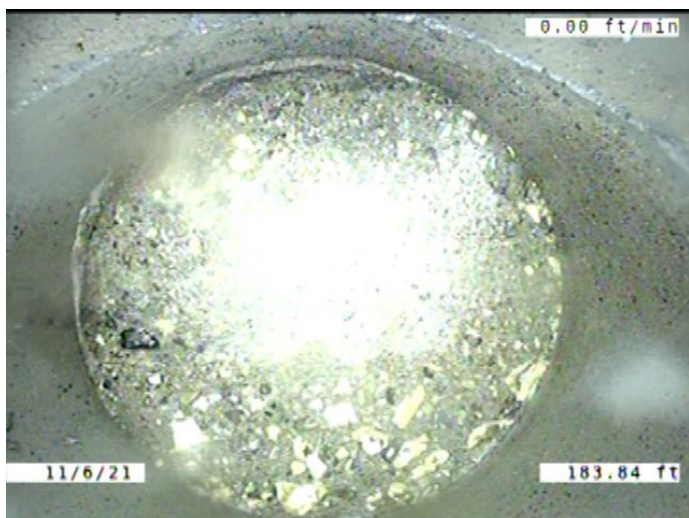
Code: **TFC**
 Description: **Tap Factory Capped**

Distance (ft): **180.8**
 Structural Grade: **0**
 O&M Grade: **0**
 Clock Start/From: **1**
 Clock To:
 1st Value: **4.000**
 2nd Value:
 Value Percent:
 Continuous Index:
 Within 8" of Joint: **YES**
 Remarks:

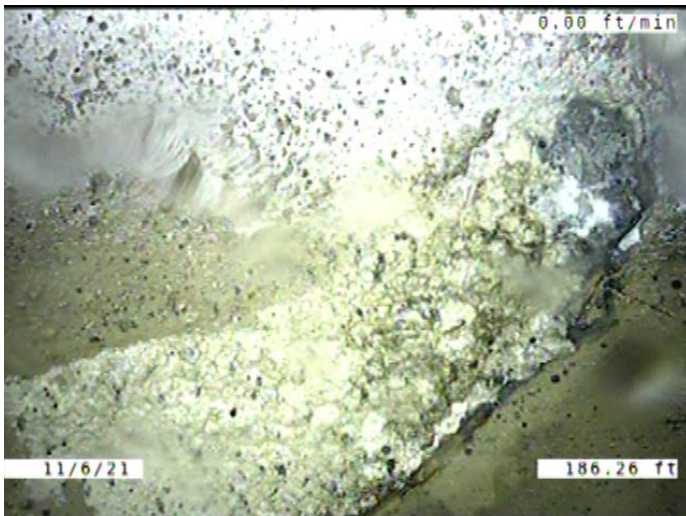
Code: **FL**
 Description: **Fracture Longitudinal**

Distance (ft): **185.8**
 Structural Grade: **3**
 O&M Grade: **0**
 Clock Start/From: **12**
 Clock To:
 1st Value:
 2nd Value:
 Value Percent:
 Continuous Index:
 Within 8" of Joint: **YES**
 Remarks:

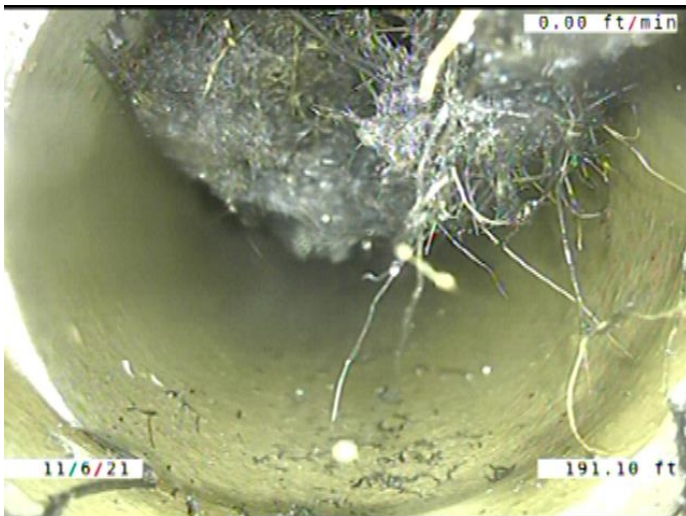
Code: **RML**
Description: **Roots Medium Lateral**

Distance (ft): **190.6**
Structural Grade: **0**
O&M Grade: **3**
Clock Start/From: **12**
Clock To:
1st Value:
2nd Value:
Value Percent: **5.000**
Continuous Index:
Within 8" of Joint: **NO**
Remarks:

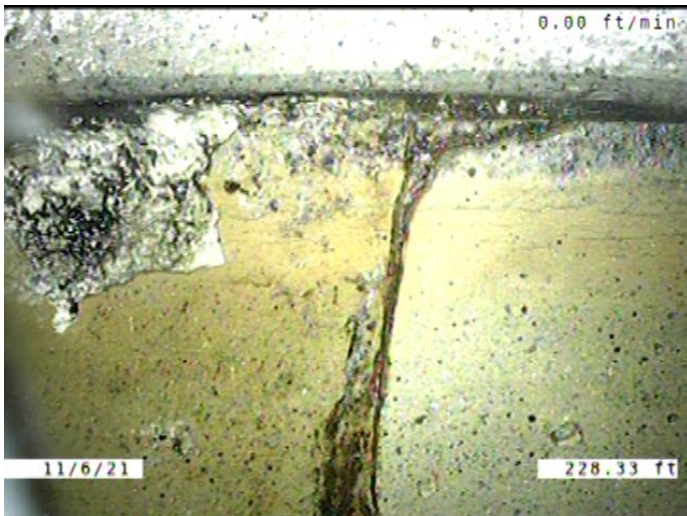
Code: **FL**
 Description: **Fracture Longitudinal**

Distance (ft): **228.3**
 Structural Grade: **3**
 O&M Grade: **0**
 Clock Start/From: **10**
 Clock To:
 1st Value:
 2nd Value:
 Value Percent:
 Continuous Index:
 Within 8" of Joint: **YES**
 Remarks:

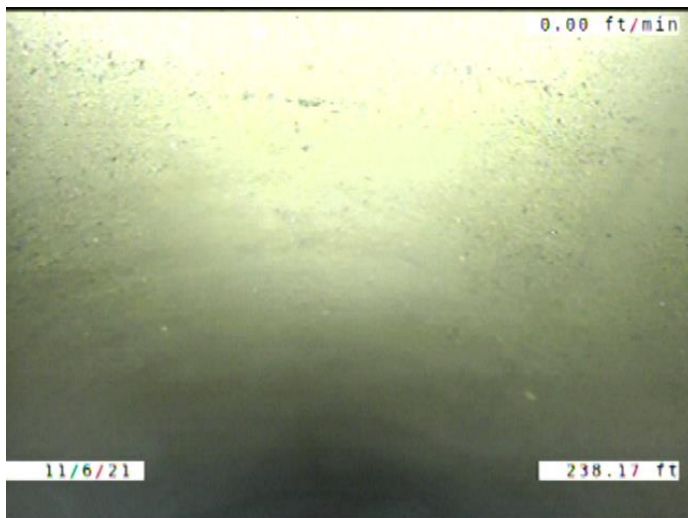
Code: **TFC**
 Description: **Tap Factory Capped**

Distance (ft): **235.7**
 Structural Grade: **0**
 O&M Grade: **0**
 Clock Start/From: **11**
 Clock To:
 1st Value: **4.000**
 2nd Value:
 Value Percent:
 Continuous Index:
 Within 8" of Joint: **YES**
 Remarks:

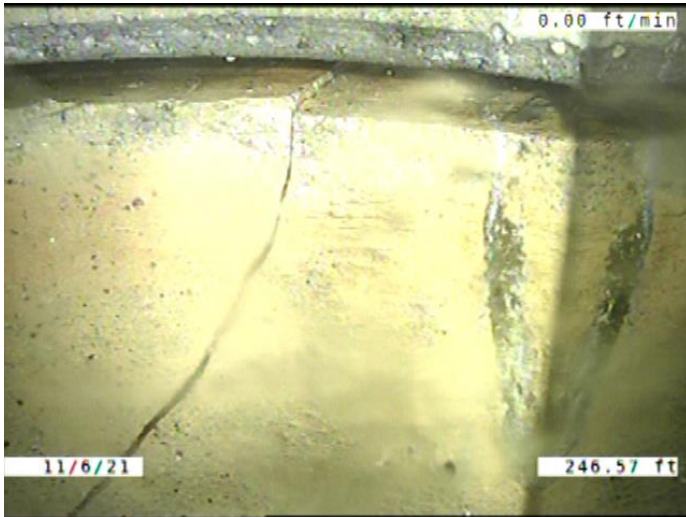
Code: **MCU**
 Description: **Miscellaneous Camera Underwater**

Distance (ft): **238.2**
 Structural Grade: **0**
 O&M Grade: **4**
 Clock Start/From:
 Clock To:
 1st Value:
 2nd Value:
 Value Percent:
 Continuous Index: **F08**
 Within 8" of Joint: **NO**
 Remarks:

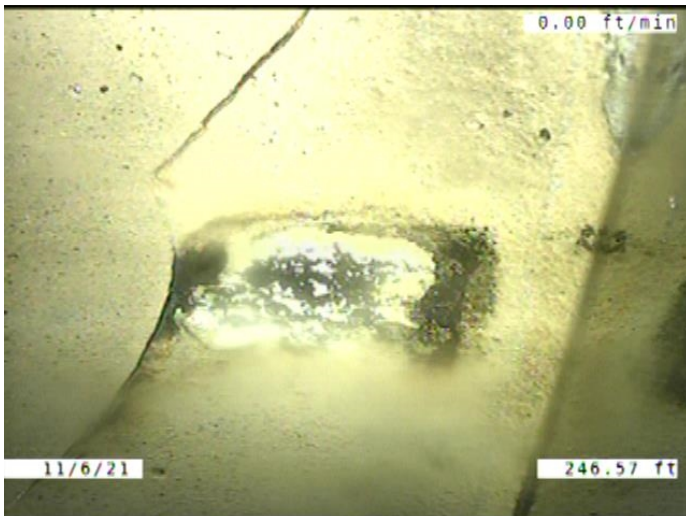
Code: **B**
 Description: **Broken**

Distance (ft): **246.6**
 Structural Grade: **4**
 O&M Grade: **0**
 Clock Start/From: **9**
 Clock To: **3**
 1st Value:
 2nd Value:
 Value Percent:
 Continuous Index:
 Within 8" of Joint: **YES**
 Remarks:

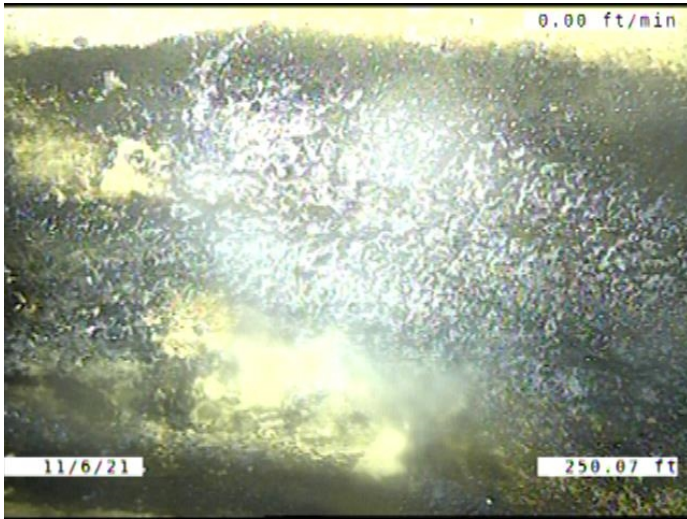
Code: **DAE**
 Description: **Deposits Attached Encrustation**

Distance (ft): **246.6**
 Structural Grade: **0**
 O&M Grade: **2**
 Clock Start/From: **9**
 Clock To: **3**
 1st Value:
 2nd Value:
 Value Percent: **5.000**
 Continuous Index:
 Within 8" of Joint: **YES**
 Remarks:

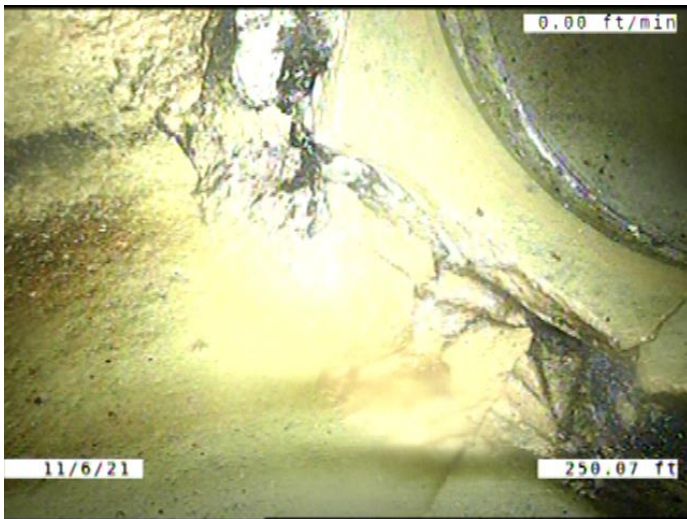
Code: **ISC**
Description: **Infiltration Stain Connection**

Distance (ft): **250.1**
Structural Grade: **0**
O&M Grade: **1**
Clock Start/From: **9**
Clock To: **3**
1st Value:
2nd Value:
Value Percent:
Continuous Index:
Within 8" of Joint: **YES**
Remarks:

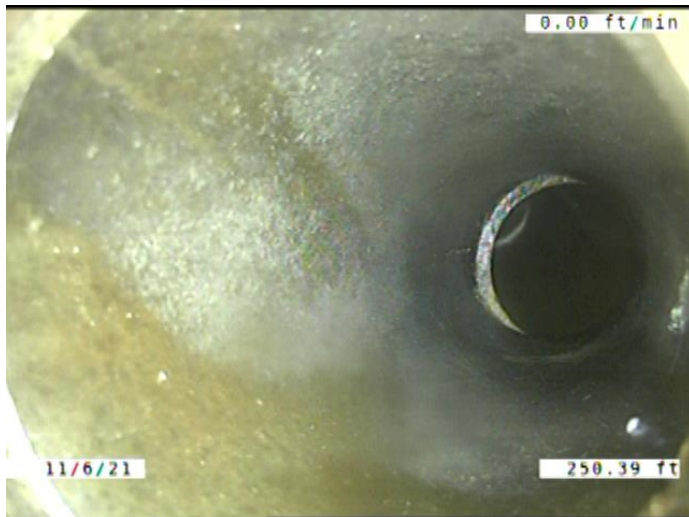
Code: **B**
Description: **Broken**

Distance (ft): **250.1**
Structural Grade: **4**
O&M Grade: **0**
Clock Start/From: **9**
Clock To: **2**
1st Value:
2nd Value:
Value Percent:
Continuous Index: **S09**
Within 8" of Joint: **YES**
Remarks:

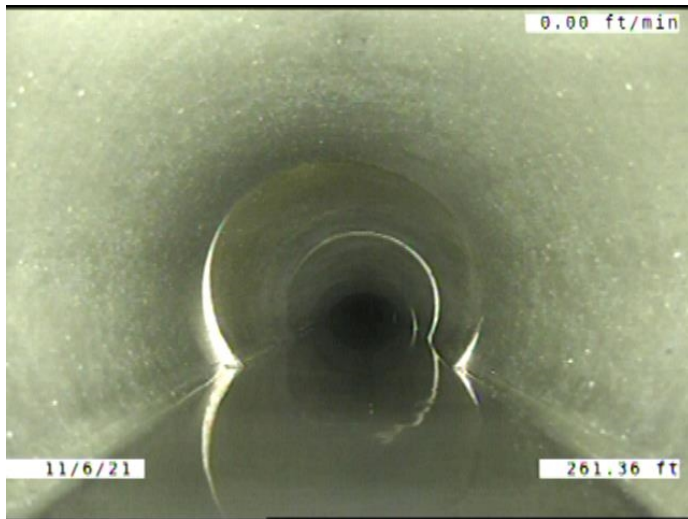
Code: **MWLS**
 Description: **Miscellaneous Water Level Sag**

Distance (ft): **261.4**
 Structural Grade: **3**
 O&M Grade: **0**
 Clock Start/From:
 Clock To:
 1st Value:
 2nd Value:
 Value Percent: **35.000**
 Continuous Index: **F07**
 Within 8" of Joint: **NO**
 Remarks:

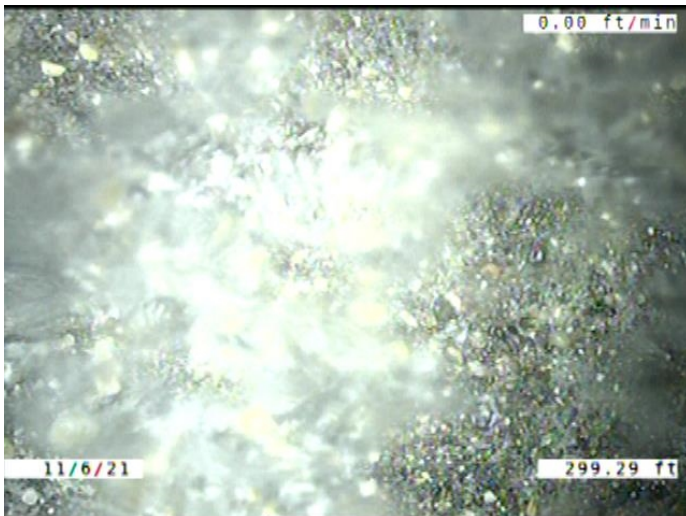
Code: **B**
Description: **Broken**

Distance (ft): **298.3**
Structural Grade: **4**
O&M Grade: **0**
Clock Start/From: **12**
Clock To: **12**
1st Value:
2nd Value:
Value Percent:
Continuous Index: **S11**
Within 8" of Joint: **YES**
Remarks:

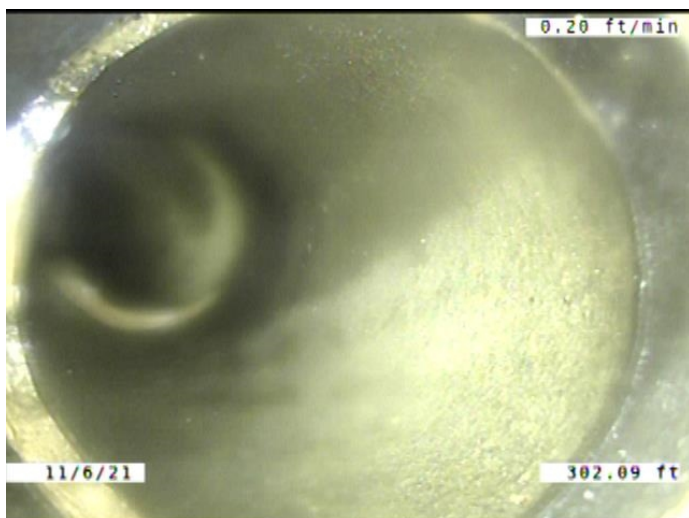
Code: **BSV**
 Description: **Broken Soil Visible**

Distance (ft): **301.5**
 Structural Grade: **5**
 O&M Grade: **0**
 Clock Start/From: **9**
 Clock To: **3**
 1st Value:
 2nd Value:
 Value Percent:
 Continuous Index:
 Within 8" of Joint: **YES**
 Remarks:

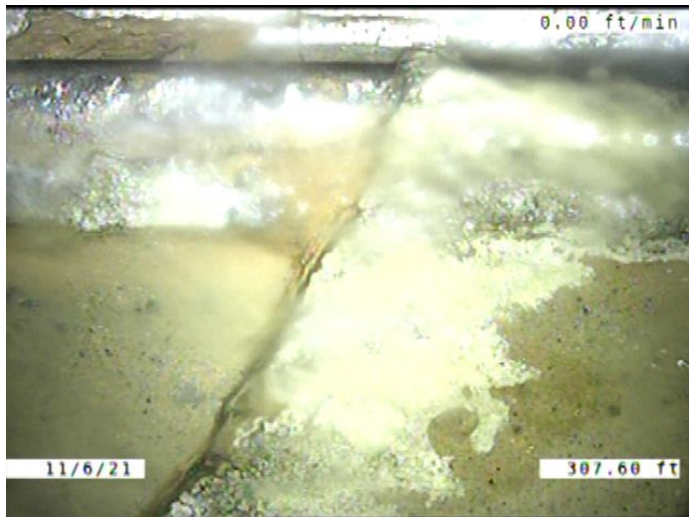
Code: **TBI**
 Description: **Tap Break-in Intruding**

Distance (ft): **302.1**
 Structural Grade: **0**
 O&M Grade: **2**
 Clock Start/From: **11**
 Clock To:
 1st Value: **4.000**
 2nd Value: **1.000**
 Value Percent:
 Continuous Index:
 Within 8" of Joint: **YES**
 Remarks: **CONSTANTLY RUNNING WATER.**

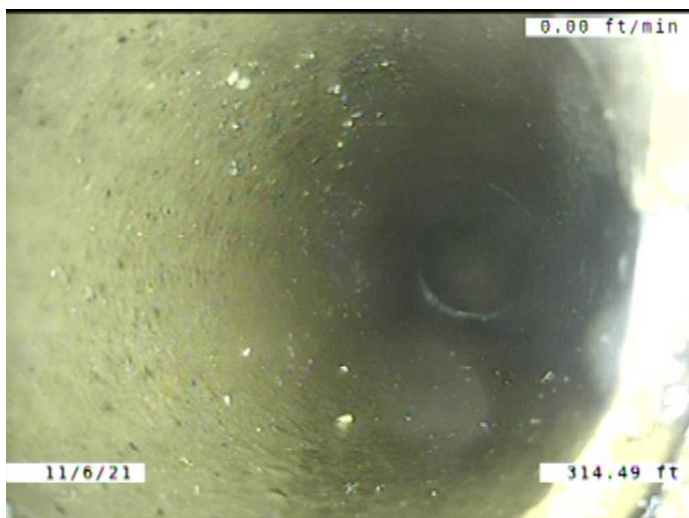
Code: **DAE**
Description: **Deposits Attached Encrustation**

Distance (ft): **307.6**
Structural Grade: **0**
O&M Grade: **2**
Clock Start/From: **9**
Clock To: **3**
1st Value:
2nd Value:
Value Percent: **5.000**
Continuous Index: **S12**
Within 8" of Joint: **YES**
Remarks:

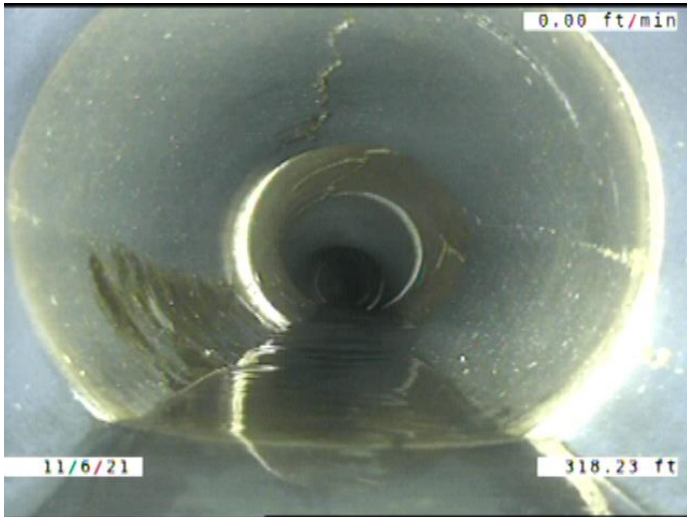
Code: **TBI**
Description: **Tap Break-in Intruding**

Distance (ft): **314.5**
Structural Grade: **0**
O&M Grade: **2**
Clock Start/From: **12**
Clock To:
1st Value: **4.000**
2nd Value: **1.000**
Value Percent:
Continuous Index:
Within 8" of Joint: **YES**
Remarks: **CONSTANTLY RUNNING WATER.**

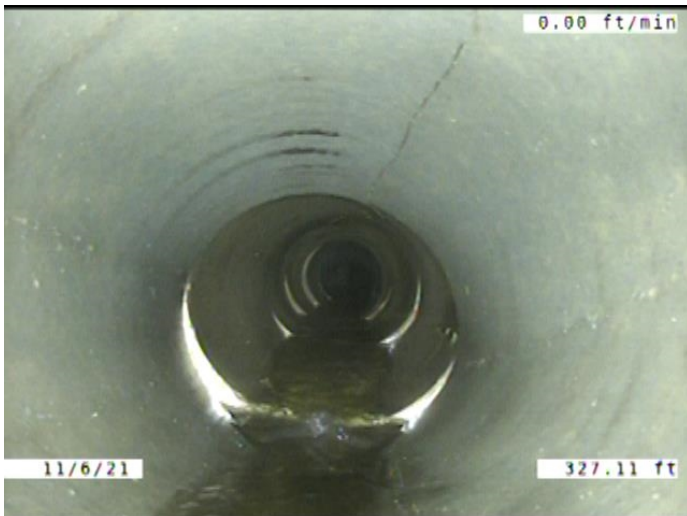
Code: **MWLS**
Description: **Miscellaneous Water Level Sag**

Distance (ft): **318.2**
Structural Grade: **3**
O&M Grade: **0**
Clock Start/From:
Clock To:
1st Value:
2nd Value:
Value Percent: **35.000**
Continuous Index: **F10**
Within 8" of Joint: **NO**
Remarks:

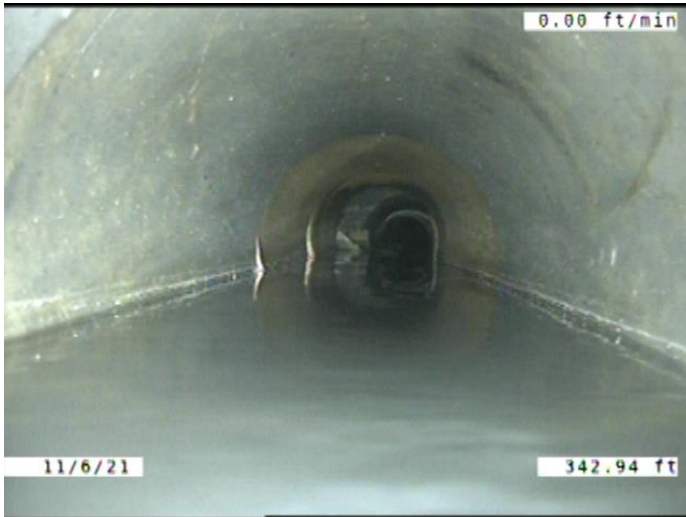
Code: **LD**
Description: **Line Down**

Distance (ft): **327.1**
Structural Grade: **0**
O&M Grade: **1**
Clock Start/From:
Clock To:
1st Value:
2nd Value:
Value Percent: **5.000**
Continuous Index:
Within 8" of Joint: **NO**
Remarks:
