Profile/Photo Observation Report

Date:	11/06/2021	Weather:		Coding:	PACP 7.0
Pipe Length (ft):	353.7	Owner:	City of Hobart	Pre Clean:	Heavy Cleaning
P.O.#:	YES502259	Surveyor:	S. Bucklin	PSR:	P-404-004-002
Customer:	City of Hobart	Clean Date:	11/06/2021	Shape:	C

Street:	North Wabash Street	Flow Control:	Not Controlled
City:	Hobart, IN	Year Renewed:	
Location:	Alley	Tape/Media #:	
Purpose:	Routine Assessment	Dia/Height:	12"
Use:	Sanitary Sewage Pipe	Material:	VCP
Drain Area:		Lining:	None
Category:	NA		
Comment:			
Location Details:		Direction of Survey:	Downstream
US MH:	M-404-004	DS MH:	M-404-002
		Total Length Surveyed (ft):	353.7

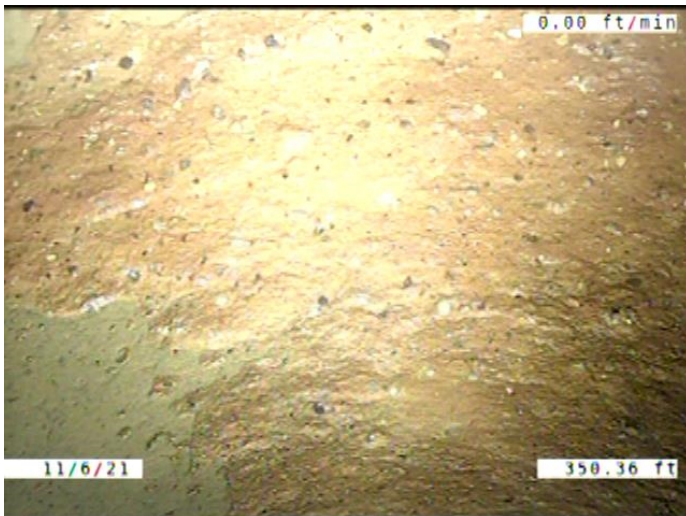
Code:	MWL
Description:	Miscellaneous Water Level
Distance (ft):	342.9
Structural Grade:	0
O&M Grade:	0
Clock Start/From:	
Clock To:	
1st Value:	
2nd Value:	
Value Percent:	20.000
Continuous Index:	
Within 8" of Joint:	NO
Remarks:	LINER ON THE 18" IN THE MANHOLE IS HIGHER THEN THE BOTTOM OF TH

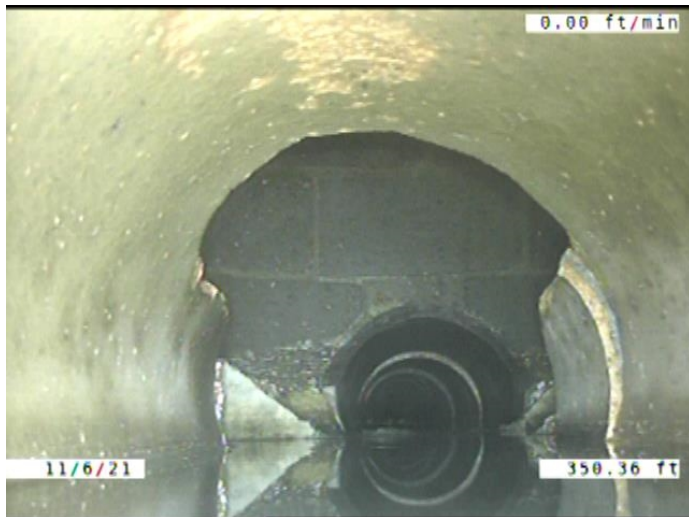
Code:	SSS
Description:	Surface Damage Surface Spalling
Distance (ft):	350.4
Structural Grade:	2
O&M Grade:	0
Clock Start/From:	10
Clock To:	1
1st Value:	
2nd Value:	
Value Percent:	
Continuous Index:	
Within 8" of Joint:	YES
Remarks:

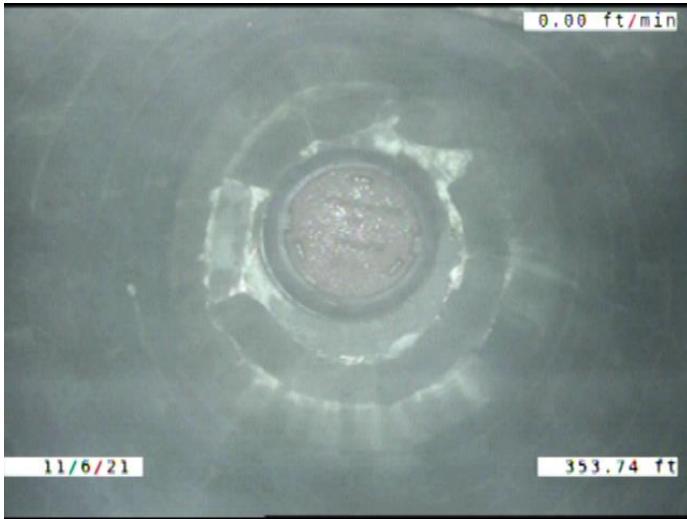
Code: **B**
 Description: **Broken**

Distance (ft): **352.9**
 Structural Grade: **4**
 O&M Grade: **0**
 Clock Start/From: **12**
 Clock To: **12**
 1st Value:
 2nd Value:
 Value Percent:
 Continuous Index: **F11**
 Within 8" of Joint: **YES**
 Remarks:
