## Profile/Photo Observation Report

Date:	<b>04/22/2018</b>	Weather:		Coding:	<b>PACP 6.0</b>
Pipe Length (ft):	<b>307.4</b>	Owner:	<b>NA</b>	Pre Clean:	<b>No Pre-Cleaning</b>
P.O.#:		Surveyor:	<b>Mark Ruby</b>	PSR:	<b>P-404-005-004</b>
Customer:		Clean Date:	<b>01/01/1900</b>	Shape:	<b>C</b>

Street:	<b>FOXCROFT STREET</b>	Flow Control:	<b>Not Controlled</b>
City:	<b>Hobart, IN</b>	Year Renewed:	
Location:	<b>Light Highway</b>	Tape/Media #:	
Purpose:	<b>Routine Assessment</b>	Dia/Height:	<b>12"</b>
Use:	<b>Sanitary</b>	Material:	<b>VCP</b>
Drain Area:	<b>NA</b>	Lining:	
Category:	<b>NA</b>		
Comment:	<b>P_C at 66 ft nothing visible. Flow direction wrong</b>		
Location Details:		Direction of Survey:	<b>Downstream</b>
US MH:	<b>M-404-005</b>	DS MH:	<b>M-404-004</b>
		Total Length Surveyed (ft):	<b>67.5</b>

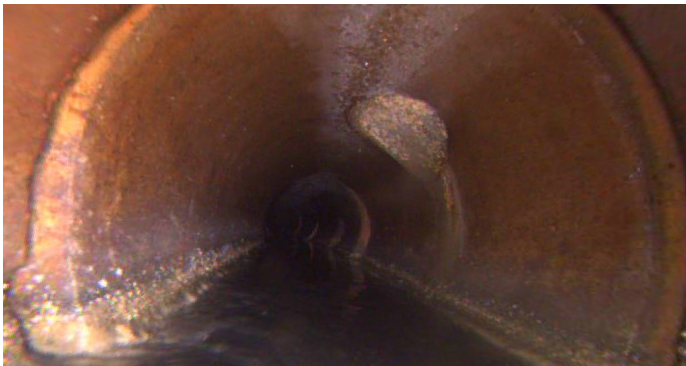
Position	Code	Observation	Video (sec)	Grade
M-404-005				
.0	AMH	Manhole	10	NA
.0	MWL	Water Level	22	NA
2.6	TFC	Tap Factory Capped	39	NA
4.5	TFC	Tap Factory Capped	55	NA
26.9	CL	Crack Longitudinal	112	S 2
28.5	CM	Crack Multiple	126	S 3
55.7	TFC	Tap Factory Capped	194	NA
61.6	CL	Crack Longitudinal	220	S 2
67.5	MSA	Abandoned Survey	247	NA
M-404-004
