Profile/Photo Observation Report

Date:	11/06/2021	Weather:		Coding:	PACP 7.0
Pipe Length (ft):	303.8	Owner:	City of Hobart	Pre Clean:	Heavy Cleaning
P.O.#:	YES502259	Surveyor:	S. Bucklin	PSR:	P-404-005-004
Customer:	City of Hobart	Clean Date:	11/06/2021	Shape:	C

Street:	North Wabash Street	Flow Control:	Not Controlled
City:	Hobart, IN	Year Renewed:	
Location:	Alley	Tape/Media #:	
Purpose:	Routine Assessment	Dia/Height:	12"
Use:	Sanitary Sewage Pipe	Material:	VCP
Drain Area:		Lining:	None
Category:	NA		
Comment:			
Location Details:		Direction of Survey:	Downstream
US MH:	M-404-005	DS MH:	M-404-004
		Total Length Surveyed (ft):	303.8

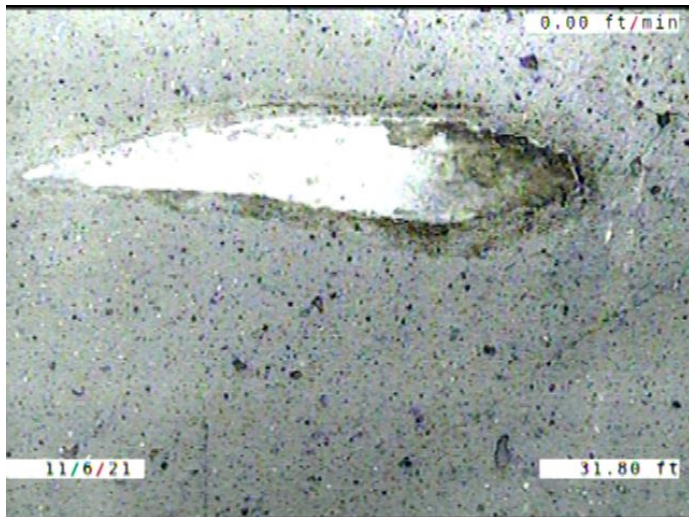
Code:	DAE
Description:	Deposits Attached Encrustation
Distance (ft):	31.8
Structural Grade:	0
O&M Grade:	2
Clock Start/From:	10
Clock To:	
1st Value:	
2nd Value:	
Value Percent:	5.000
Continuous Index:	
Within 8" of Joint:	NO
Remarks:

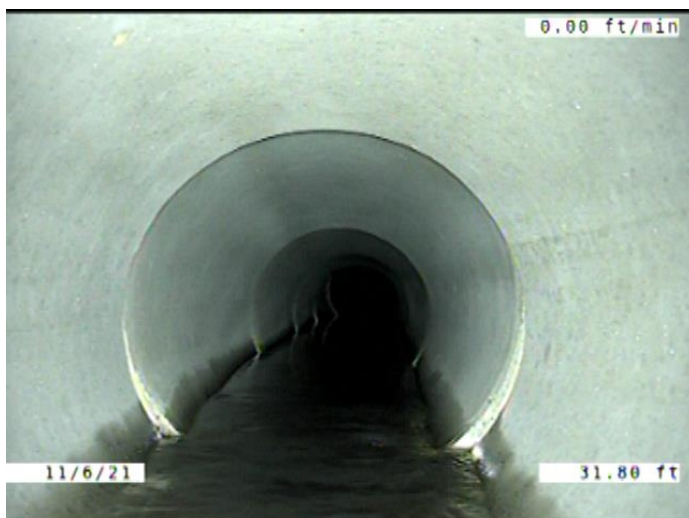
Code:	MWLS
Description:	Miscellaneous Water Level Sag
Distance (ft):	31.8
Structural Grade:	2
O&M Grade:	0
Clock Start/From:	
Clock To:	
1st Value:	
2nd Value:	
Value Percent:	10.000
Continuous Index:	S02
Within 8" of Joint:	NO
Remarks:

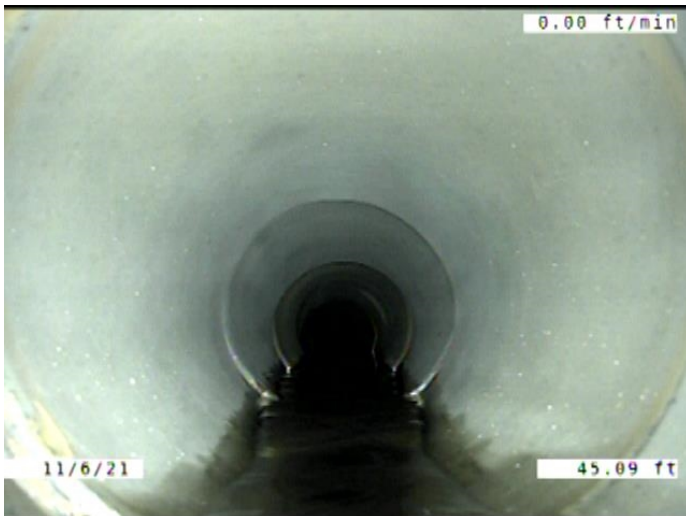
Code: **MWLS**
Description: **Miscellaneous Water Level Sag**

Distance (ft): **45.1**
Structural Grade: **2**
O&M Grade: **0**
Clock Start/From:
Clock To:
1st Value:
2nd Value:
Value Percent: **10.000**
Continuous Index: **F02**
Within 8" of Joint: **NO**
Remarks:

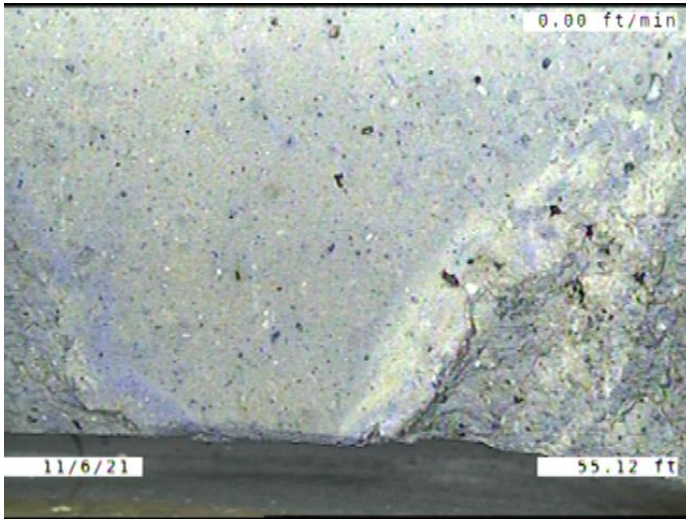
Code: **SSS**
Description: **Surface Damage Surface Spalling**

Distance (ft): **55.1**
Structural Grade: **2**
O&M Grade: **0**
Clock Start/From: **1**
Clock To: **3**
1st Value:
2nd Value:
Value Percent:
Continuous Index:
Within 8" of Joint: **YES**
Remarks:

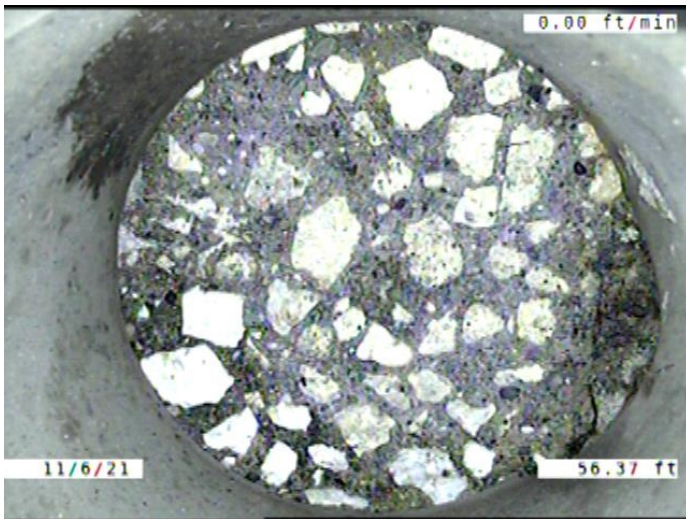
Code: **TFC**
Description: **Tap Factory Capped**

Distance (ft): **56.4**
Structural Grade: **0**
O&M Grade: **0**
Clock Start/From: **2**
Clock To:
1st Value: **4.000**
2nd Value:
Value Percent:
Continuous Index:
Within 8" of Joint: **YES**
Remarks:

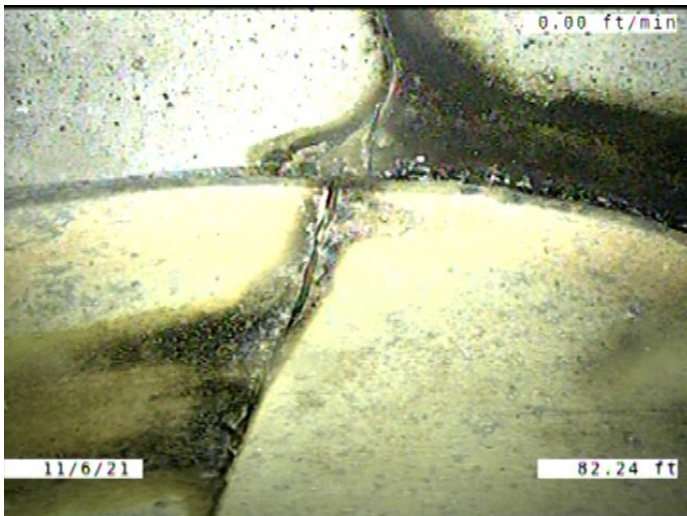
Code: **ISB**
 Description: **Infiltration Stain Barrel**

Distance (ft): **82.2**
 Structural Grade: **0**
 O&M Grade: **1**
 Clock Start/From: **8**
 Clock To: **4**
 1st Value:
 2nd Value:
 Value Percent:
 Continuous Index:
 Within 8" of Joint: **YES**
 Remarks:

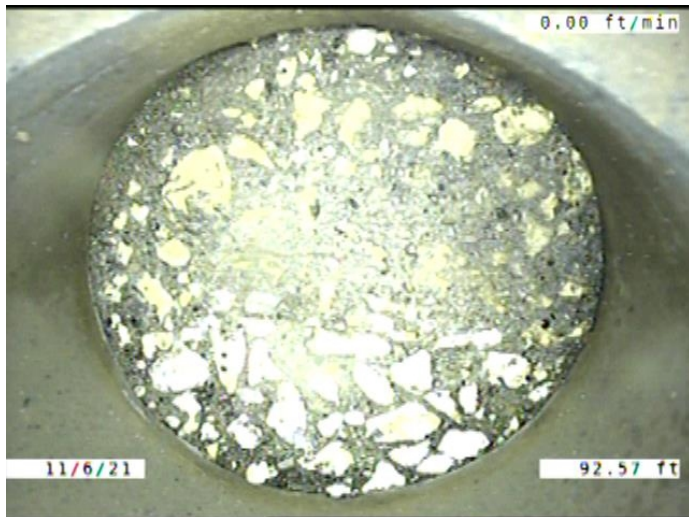
Code: **TFC**
 Description: **Tap Factory Capped**

Distance (ft): **92.6**
 Structural Grade: **0**
 O&M Grade: **0**
 Clock Start/From: **11**
 Clock To:
 1st Value: **4.000**
 2nd Value:
 Value Percent:
 Continuous Index:
 Within 8" of Joint: **YES**
 Remarks:

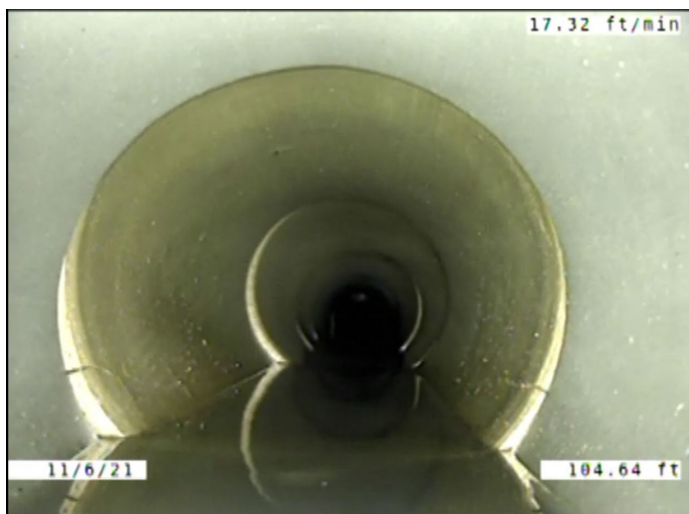
Code: **FS**
 Description: **Fracture Spiral**

Distance (ft): **104.6**
 Structural Grade: **3**
 O&M Grade: **0**
 Clock Start/From: **7**
 Clock To: **8**
 1st Value:
 2nd Value:
 Value Percent:
 Continuous Index:
 Within 8" of Joint: **YES**
 Remarks:

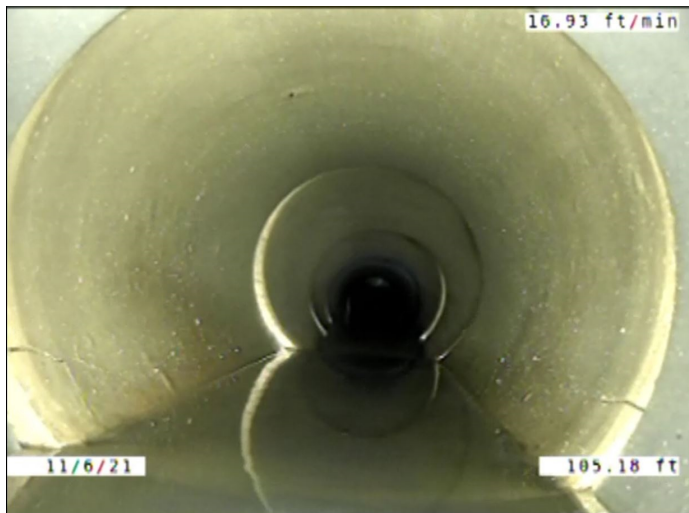
Code: **FL**
Description: **Fracture Longitudinal**

Distance (ft): **105.2**
Structural Grade: **3**
O&M Grade: **0**
Clock Start/From: **4**
Clock To:
1st Value:
2nd Value:
Value Percent:
Continuous Index:
Within 8" of Joint: **YES**
Remarks:

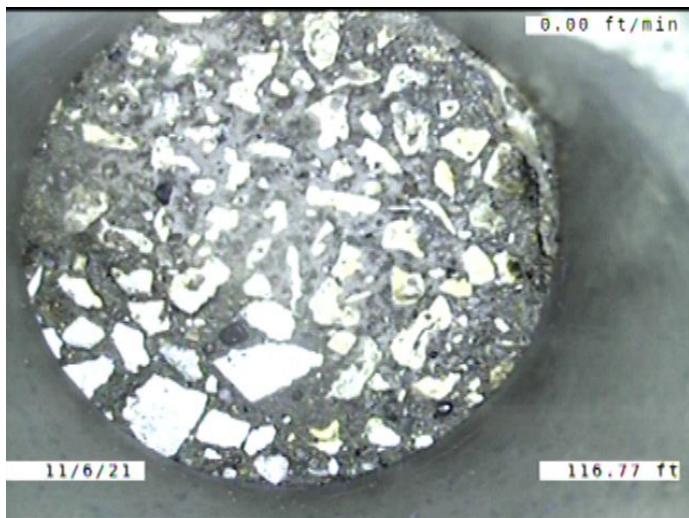
Code: **TFC**
Description: **Tap Factory Capped**

Distance (ft): **116.8**
Structural Grade: **0**
O&M Grade: **0**
Clock Start/From: **2**
Clock To:
1st Value: **4.000**
2nd Value:
Value Percent:
Continuous Index:
Within 8" of Joint: **YES**
Remarks:

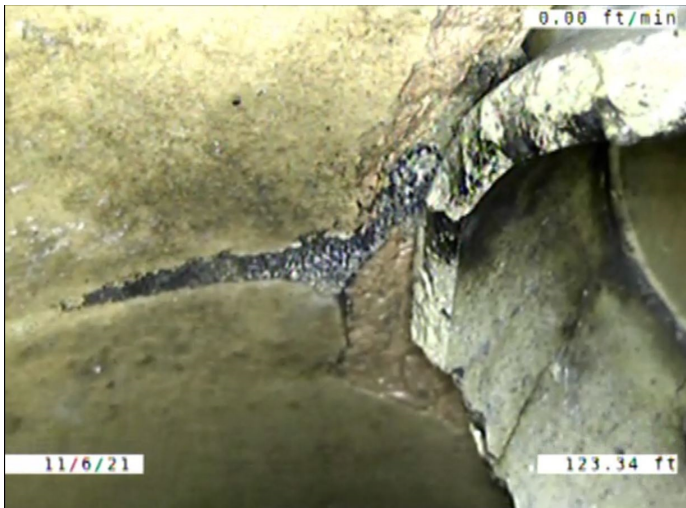
Code: **SSS**
Description: **Surface Damage Surface Spalling**

Distance (ft): **123.3**
Structural Grade: **2**
O&M Grade: **0**
Clock Start/From: **12**
Clock To: **2**
1st Value:
2nd Value:
Value Percent:
Continuous Index:
Within 8" of Joint: **NO**
Remarks:

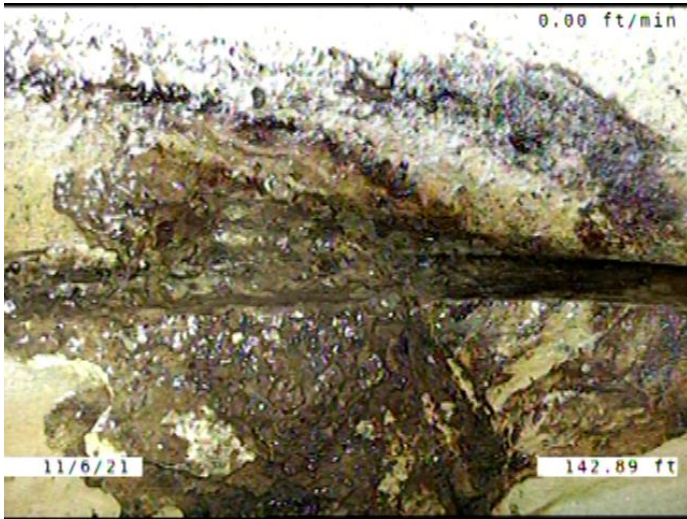
Code: **DAE**
Description: **Deposits Attached Encrustation**

Distance (ft): **142.9**
Structural Grade: **0**
O&M Grade: **2**
Clock Start/From: **9**
Clock To: **11**
1st Value:
2nd Value:
Value Percent: **5.000**
Continuous Index:
Within 8" of Joint: **YES**
Remarks:

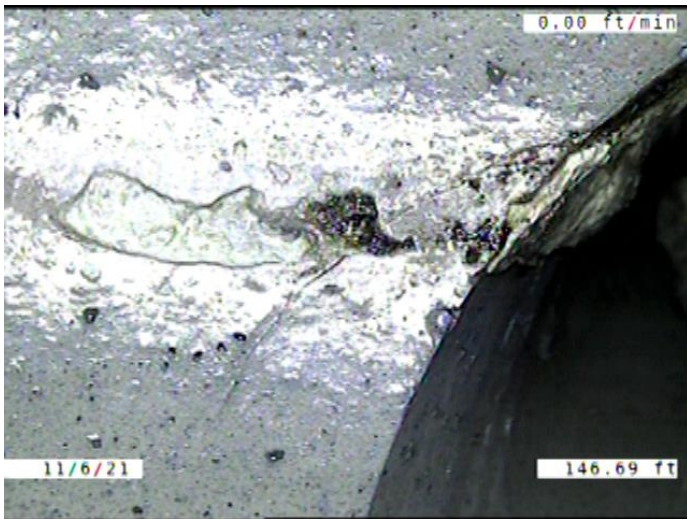
Code: **DAE**
Description: **Deposits Attached Encrustation**

Distance (ft): **146.7**
Structural Grade: **0**
O&M Grade: **2**
Clock Start/From: **10**
Clock To: **11**
1st Value:
2nd Value:
Value Percent: **5.000**
Continuous Index:
Within 8" of Joint: **YES**
Remarks:

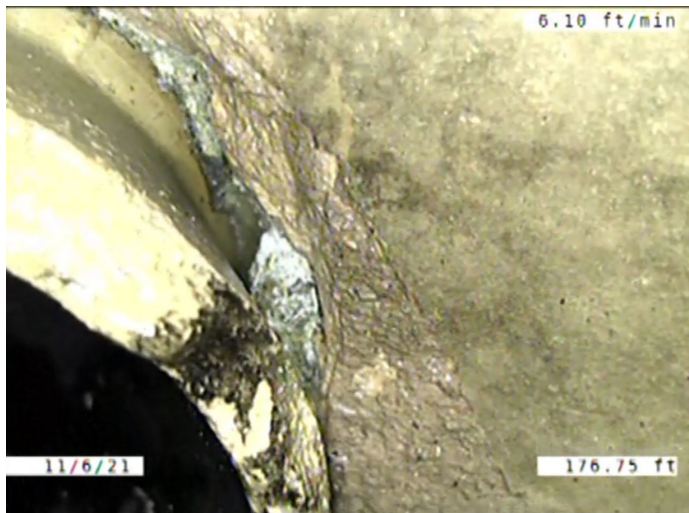
Code: **SSS**
Description: **Surface Damage Surface Spalling**

Distance (ft): **176.8**
Structural Grade: **2**
O&M Grade: **0**
Clock Start/From: **11**
Clock To:
1st Value:
2nd Value:
Value Percent:
Continuous Index:
Within 8" of Joint: **NO**
Remarks:

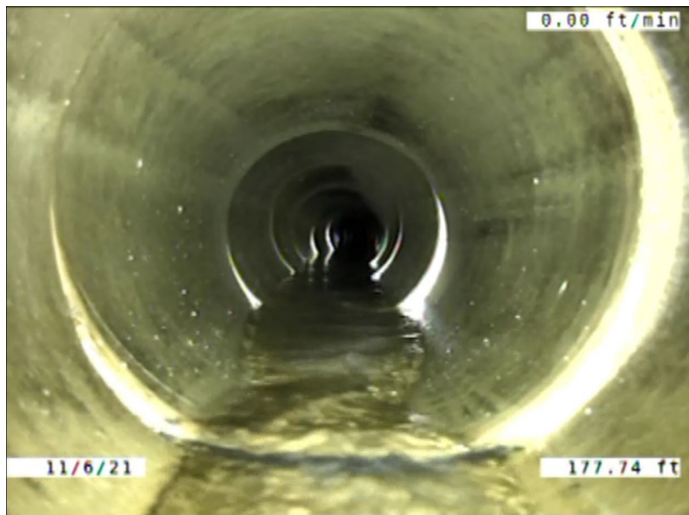
Code: **CM**
 Description: **Crack Multiple**

Distance (ft): **177.7**
 Structural Grade: **3**
 O&M Grade: **0**
 Clock Start/From: **8**
 Clock To: **4**
 1st Value:
 2nd Value:
 Value Percent:
 Continuous Index: **F07**
 Within 8" of Joint: **YES**
 Remarks: **Wandering**

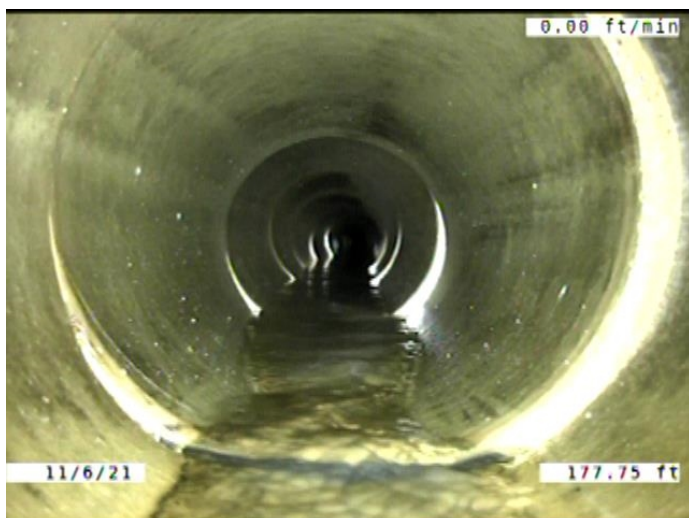
Code: **DAE**
 Description: **Deposits Attached Encrustation**

Distance (ft): **177.7**
 Structural Grade: **0**
 O&M Grade: **2**
 Clock Start/From: **9**
 Clock To: **3**
 1st Value:
 2nd Value:
 Value Percent: **5.000**
 Continuous Index: **F04**
 Within 8" of Joint: **YES**
 Remarks:

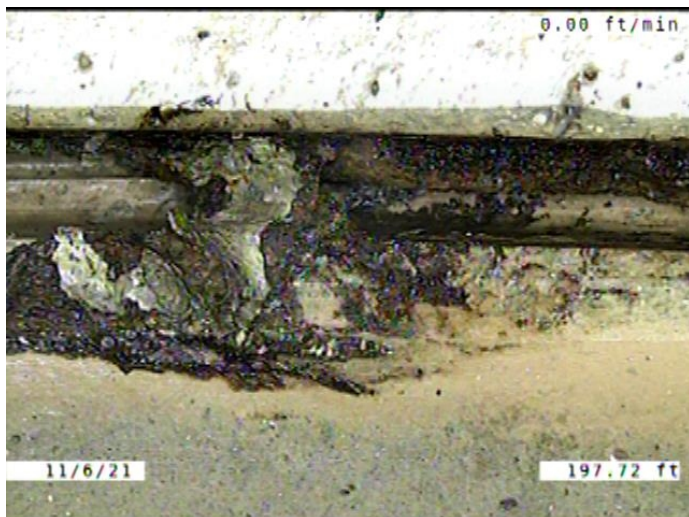
Code: **DAE**
 Description: **Deposits Attached Encrustation**

Distance (ft): **197.7**
 Structural Grade: **0**
 O&M Grade: **2**
 Clock Start/From: **9**
 Clock To: **3**
 1st Value:
 2nd Value:
 Value Percent: **5.000**
 Continuous Index:
 Within 8" of Joint: **YES**
 Remarks:

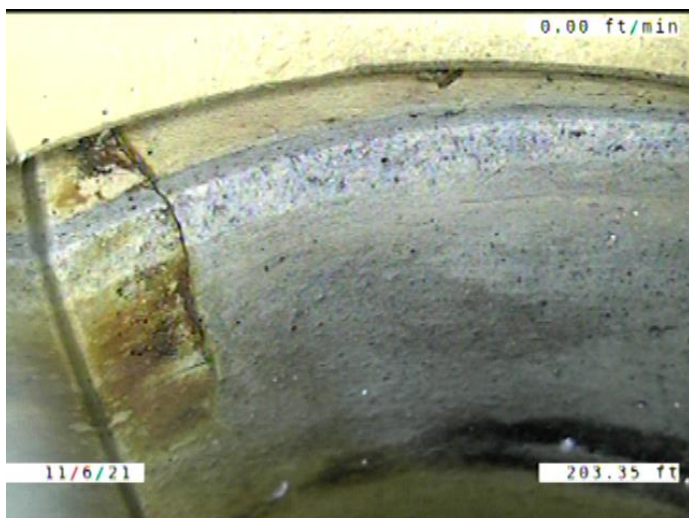
Code: **ISB**
 Description: **Infiltration Stain Barrel**

Distance (ft): **203.4**
 Structural Grade: **0**
 O&M Grade: **1**
 Clock Start/From: **9**
 Clock To:
 1st Value:
 2nd Value:
 Value Percent:
 Continuous Index:
 Within 8" of Joint: **YES**
 Remarks:

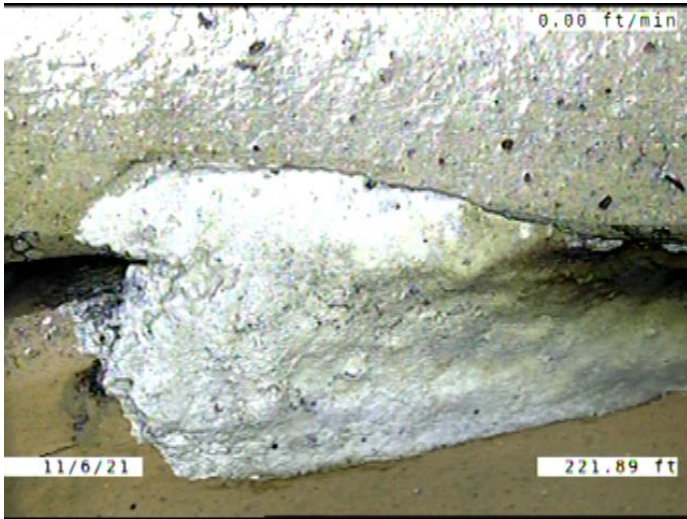
Code: **DAE**
Description: **Deposits Attached Encrustation**

Distance (ft): **221.9**
Structural Grade: **0**
O&M Grade: **2**
Clock Start/From: **9**
Clock To: **3**
1st Value:
2nd Value:
Value Percent: **5.000**
Continuous Index:
Within 8" of Joint: **YES**
Remarks:

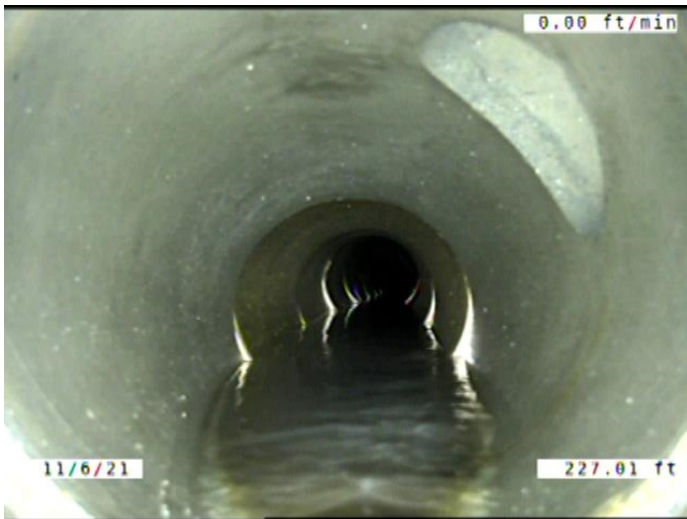
Code: **MWLS**
Description: **Miscellaneous Water Level Sag**

Distance (ft): **227.0**
Structural Grade: **2**
O&M Grade: **0**
Clock Start/From:
Clock To:
1st Value:
2nd Value:
Value Percent: **15.000**
Continuous Index: **F05**
Within 8" of Joint: **NO**
Remarks:

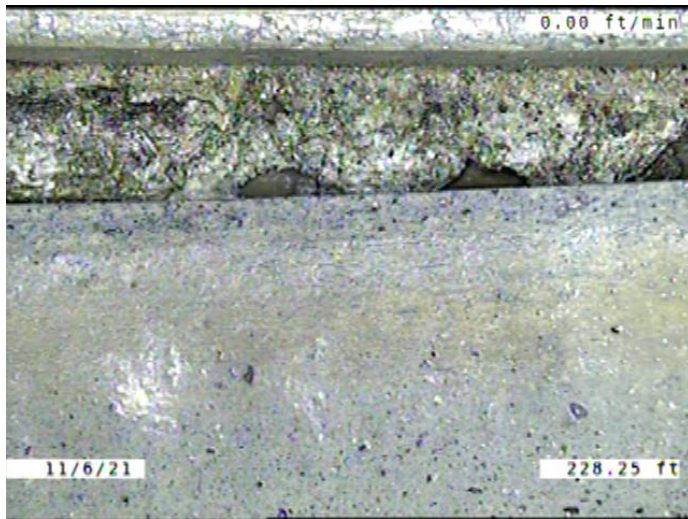
Code: **DAE**
 Description: **Deposits Attached Encrustation**

Distance (ft): **228.3**
 Structural Grade: **0**
 O&M Grade: **2**
 Clock Start/From: **9**
 Clock To: **3**
 1st Value:
 2nd Value:
 Value Percent: **5.000**
 Continuous Index:
 Within 8" of Joint: **YES**
 Remarks:

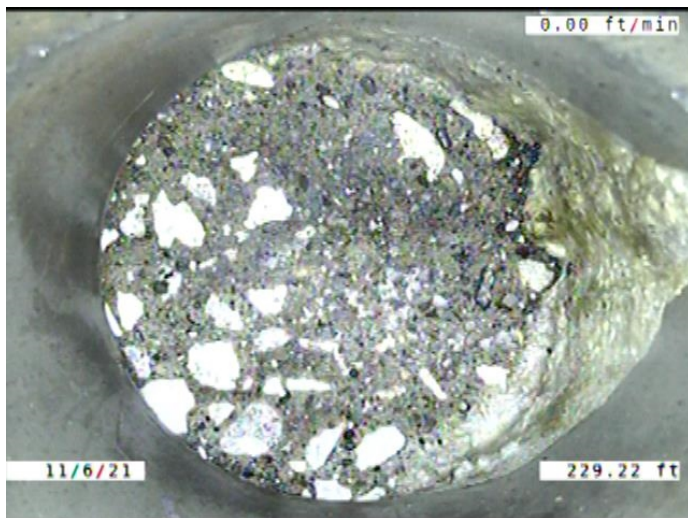
Code: **TFC**
 Description: **Tap Factory Capped**

Distance (ft): **229.2**
 Structural Grade: **0**
 O&M Grade: **0**
 Clock Start/From: **2**
 Clock To:
 1st Value: **4.000**
 2nd Value:
 Value Percent:
 Continuous Index:
 Within 8" of Joint: **YES**
 Remarks: **ENCUSTATION AROUND THE CAP**

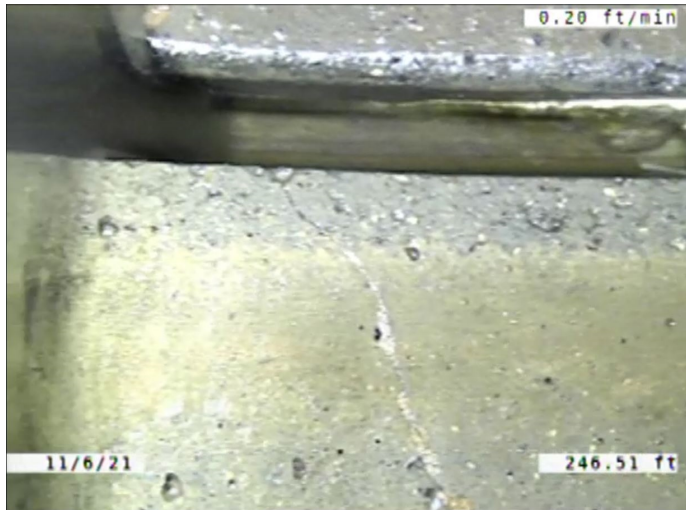
Code: **CL**
 Description: **Crack Longitudinal**

Distance (ft): **246.5**
 Structural Grade: **2**
 O&M Grade: **0**
 Clock Start/From: **8**
 Clock To:
 1st Value:
 2nd Value:
 Value Percent:
 Continuous Index:
 Within 8" of Joint: **YES**
 Remarks:

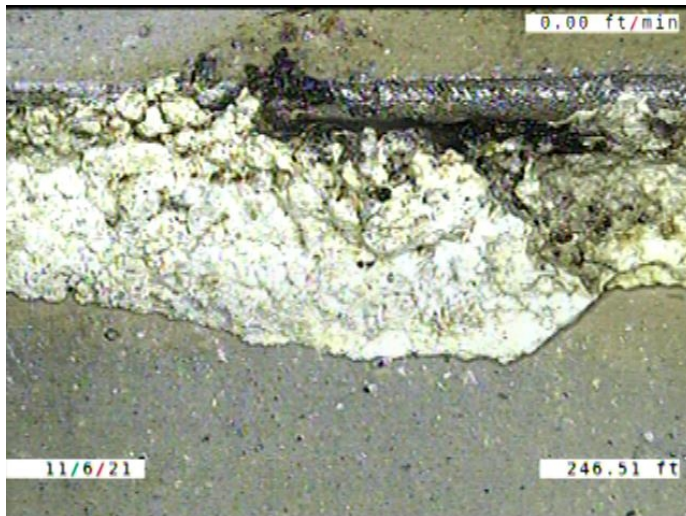
Code: **DAE**
 Description: **Deposits Attached Encrustation**

Distance (ft): **246.5**
 Structural Grade: **0**
 O&M Grade: **2**
 Clock Start/From: **9**
 Clock To: **3**
 1st Value:
 2nd Value:
 Value Percent: **5.000**
 Continuous Index:
 Within 8" of Joint: **YES**
 Remarks:

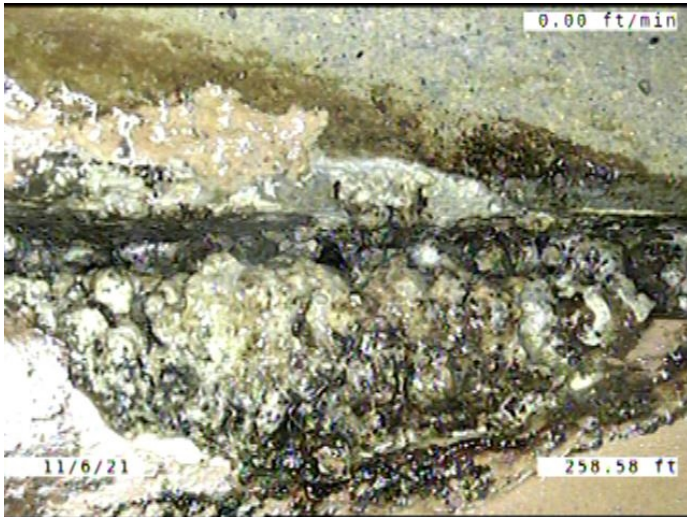
Code: **DAE**
 Description: **Deposits Attached Encrustation**

Distance (ft): **258.6**
 Structural Grade: **0**
 O&M Grade: **2**
 Clock Start/From: **8**
 Clock To: **11**
 1st Value:
 2nd Value:
 Value Percent: **5.000**
 Continuous Index:
 Within 8" of Joint: **YES**
 Remarks:
