# Profile/Photo Observation Report

Date:	11/06/2021	Weather:		Coding:	PACP 7.0
Pipe Length (ft):	303.8	Owner:	City of Hobart	Pre Clean:	Heavy Cleaning
P.O.#:	YES502259	Surveyor:	S. Bucklin	PSR:	P-404-005-004
Customer:	City of Hobart	Clean Date:	11/06/2021	Shape:	C

Street:	North Wabash Street	Flow Control:	Not Controlled
City:	Hobart, IN	Year Renewed:	
Location:	Alley	Tape/Media #:	
Purpose:	Routine Assessment	Dia/Height:	12"
Use:	Sanitary Sewage Pipe	Material:	VCP
Drain Area:		Lining:	None
Category:	NA		
Comment:			
Location Details:		Direction of Survey:	Downstream
US MH:	M-404-005	DS MH:	M-404-004
		Total Length Surveyed (ft):	303.8

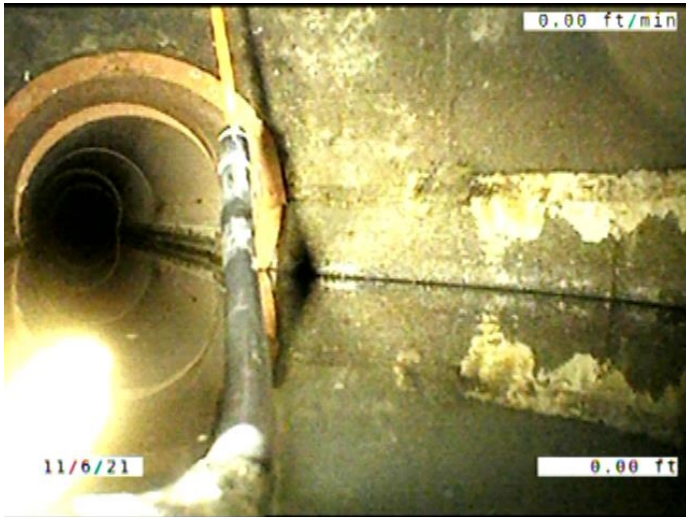
Code: **AMH**  
 Description: **Manhole**

Distance (ft): **.0**  
 Structural Grade: **0**  
 O&M Grade: **0**  
 Clock Start/From:  
 Clock To:  
 1st Value:  
 2nd Value:  
 Value Percent:  
 Continuous Index:  
 Within 8" of Joint: **NO**  
 Remarks: **M-404-005**

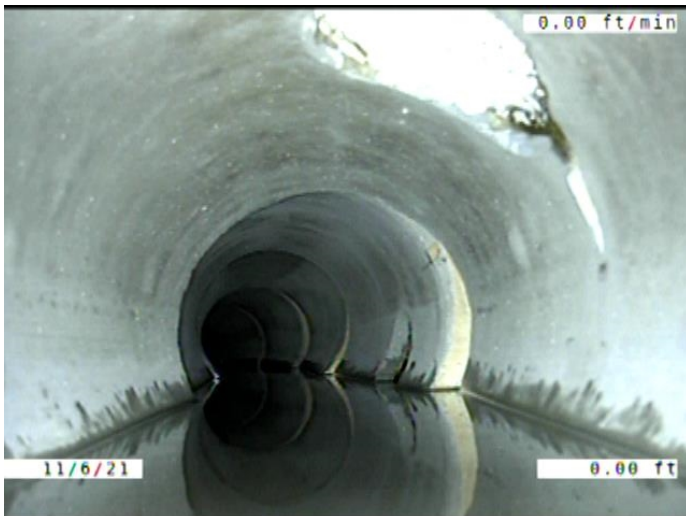
Code: **MWL**  
 Description: **Miscellaneous Water Level**

Distance (ft): **.0**  
 Structural Grade: **0**  
 O&M Grade: **0**  
 Clock Start/From:  
 Clock To:  
 1st Value:  
 2nd Value:  
 Value Percent: **10.000**  
 Continuous Index:  
 Within 8" of Joint: **NO**  
 Remarks:

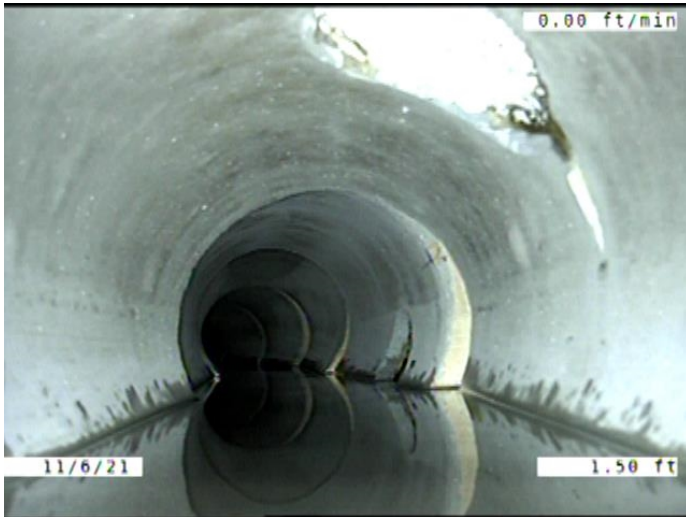
Code: **MGO**  
 Description: **Miscellaneous General Observation**

Distance (ft): **1.5**  
 Structural Grade: **0**  
 O&M Grade: **0**  
 Clock Start/From:  
 Clock To:  
 1st Value:  
 2nd Value:  
 Value Percent:  
 Continuous Index:  
 Within 8" of Joint: **NO**  
 Remarks: **DROP INTO THE MANHOLE. HAD TO START IN THE PIPE.**

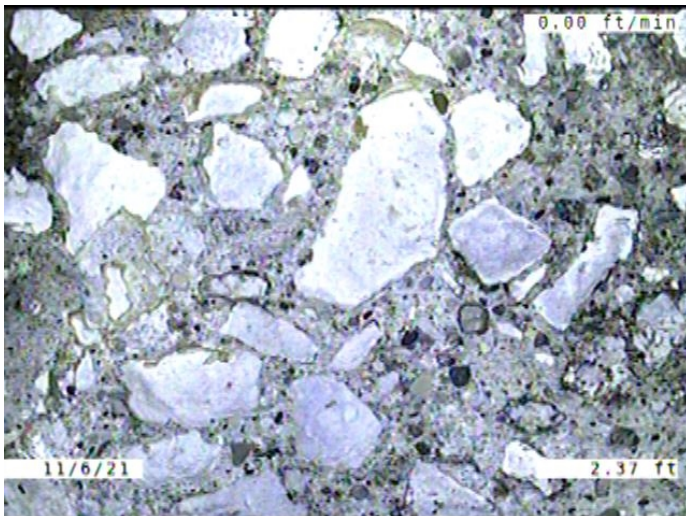
Code: **TFC**  
 Description: **Tap Factory Capped**

Distance (ft): **2.4**  
 Structural Grade: **0**  
 O&M Grade: **0**  
 Clock Start/From: **1**  
 Clock To:  
 1st Value: **4.000**  
 2nd Value:  
 Value Percent:  
 Continuous Index:  
 Within 8" of Joint: **YES**  
 Remarks:

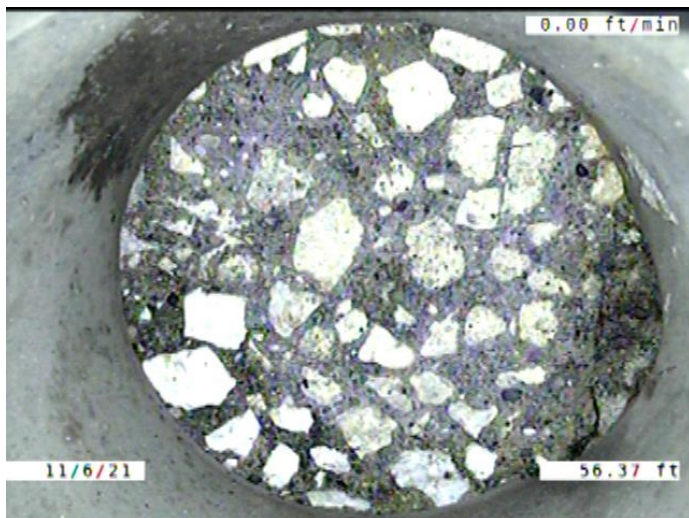
Code: **TFC**  
 Description: **Tap Factory Capped**

Distance (ft): **56.4**  
 Structural Grade: **0**  
 O&M Grade: **0**  
 Clock Start/From: **2**  
 Clock To:  
 1st Value: **4.000**  
 2nd Value:  
 Value Percent:  
 Continuous Index:  
 Within 8" of Joint: **YES**  
 Remarks:

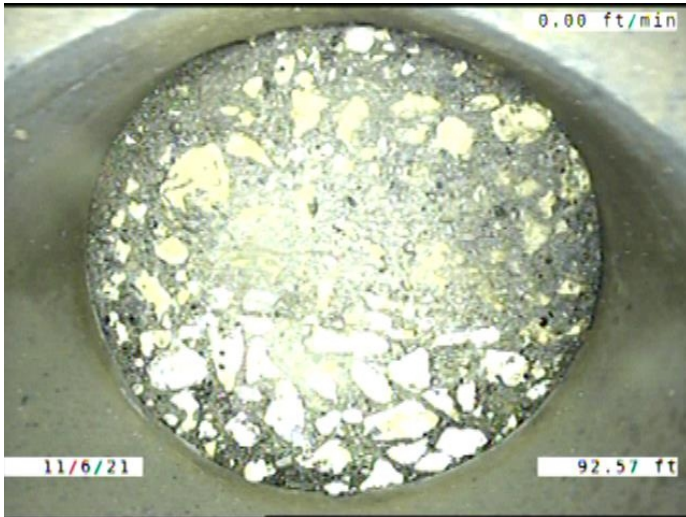
Code: **TFC**  
 Description: **Tap Factory Capped**

Distance (ft): **92.6**  
 Structural Grade: **0**  
 O&M Grade: **0**  
 Clock Start/From: **11**  
 Clock To:  
 1st Value: **4.000**  
 2nd Value:  
 Value Percent:  
 Continuous Index:  
 Within 8" of Joint: **YES**  
 Remarks:

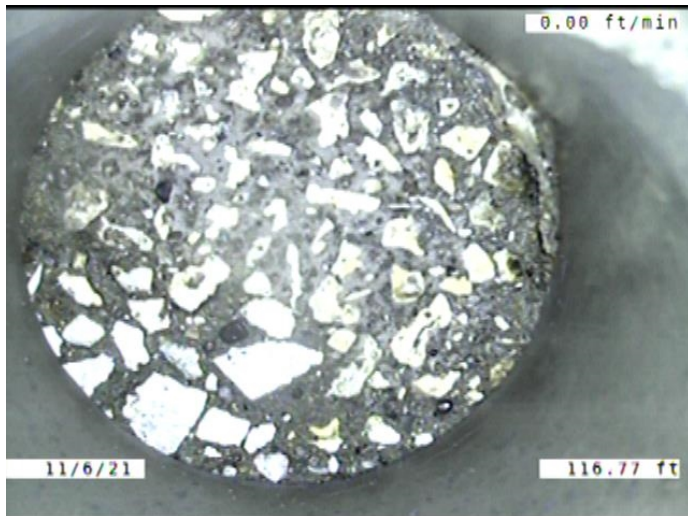
Code: **TFC**  
Description: **Tap Factory Capped**

Distance (ft): **116.8**  
Structural Grade: **0**  
O&M Grade: **0**  
Clock Start/From: **2**  
Clock To:  
1st Value: **4.000**  
2nd Value:  
Value Percent:  
Continuous Index:  
Within 8" of Joint: **YES**  
Remarks:

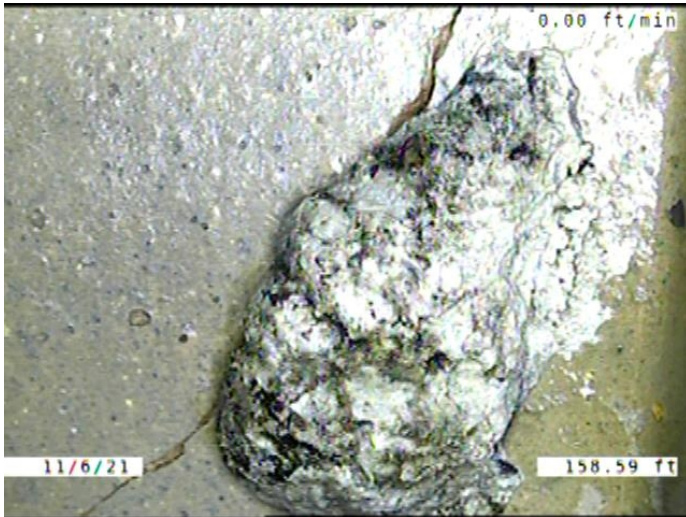
Code: **DAE**  
 Description: **Deposits Attached Encrustation**

Distance (ft): **158.6**  
 Structural Grade: **0**  
 O&M Grade: **2**  
 Clock Start/From: **3**  
 Clock To:  
 1st Value:  
 2nd Value:  
 Value Percent: **5.000**  
 Continuous Index:  
 Within 8" of Joint: **YES**  
 Remarks:

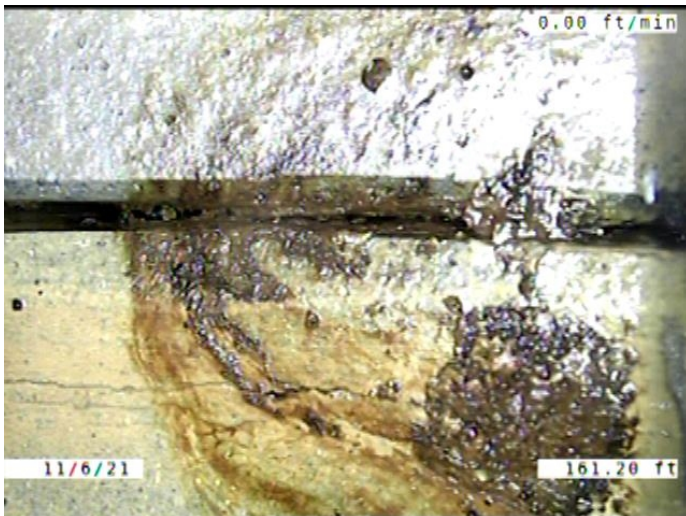
Code: **DAE**  
 Description: **Deposits Attached Encrustation**

Distance (ft): **161.2**  
 Structural Grade: **0**  
 O&M Grade: **2**  
 Clock Start/From: **9**  
 Clock To: **3**  
 1st Value:  
 2nd Value:  
 Value Percent: **5.000**  
 Continuous Index: **S04**  
 Within 8" of Joint: **YES**  
 Remarks:

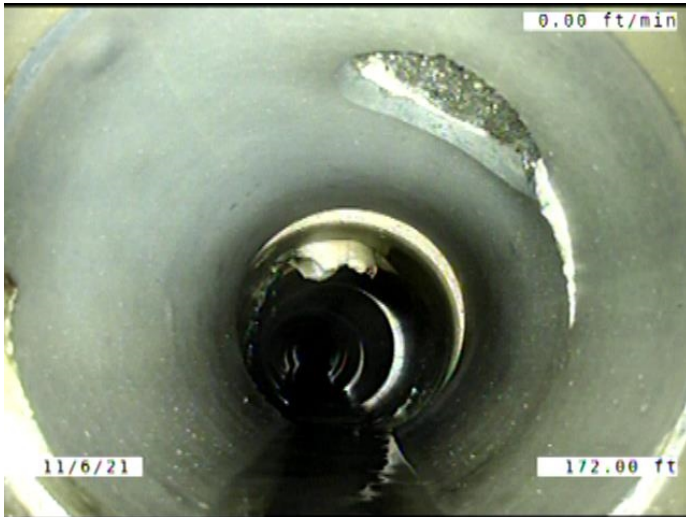
Code: **MWLS**  
 Description: **Miscellaneous Water Level Sag**

Distance (ft): **172.0**  
 Structural Grade: **2**  
 O&M Grade: **0**  
 Clock Start/From:  
 Clock To:  
 1st Value:  
 2nd Value:  
 Value Percent: **15.000**  
 Continuous Index: **F03**  
 Within 8" of Joint: **NO**  
 Remarks:

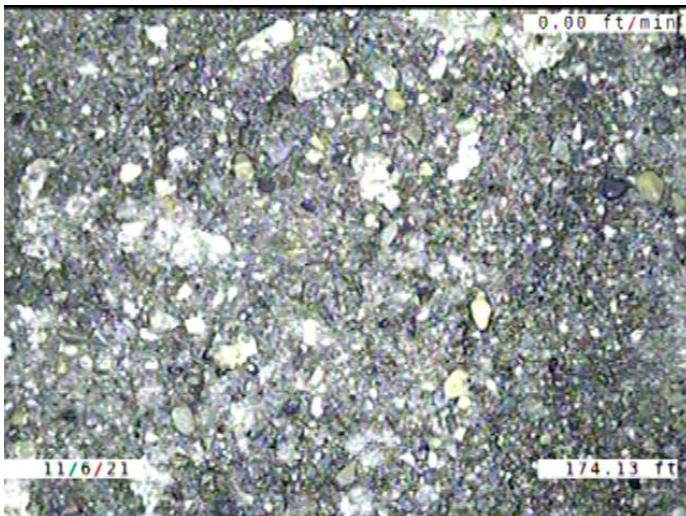
Code: **TFC**  
 Description: **Tap Factory Capped**

Distance (ft): **174.1**  
 Structural Grade: **0**  
 O&M Grade: **0**  
 Clock Start/From: **1**  
 Clock To:  
 1st Value: **4.000**  
 2nd Value:  
 Value Percent:  
 Continuous Index:  
 Within 8" of Joint: **YES**  
 Remarks: **ENCRUSTATION AROUND THE CAP**

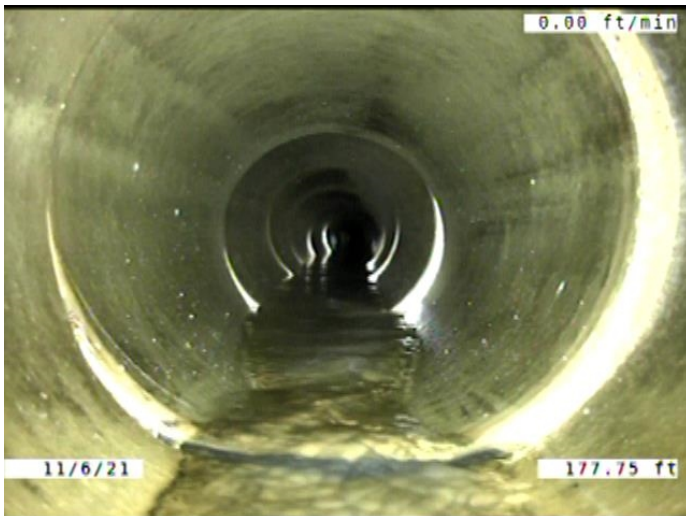
Code: **DAE**  
Description: **Deposits Attached Encrustation**

Distance (ft): **177.7**  
Structural Grade: **0**  
O&M Grade: **2**  
Clock Start/From: **9**  
Clock To: **3**  
1st Value:  
2nd Value:  
Value Percent: **5.000**  
Continuous Index: **F04**  
Within 8" of Joint: **YES**  
Remarks:

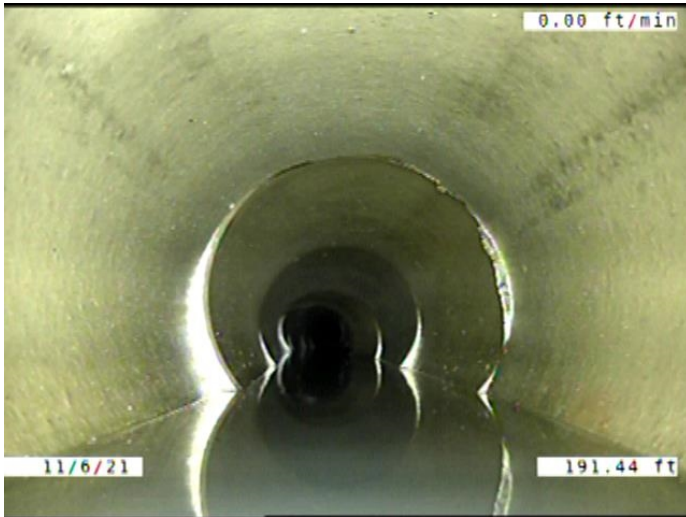
Code: **MWLS**  
 Description: **Miscellaneous Water Level Sag**

Distance (ft): **191.4**  
 Structural Grade: **2**  
 O&M Grade: **0**  
 Clock Start/From:  
 Clock To:  
 1st Value:  
 2nd Value:  
 Value Percent: **15.000**  
 Continuous Index: **S05**  
 Within 8" of Joint: **NO**  
 Remarks:

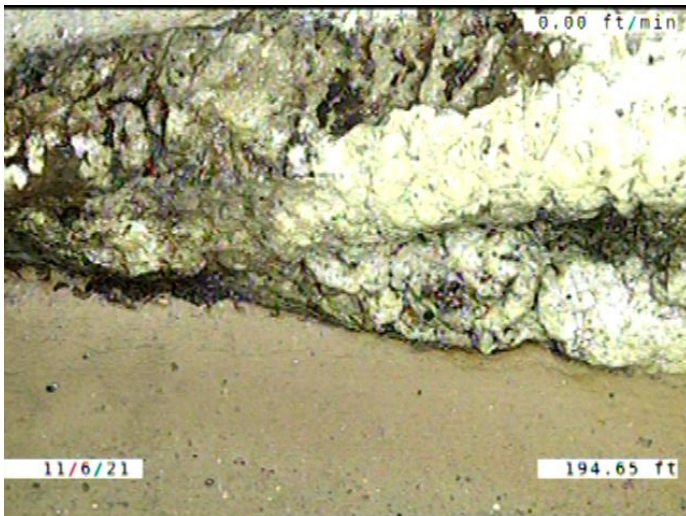
Code: **DAE**  
 Description: **Deposits Attached Encrustation**

Distance (ft): **194.6**  
 Structural Grade: **0**  
 O&M Grade: **2**  
 Clock Start/From: **9**  
 Clock To: **3**  
 1st Value:  
 2nd Value:  
 Value Percent: **5.000**  
 Continuous Index:  
 Within 8" of Joint: **YES**  
 Remarks:

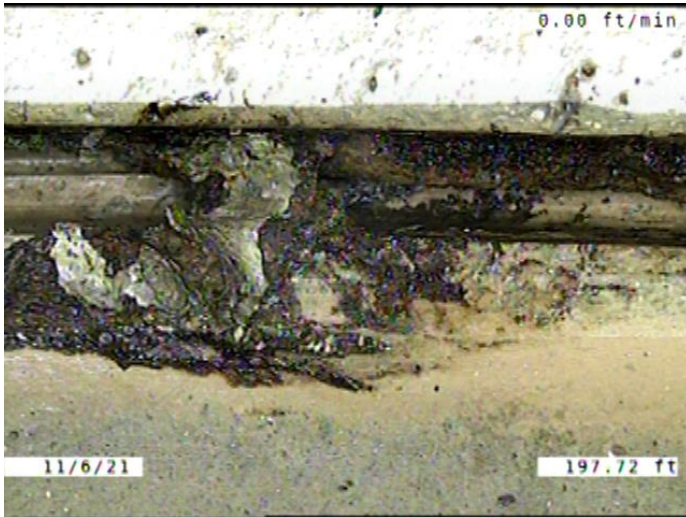
Code: **DAE**  
 Description: **Deposits Attached Encrustation**

Distance (ft): **197.7**  
 Structural Grade: **0**  
 O&M Grade: **2**  
 Clock Start/From: **9**  
 Clock To: **3**  
 1st Value:  
 2nd Value:  
 Value Percent: **5.000**  
 Continuous Index:  
 Within 8" of Joint: **YES**  
 Remarks:

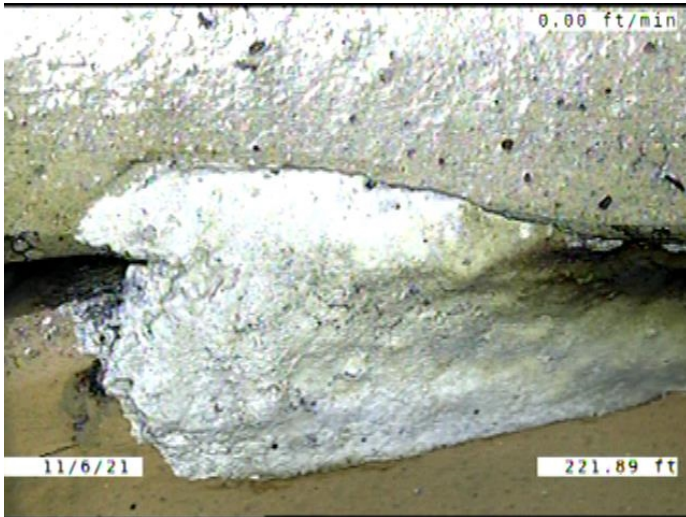
Code: **DAE**  
 Description: **Deposits Attached Encrustation**

Distance (ft): **221.9**  
 Structural Grade: **0**  
 O&M Grade: **2**  
 Clock Start/From: **9**  
 Clock To: **3**  
 1st Value:  
 2nd Value:  
 Value Percent: **5.000**  
 Continuous Index:  
 Within 8" of Joint: **YES**  
 Remarks:

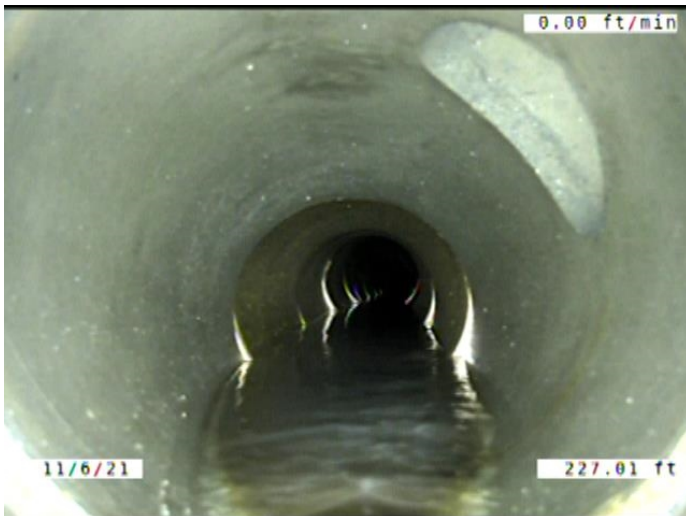
Code: **MWLS**  
 Description: **Miscellaneous Water Level Sag**

Distance (ft): **227.0**  
 Structural Grade: **2**  
 O&M Grade: **0**  
 Clock Start/From:  
 Clock To:  
 1st Value:  
 2nd Value:  
 Value Percent: **15.000**  
 Continuous Index: **F05**  
 Within 8" of Joint: **NO**  
 Remarks:

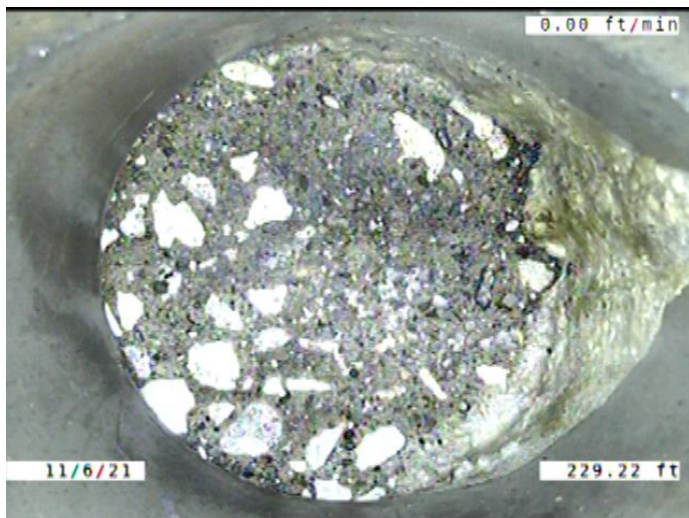
Code: **TFC**  
 Description: **Tap Factory Capped**

Distance (ft): **229.2**  
 Structural Grade: **0**  
 O&M Grade: **0**  
 Clock Start/From: **2**  
 Clock To:  
 1st Value: **4.000**  
 2nd Value:  
 Value Percent:  
 Continuous Index:  
 Within 8" of Joint: **YES**  
 Remarks: **ENCUSTATION AROUND THE CAP**

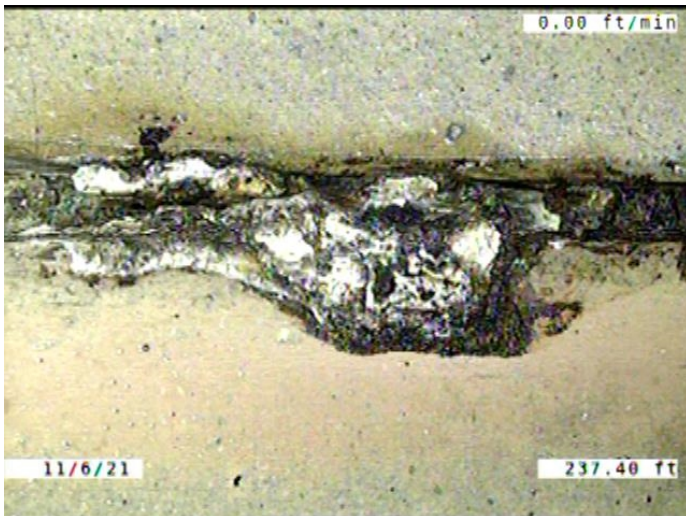
Code: **DAE**  
Description: **Deposits Attached Encrustation**

Distance (ft): **237.4**  
Structural Grade: **0**  
O&M Grade: **2**  
Clock Start/From: **9**  
Clock To: **3**  
1st Value:  
2nd Value:  
Value Percent: **5.000**  
Continuous Index:  
Within 8" of Joint: **YES**  
Remarks:

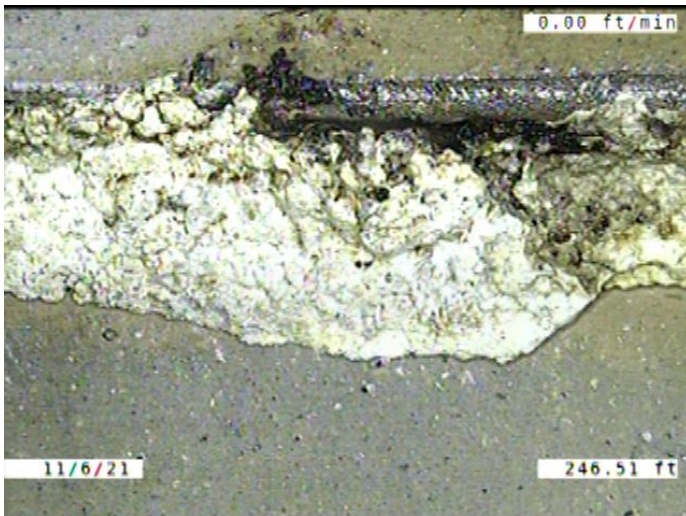
Code: **DAE**  
Description: **Deposits Attached Encrustation**

Distance (ft): **246.5**  
Structural Grade: **0**  
O&M Grade: **2**  
Clock Start/From: **9**  
Clock To: **3**  
1st Value:  
2nd Value:  
Value Percent: **5.000**  
Continuous Index:  
Within 8" of Joint: **YES**  
Remarks:

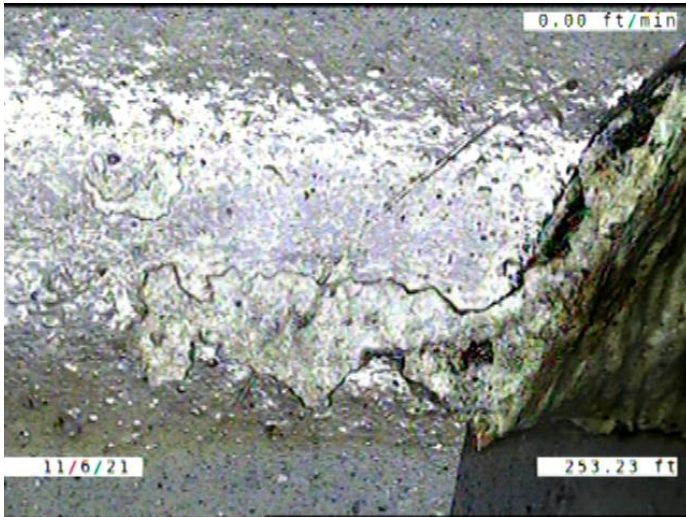
Code: **DAE**  
 Description: **Deposits Attached Encrustation**

Distance (ft): **253.2**  
 Structural Grade: **0**  
 O&M Grade: **2**  
 Clock Start/From: **9**  
 Clock To: **11**  
 1st Value:  
 2nd Value:  
 Value Percent: **5.000**  
 Continuous Index:  
 Within 8" of Joint: **YES**  
 Remarks:

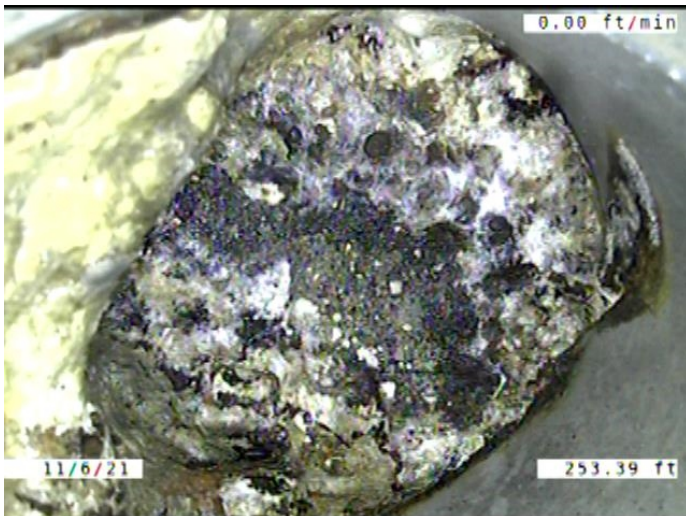
Code: **TFC**  
 Description: **Tap Factory Capped**

Distance (ft): **253.4**  
 Structural Grade: **0**  
 O&M Grade: **0**  
 Clock Start/From: **10**  
 Clock To:  
 1st Value: **4.000**  
 2nd Value:  
 Value Percent:  
 Continuous Index:  
 Within 8" of Joint: **YES**  
 Remarks: **ENCrustATION AROUND THE CAP**

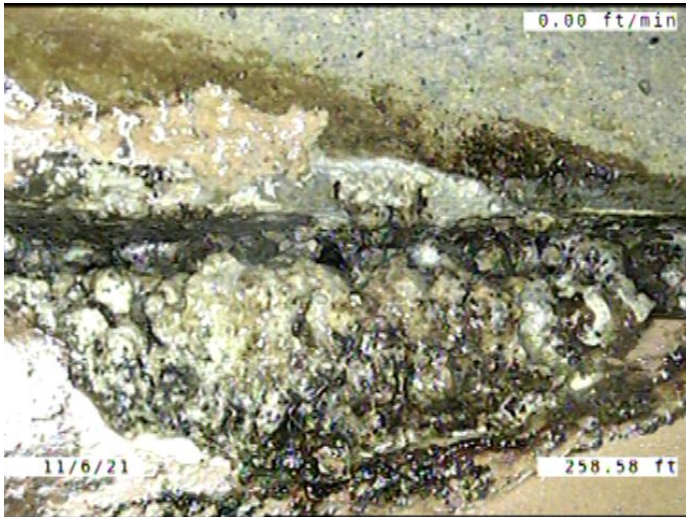
Code: **DAE**  
 Description: **Deposits Attached Encrustation**

Distance (ft): **258.6**  
 Structural Grade: **0**  
 O&M Grade: **2**  
 Clock Start/From: **8**  
 Clock To: **11**  
 1st Value:  
 2nd Value:  
 Value Percent: **5.000**  
 Continuous Index:  
 Within 8" of Joint: **YES**  
 Remarks:

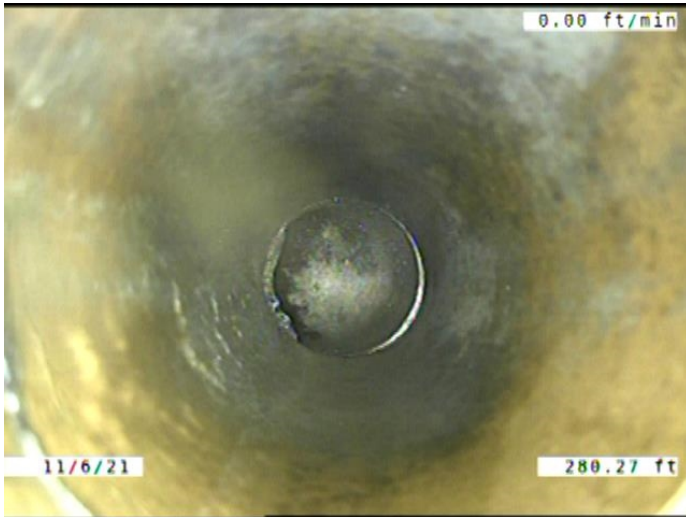
Code: **TBI**  
Description: **Tap Break-in Intruding**

Distance (ft): **280.3**  
Structural Grade: **0**  
O&M Grade: **2**  
Clock Start/From: **12**  
Clock To:  
1st Value: **4.000**  
2nd Value: **1.000**  
Value Percent:  
Continuous Index:  
Within 8" of Joint: **YES**  
Remarks: **CONSTANTLY RUNNING WATER.**

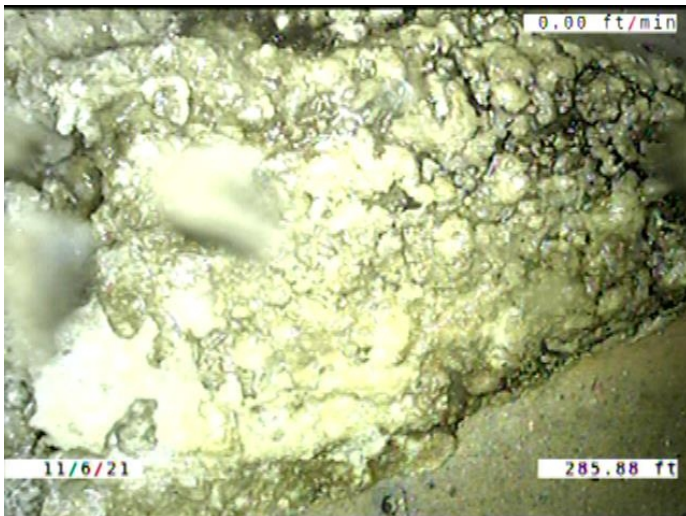
Code: **DAE**  
Description: **Deposits Attached Encrustation**

Distance (ft): **285.9**  
Structural Grade: **0**  
O&M Grade: **2**  
Clock Start/From: **9**  
Clock To: **3**  
1st Value:  
2nd Value:  
Value Percent: **5.000**  
Continuous Index: **S06**  
Within 8" of Joint: **YES**  
Remarks:

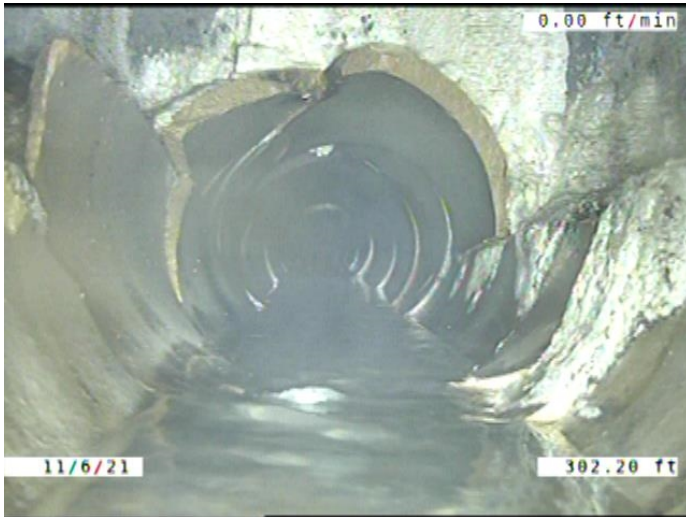
Code: **DAE**  
 Description: **Deposits Attached Encrustation**

Distance (ft): **302.2**  
 Structural Grade: **0**  
 O&M Grade: **2**  
 Clock Start/From: **9**  
 Clock To: **3**  
 1st Value:  
 2nd Value:  
 Value Percent: **5.000**  
 Continuous Index: **F06**  
 Within 8" of Joint: **YES**  
 Remarks:

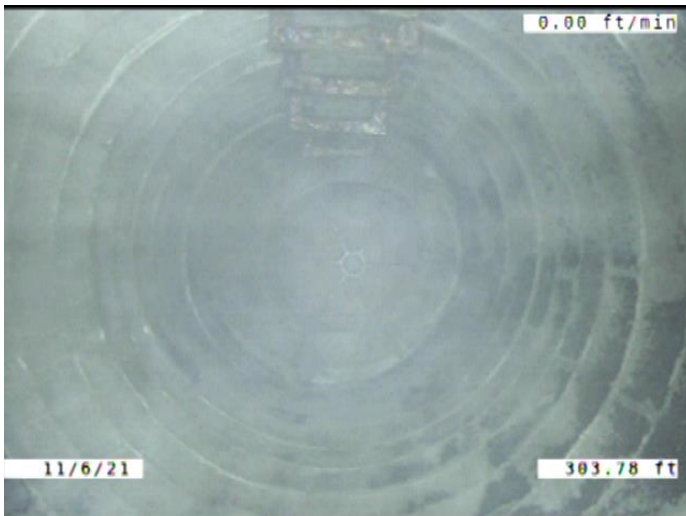
Code: **AMH**  
 Description: **Manhole**

Distance (ft): **303.8**  
 Structural Grade: **0**  
 O&M Grade: **0**  
 Clock Start/From:  
 Clock To:  
 1st Value:  
 2nd Value:  
 Value Percent:  
 Continuous Index:  
 Within 8" of Joint: **NO**  
 Remarks: **M-404-004**
