Profile/Photo Observation Report

Date:	11/06/2021	Weather:		Coding:	PACP 7.0
Pipe Length (ft):	658.6	Owner:	City of Hobart	Pre Clean:	Heavy Cleaning
P.O.#:	YES502259	Surveyor:	S. Bucklin	PSR:	P-404-006-005
Customer:	City of Hobart	Clean Date:	10/23/2021	Shape:	C

Street:	North Wabash Street	Flow Control:	Not Controlled
City:	Hobart, IN	Year Renewed:	
Location:	Alley	Tape/Media #:	
Purpose:	Routine Assessment	Dia/Height:	12"
Use:	Sanitary Sewage Pipe	Material:	VCP
Drain Area:		Lining:	None
Category:	NA		
Comment:			
Location Details:		Direction of Survey:	Upstream
US MH:	M-404-006	DS MH:	M-404-005
		Total Length Surveyed (ft):	658.6

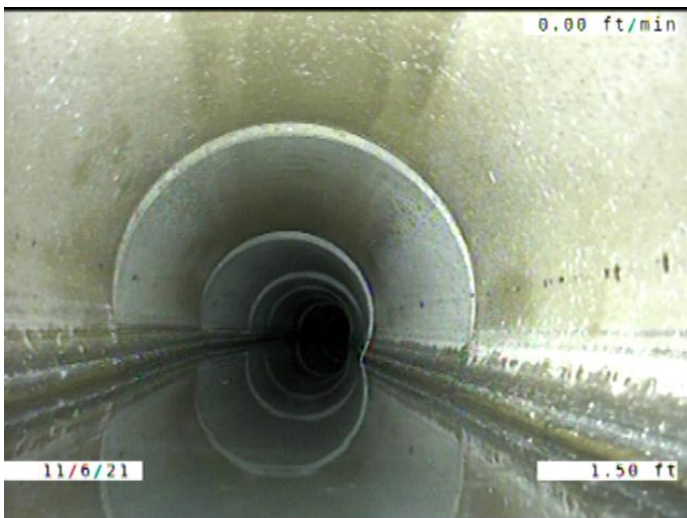
Code: **MGO**
 Description: **Miscellaneous General Observation**

Distance (ft): **1.5**
 Structural Grade: **0**
 O&M Grade: **0**
 Clock Start/From:
 Clock To:
 1st Value:
 2nd Value:
 Value Percent:
 Continuous Index:
 Within 8" of Joint: **NO**
 Remarks: **DROP INTO THE MANHOLE. HAD TO START IN THE PIPE.**

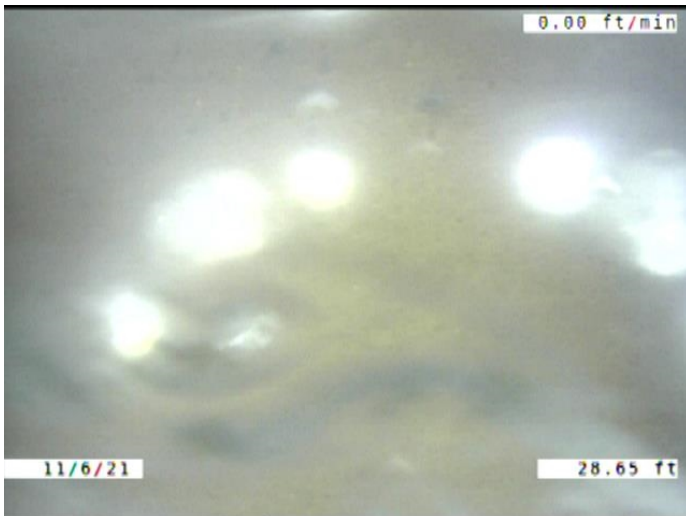
Code: **MCU**
 Description: **Miscellaneous Camera Underwater**

Distance (ft): **28.6**
 Structural Grade: **0**
 O&M Grade: **4**
 Clock Start/From:
 Clock To:
 1st Value:
 2nd Value:
 Value Percent:
 Continuous Index: **S02**
 Within 8" of Joint: **NO**
 Remarks:

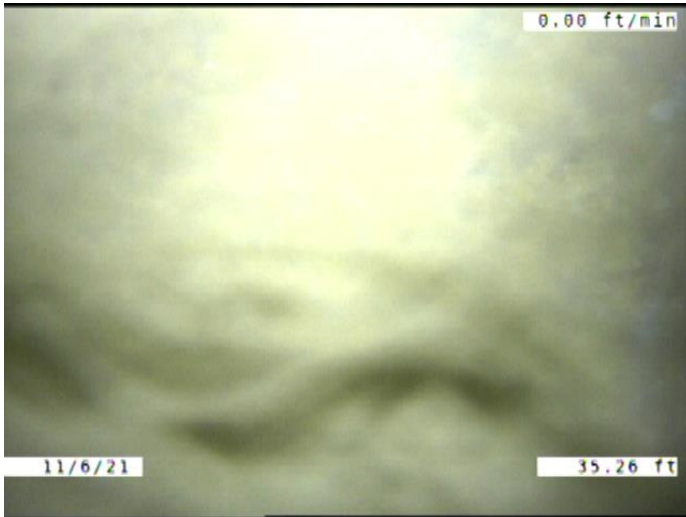
Code: **MCU**
Description: **Miscellaneous Camera Underwater**

Distance (ft): **35.3**
Structural Grade: **0**
O&M Grade: **4**
Clock Start/From:
Clock To:
1st Value:
2nd Value:
Value Percent:
Continuous Index: **F02**
Within 8" of Joint: **NO**
Remarks:

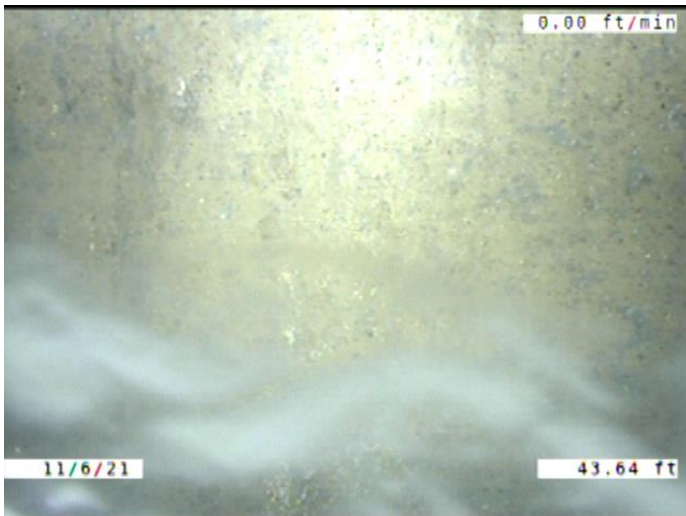
Code: **MCU**
Description: **Miscellaneous Camera Underwater**

Distance (ft): **43.6**
Structural Grade: **0**
O&M Grade: **4**
Clock Start/From:
Clock To:
1st Value:
2nd Value:
Value Percent:
Continuous Index:
Within 8" of Joint: **NO**
Remarks: **Out at 45**

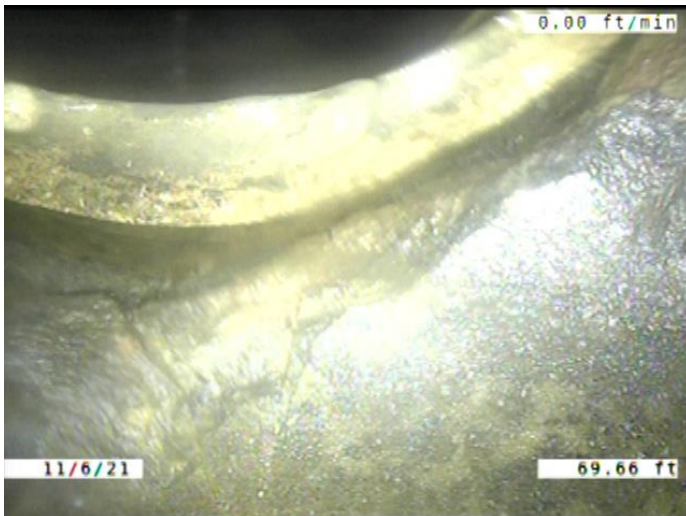
Code: **SSS**
 Description: **Surface Damage Surface Spalling**

Distance (ft): **69.7**
 Structural Grade: **2**
 O&M Grade: **0**
 Clock Start/From: **11**
 Clock To: **1**
 1st Value:
 2nd Value:
 Value Percent:
 Continuous Index:
 Within 8" of Joint: **YES**
 Remarks:

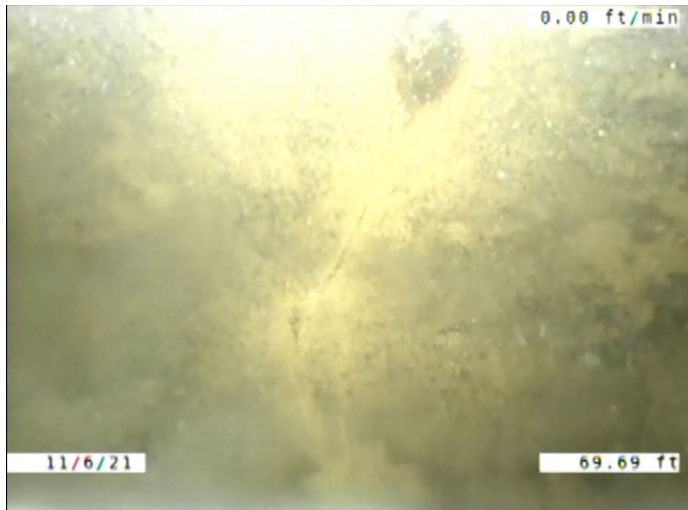
Code: **CL**
Description: **Crack Longitudinal**

Distance (ft): **69.7**
Structural Grade: **2**
O&M Grade: **0**
Clock Start/From: **12**
Clock To:
1st Value:
2nd Value:
Value Percent:
Continuous Index:
Within 8" of Joint: **NO**
Remarks:

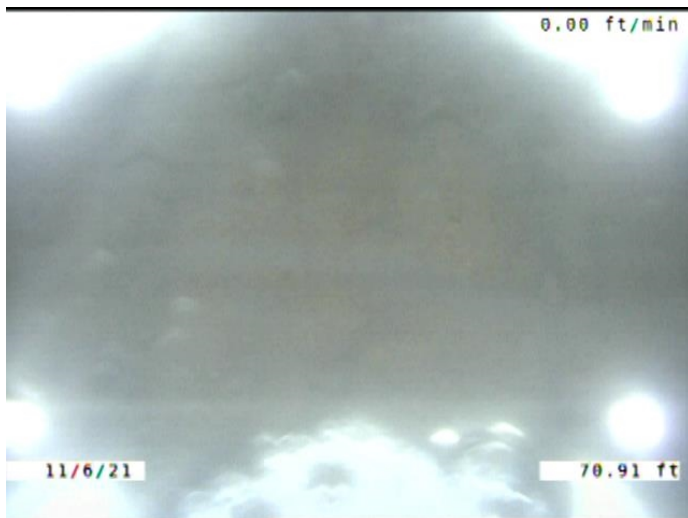
Code: **MCU**
Description: **Miscellaneous Camera Underwater**

Distance (ft): **70.9**
Structural Grade: **0**
O&M Grade: **4**
Clock Start/From:
Clock To:
1st Value:
2nd Value:
Value Percent:
Continuous Index:
Within 8" of Joint: **NO**
Remarks: **Out at 71.6**

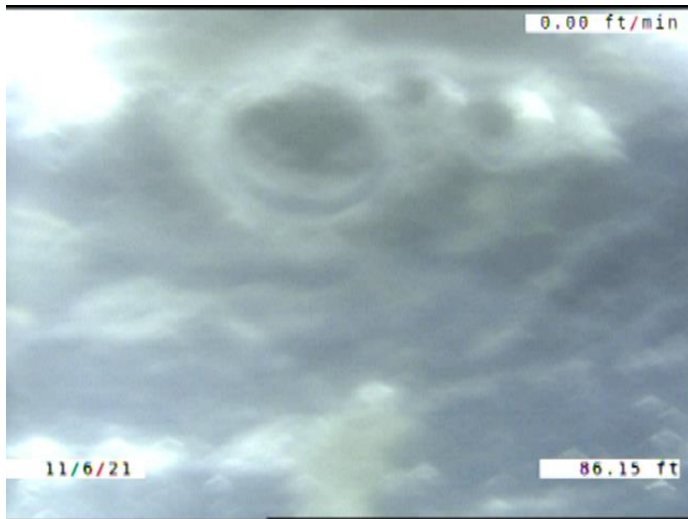
Code: **MCU**
Description: **Miscellaneous Camera Underwater**

Distance (ft): **86.2**
Structural Grade: **0**
O&M Grade: **4**
Clock Start/From:
Clock To:
1st Value:
2nd Value:
Value Percent:
Continuous Index:
Within 8" of Joint: **NO**
Remarks: **Out at 88**

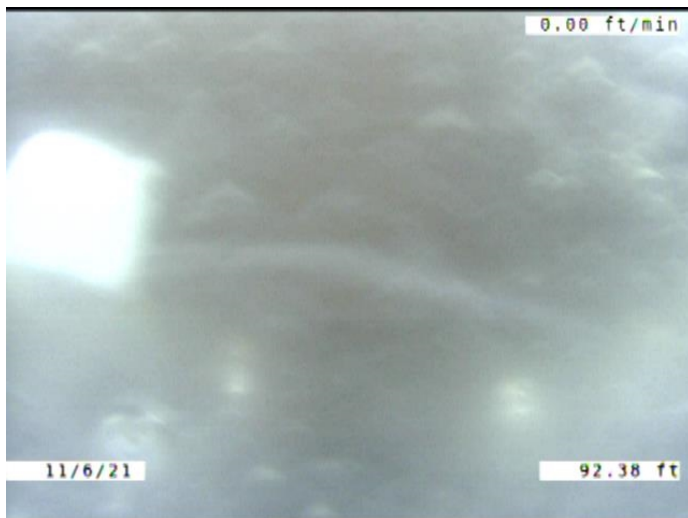
Code: **MCU**
Description: **Miscellaneous Camera Underwater**

Distance (ft): **92.4**
Structural Grade: **0**
O&M Grade: **4**
Clock Start/From:
Clock To:
1st Value:
2nd Value:
Value Percent:
Continuous Index:
Within 8" of Joint: **NO**
Remarks: **Out at 93**

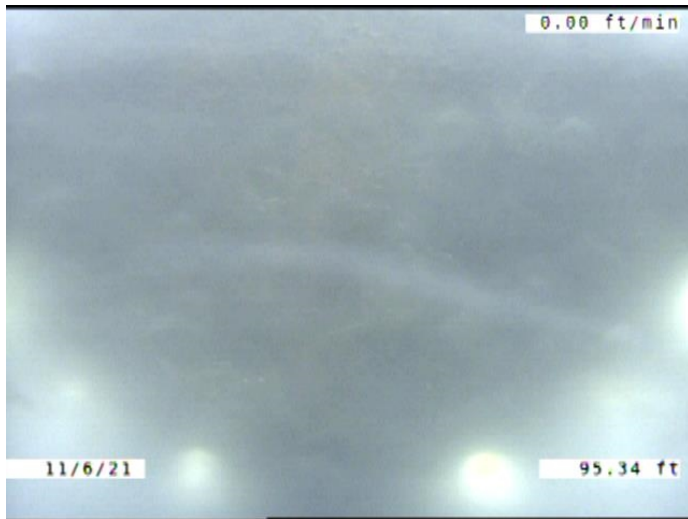
Code:	MCU
Description:	Miscellaneous Camera Underwater
Distance (ft):	95.3
Structural Grade:	0
O&M Grade:	4
Clock Start/From:	
Clock To:	
1st Value:	
2nd Value:	
Value Percent:	
Continuous Index:	
Within 8" of Joint:	NO
Remarks:	Out at 96.2

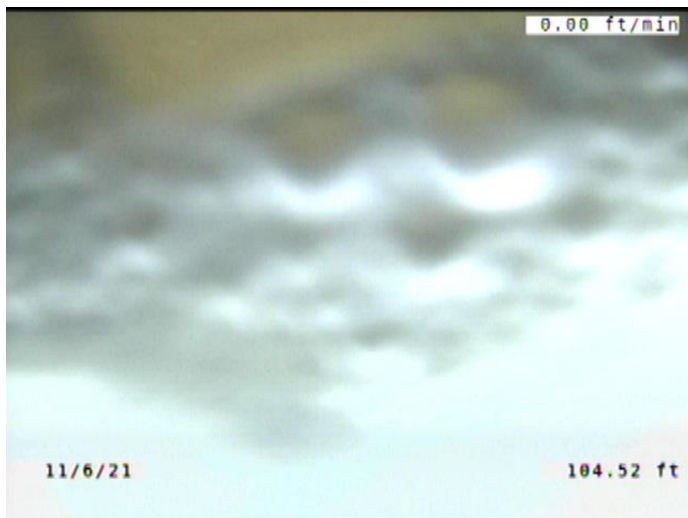
Code:	MCU
Description:	Miscellaneous Camera Underwater
Distance (ft):	104.5
Structural Grade:	0
O&M Grade:	4
Clock Start/From:	
Clock To:	
1st Value:	
2nd Value:	
Value Percent:	
Continuous Index:	S19
Within 8" of Joint:	NO
Remarks:

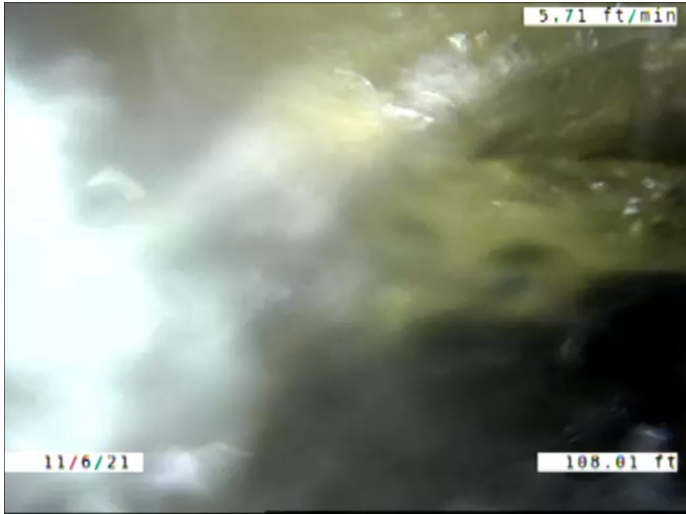
Code: **MCU**
Description: **Miscellaneous Camera Underwater**

Distance (ft): **108.0**
Structural Grade: **0**
O&M Grade: **4**
Clock Start/From:
Clock To:
1st Value:
2nd Value:
Value Percent:
Continuous Index: **F19**
Within 8" of Joint: **NO**
Remarks:

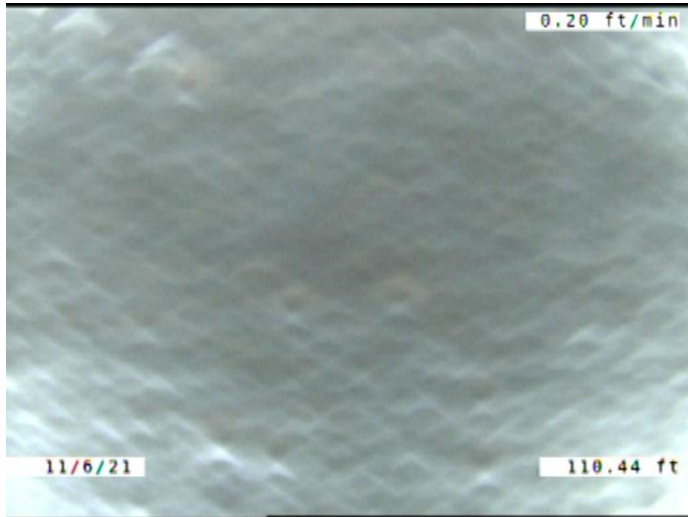
Code:	MCU
Description:	Miscellaneous Camera Underwater
Distance (ft):	110.4
Structural Grade:	0
O&M Grade:	4
Clock Start/From:	
Clock To:	
1st Value:	
2nd Value:	
Value Percent:	
Continuous Index:	
Within 8" of Joint:	NO
Remarks:	Out at 112.1

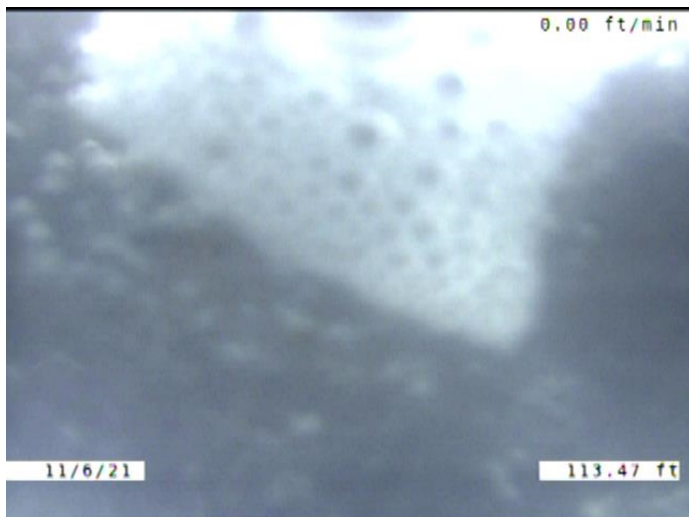
Code: **MCU**
Description: **Miscellaneous Camera Underwater**

Distance (ft): **113.5**
Structural Grade: **0**
O&M Grade: **4**
Clock Start/From:
Clock To:
1st Value:
2nd Value:
Value Percent:
Continuous Index: **S20**
Within 8" of Joint: **NO**
Remarks:

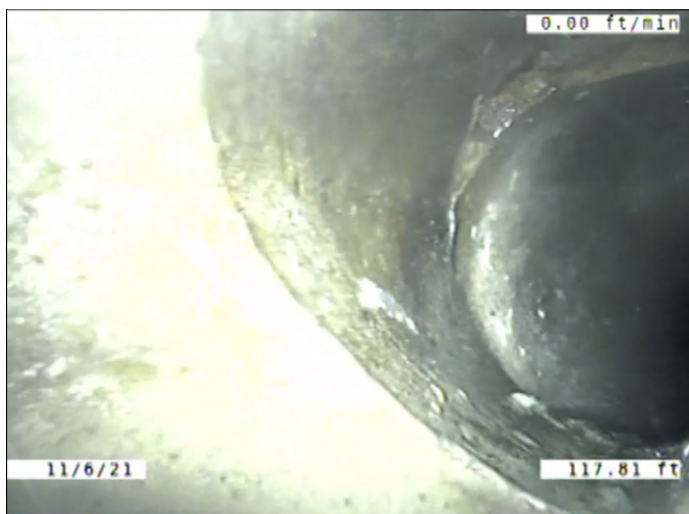
Code: **MCU**
Description: **Miscellaneous Camera Underwater**

Distance (ft): **117.8**
Structural Grade: **0**
O&M Grade: **4**
Clock Start/From:
Clock To:
1st Value:
2nd Value:
Value Percent:
Continuous Index: **F20**
Within 8" of Joint: **NO**
Remarks:

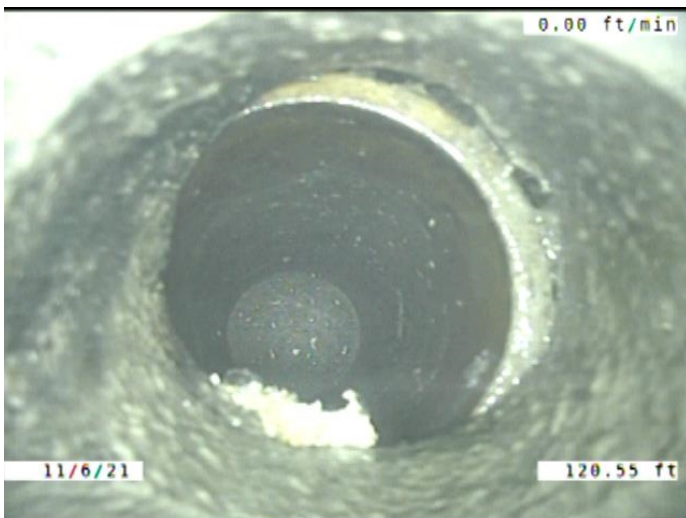
Code: **TFC**
Description: **Tap Factory Capped**

Distance (ft): **120.6**
Structural Grade: **0**
O&M Grade: **0**
Clock Start/From: **11**
Clock To:
1st Value: **4.000**
2nd Value:
Value Percent:
Continuous Index:
Within 8" of Joint: **YES**
Remarks: **CAPPED. CONSTANTLY RUNNING WATER.**

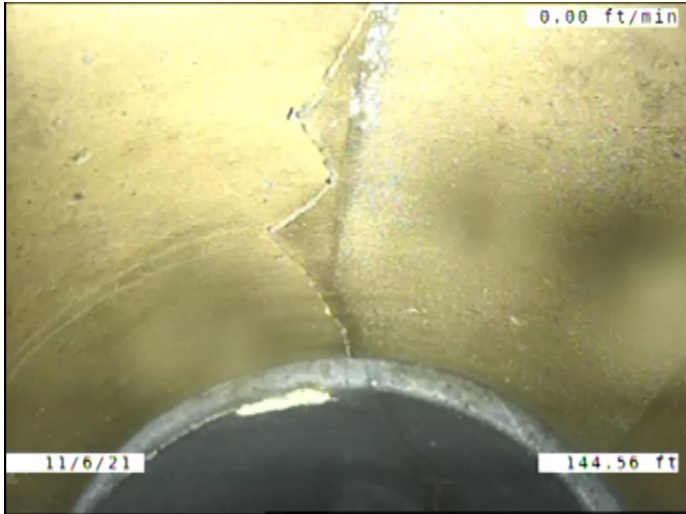
Code: **B**
Description: **Broken**

Distance (ft): **144.6**
Structural Grade: **4**
O&M Grade: **0**
Clock Start/From: **12**
Clock To:
1st Value:
2nd Value:
Value Percent:
Continuous Index:
Within 8" of Joint: **YES**
Remarks:

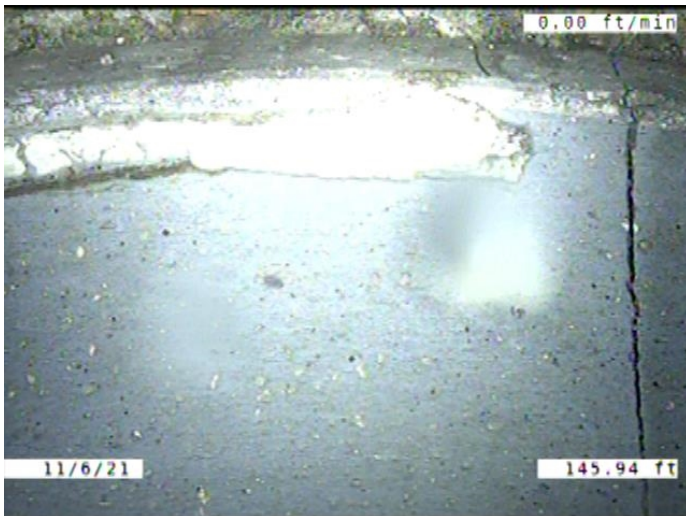
Code: **DAE**
Description: **Deposits Attached Encrustation**

Distance (ft): **145.9**
Structural Grade: **0**
O&M Grade: **2**
Clock Start/From: **9**
Clock To: **11**
1st Value:
2nd Value:
Value Percent: **5.000**
Continuous Index:
Within 8" of Joint: **YES**
Remarks:

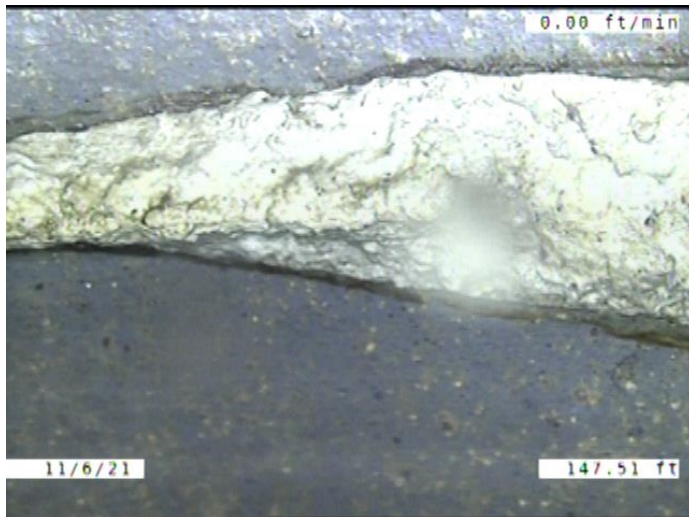
Code: **DAE**
 Description: **Deposits Attached Encrustation**

Distance (ft): **147.5**
 Structural Grade: **0**
 O&M Grade: **2**
 Clock Start/From: **12**
 Clock To: **4**
 1st Value:
 2nd Value:
 Value Percent: **5.000**
 Continuous Index:
 Within 8" of Joint: **NO**
 Remarks:

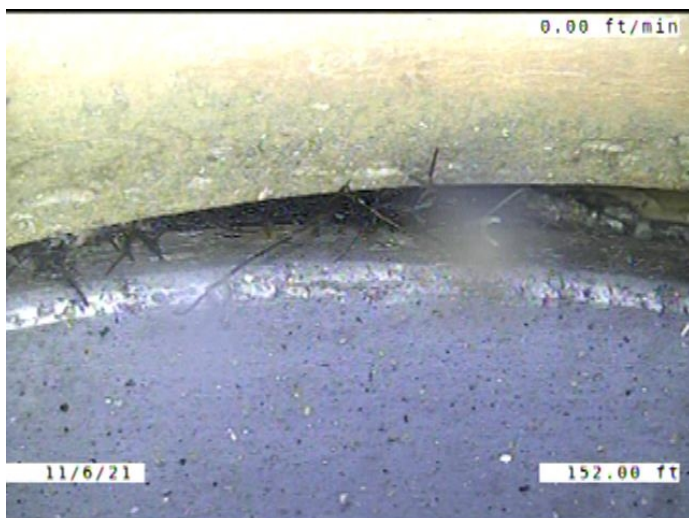
Code: **RFJ**
 Description: **Roots Fine Joint**

Distance (ft): **152.0**
 Structural Grade: **0**
 O&M Grade: **1**
 Clock Start/From: **9**
 Clock To: **10**
 1st Value:
 2nd Value:
 Value Percent:
 Continuous Index:
 Within 8" of Joint: **YES**
 Remarks:

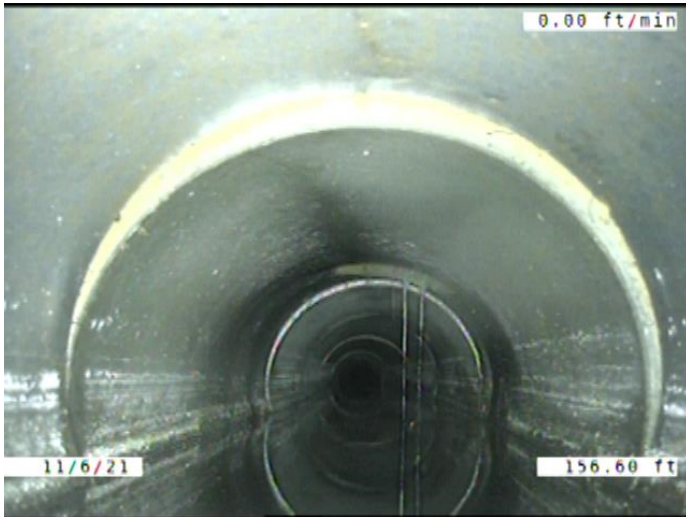
Code: **MWLS**
Description: **Miscellaneous Water Level Sag**

Distance (ft): **156.6**
Structural Grade: **2**
O&M Grade: **0**
Clock Start/From:
Clock To:
1st Value:
2nd Value:
Value Percent: **20.000**
Continuous Index: **S05**
Within 8" of Joint: **NO**
Remarks:

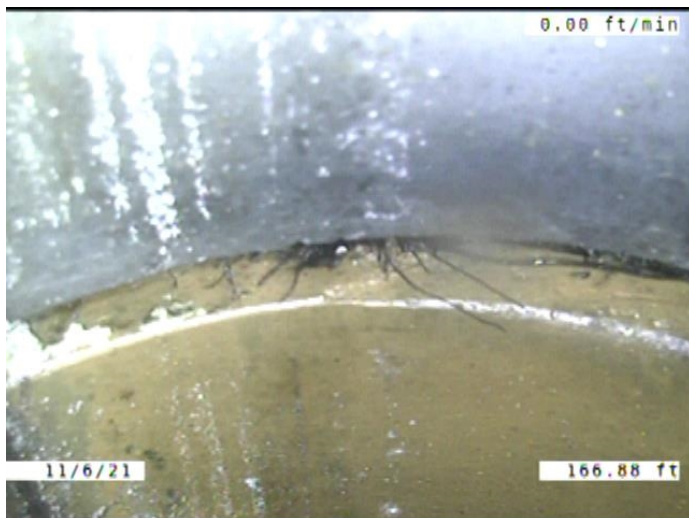
Code: **RFJ**
 Description: **Roots Fine Joint**

Distance (ft): **166.9**
 Structural Grade: **0**
 O&M Grade: **1**
 Clock Start/From: **10**
 Clock To: **2**
 1st Value:
 2nd Value:
 Value Percent:
 Continuous Index:
 Within 8" of Joint: **YES**
 Remarks:

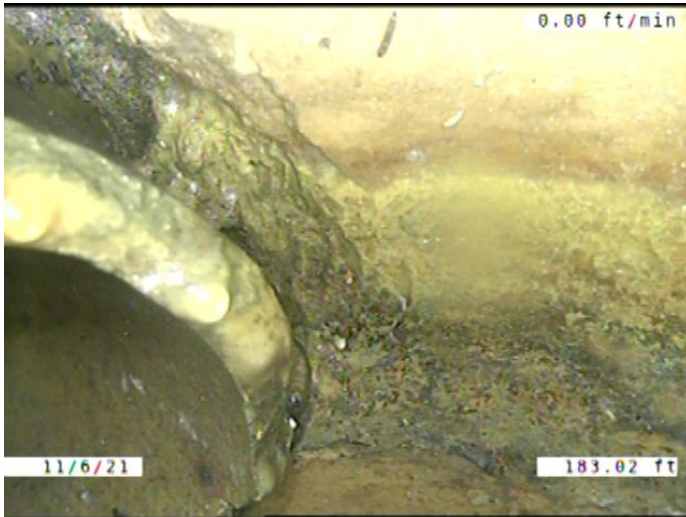
Code: **ISC**
Description: **Infiltration Stain Connection**

Distance (ft): **183.0**
Structural Grade: **0**
O&M Grade: **1**
Clock Start/From: **1**
Clock To: **3**
1st Value:
2nd Value:
Value Percent:
Continuous Index:
Within 8" of Joint: **YES**
Remarks:

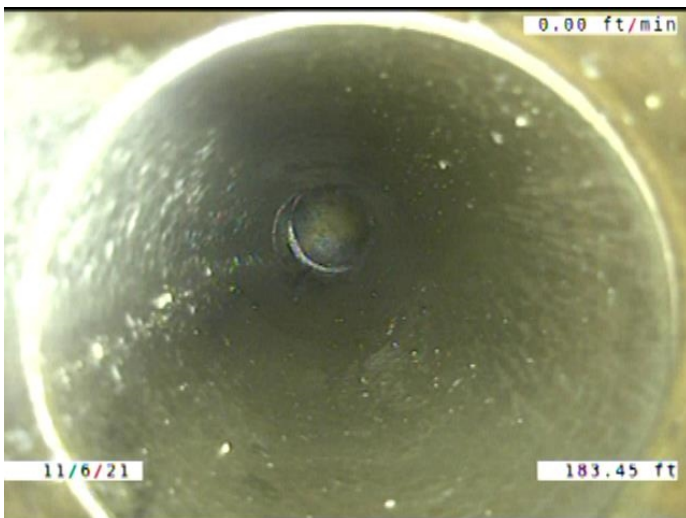
Code: **TBI**
Description: **Tap Break-in Intruding**

Distance (ft): **183.5**
Structural Grade: **0**
O&M Grade: **2**
Clock Start/From: **12**
Clock To:
1st Value: **4.000**
2nd Value: **2.000**
Value Percent:
Continuous Index:
Within 8" of Joint: **YES**
Remarks: **CONSTANTLY RUNNING WATER.**

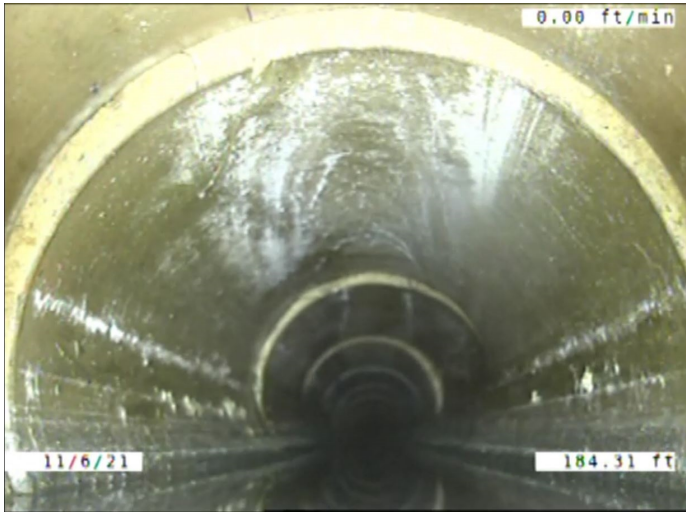
Code: **FM**
Description: **Fracture Multiple**

Distance (ft): **184.3**
Structural Grade: **4**
O&M Grade: **0**
Clock Start/From: **8**
Clock To: **4**
1st Value:
2nd Value:
Value Percent:
Continuous Index: **S21**
Within 8" of Joint: **YES**
Remarks:

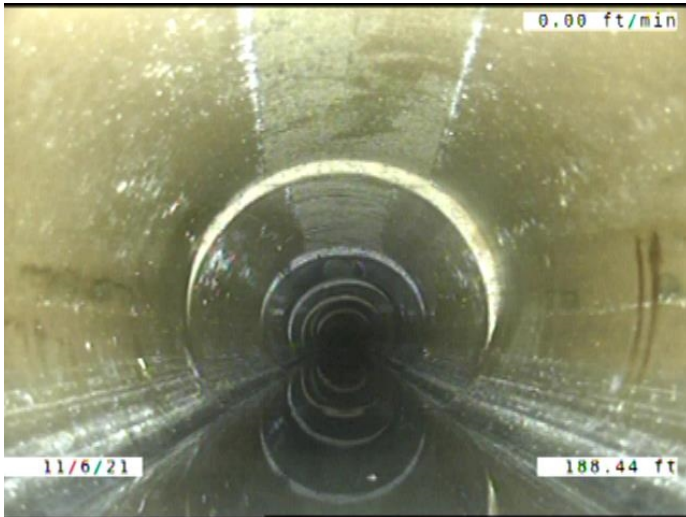
Code: **ISB**
Description: **Infiltration Stain Barrel**

Distance (ft): **188.4**
Structural Grade: **0**
O&M Grade: **1**
Clock Start/From: **2**
Clock To: **4**
1st Value:
2nd Value:
Value Percent:
Continuous Index:
Within 8" of Joint: **NO**
Remarks:

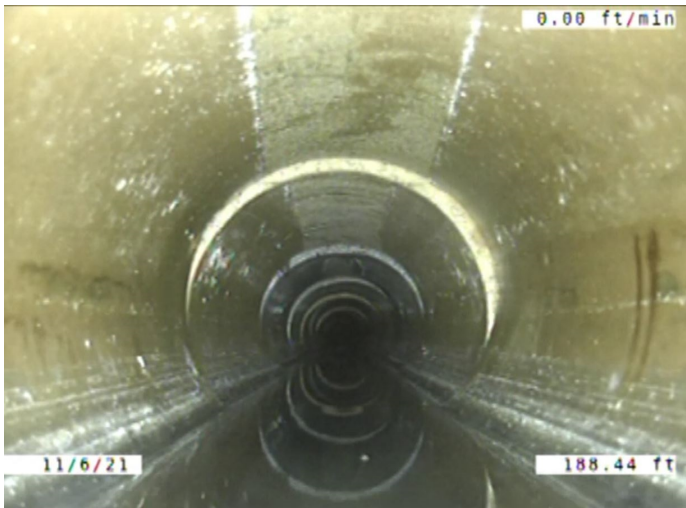
Code: **IS**
Description: **Infiltration Stain**

Distance (ft): **188.4**
Structural Grade: **0**
O&M Grade: **1**
Clock Start/From: **2**
Clock To: **4**
1st Value:
2nd Value:
Value Percent:
Continuous Index:
Within 8" of Joint: **NO**
Remarks:

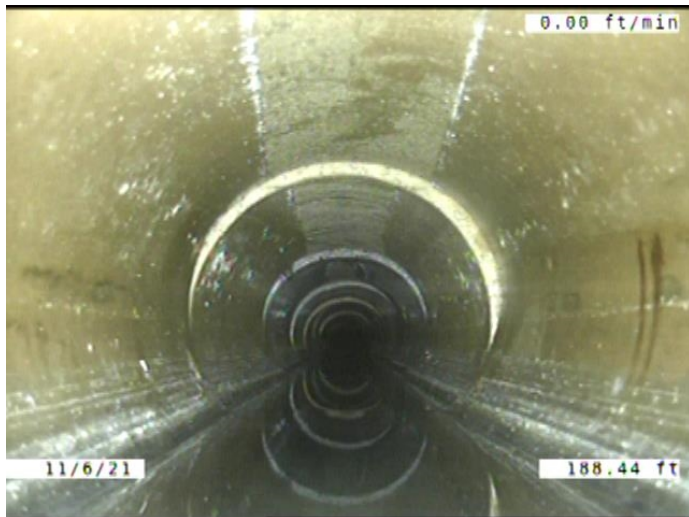
Code: **ISB**
 Description: **Infiltration Stain Barrel**

Distance (ft): **188.4**
 Structural Grade: **0**
 O&M Grade: **1**
 Clock Start/From: **8**
 Clock To: **9**
 1st Value:
 2nd Value:
 Value Percent:
 Continuous Index:
 Within 8" of Joint: **NO**
 Remarks:

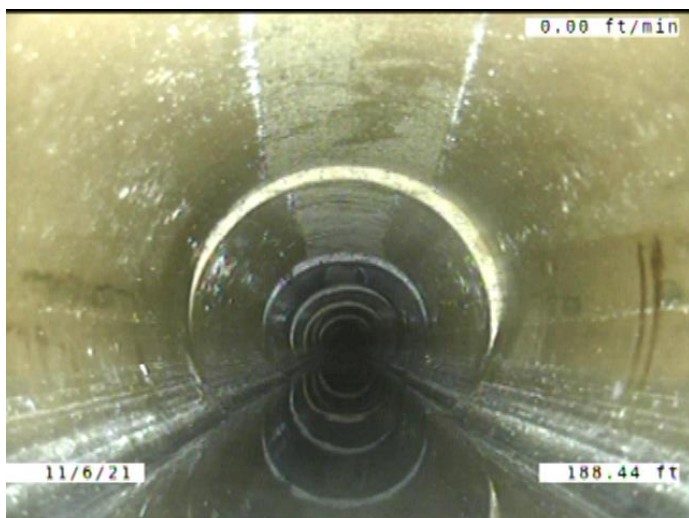
Code: **MWLS**
 Description: **Miscellaneous Water Level Sag**

Distance (ft): **188.4**
 Structural Grade: **2**
 O&M Grade: **0**
 Clock Start/From:
 Clock To:
 1st Value:
 2nd Value:
 Value Percent: **20.000**
 Continuous Index: **F05**
 Within 8" of Joint: **NO**
 Remarks:

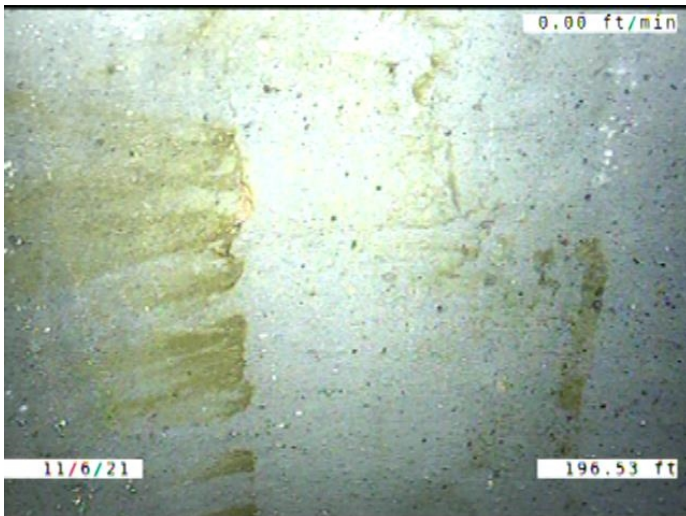
Code: **RFJ**
 Description: **Roots Fine Joint**

Distance (ft): **194.5**
 Structural Grade: **0**
 O&M Grade: **1**
 Clock Start/From: **10**
 Clock To: **1**
 1st Value:
 2nd Value:
 Value Percent:
 Continuous Index:
 Within 8" of Joint: **YES**
 Remarks:

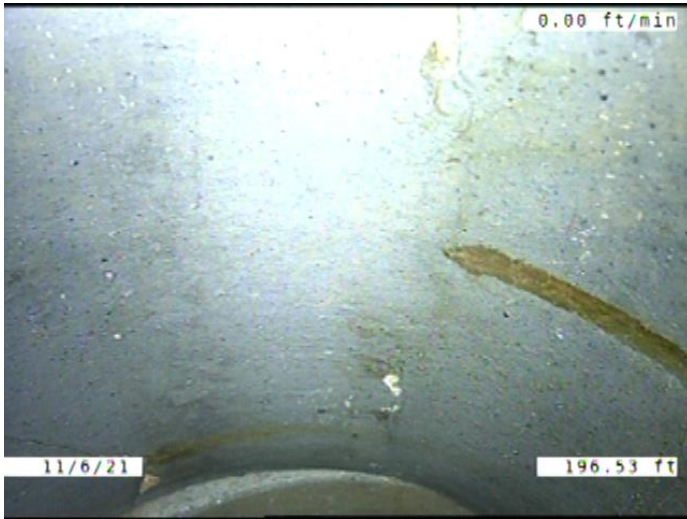
Code: **ISB**
 Description: **Infiltration Stain Barrel**

Distance (ft): **196.5**
 Structural Grade: **0**
 O&M Grade: **1**
 Clock Start/From: **8**
 Clock To: **10**
 1st Value:
 2nd Value:
 Value Percent:
 Continuous Index:
 Within 8" of Joint: **NO**
 Remarks:

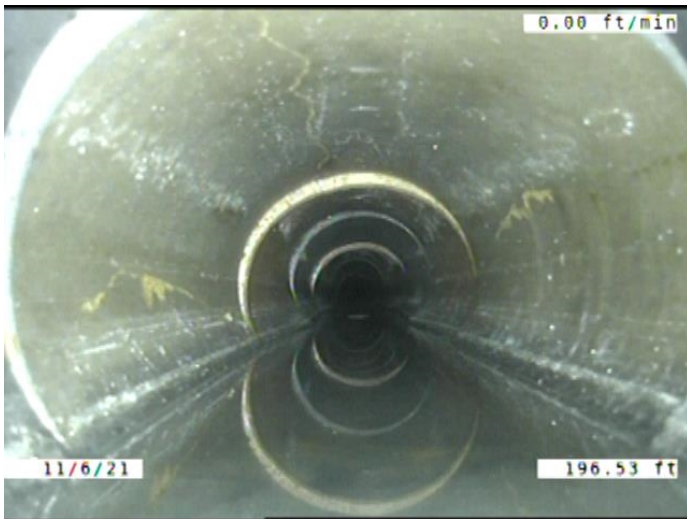
Code: **ISB**
Description: **Infiltration Stain Barrel**

Distance (ft): **196.5**
Structural Grade: **0**
O&M Grade: **1**
Clock Start/From: **1**
Clock To: **4**
1st Value:
2nd Value:
Value Percent:
Continuous Index:
Within 8" of Joint: **YES**
Remarks:

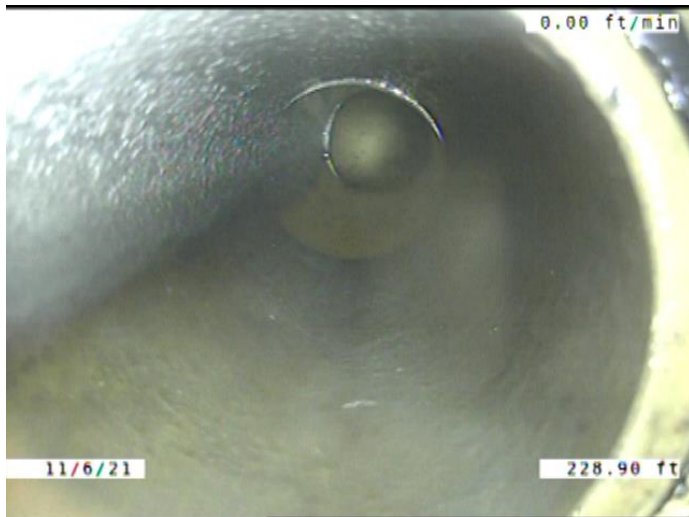
Code: **MWLS**
Description: **Miscellaneous Water Level Sag**

Distance (ft): **225.7**
Structural Grade: **2**
O&M Grade: **0**
Clock Start/From:
Clock To:
1st Value:
2nd Value:
Value Percent: **10.000**
Continuous Index:
Within 8" of Joint: **NO**
Remarks:

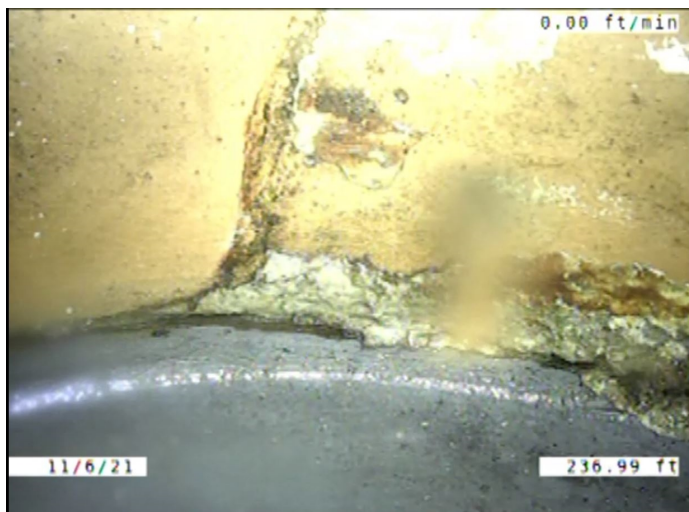
Code: **TBI**
Description: **Tap Break-in Intruding**

Distance (ft): **228.9**
Structural Grade: **0**
O&M Grade: **2**
Clock Start/From: **12**
Clock To:
1st Value: **4.000**
2nd Value: **1.000**
Value Percent:
Continuous Index:
Within 8" of Joint: **YES**
Remarks: **CONSTANTLY RUNNING WATER.**

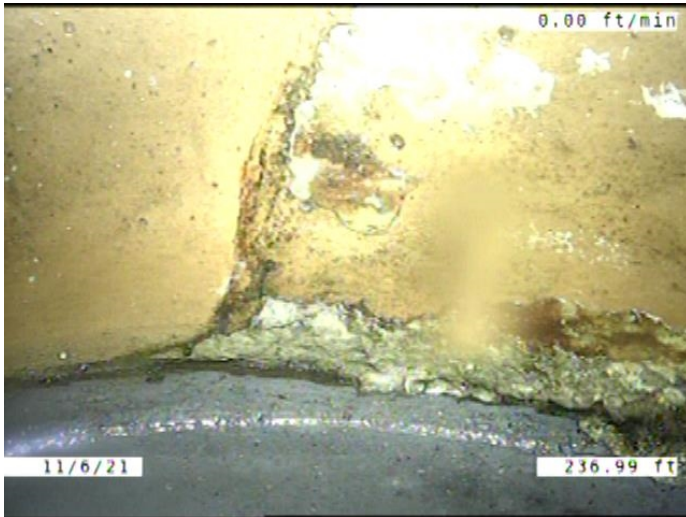
Code: **CL**
Description: **Crack Longitudinal**

Distance (ft): **237.0**
Structural Grade: **2**
O&M Grade: **0**
Clock Start/From: **2**
Clock To:
1st Value:
2nd Value:
Value Percent:
Continuous Index:
Within 8" of Joint: **YES**
Remarks:

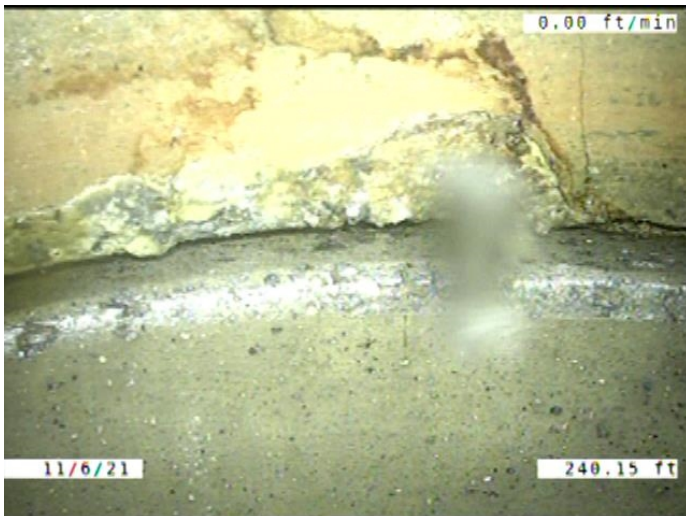
Code: **DAE**
Description: **Deposits Attached Encrustation**

Distance (ft): **237.0**
Structural Grade: **0**
O&M Grade: **2**
Clock Start/From: **1**
Clock To: **4**
1st Value:
2nd Value:
Value Percent: **5.000**
Continuous Index:
Within 8" of Joint: **YES**
Remarks:

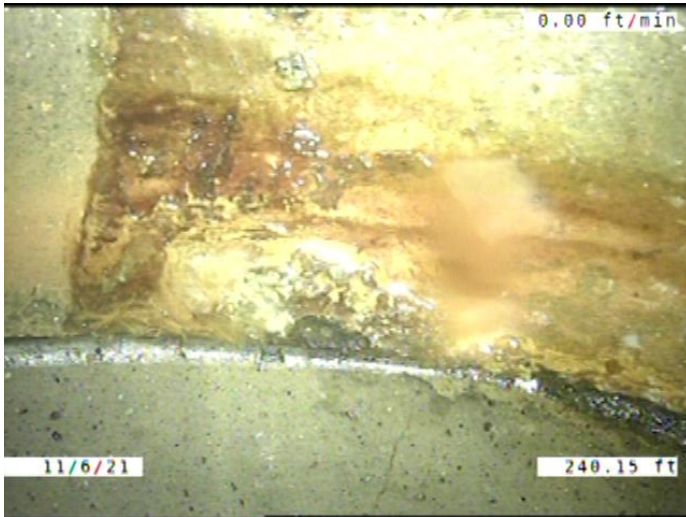
Code: **DAE**
Description: **Deposits Attached Encrustation**

Distance (ft): **240.1**
Structural Grade: **0**
O&M Grade: **2**
Clock Start/From: **8**
Clock To: **9**
1st Value:
2nd Value:
Value Percent: **5.000**
Continuous Index:
Within 8" of Joint: **YES**
Remarks:

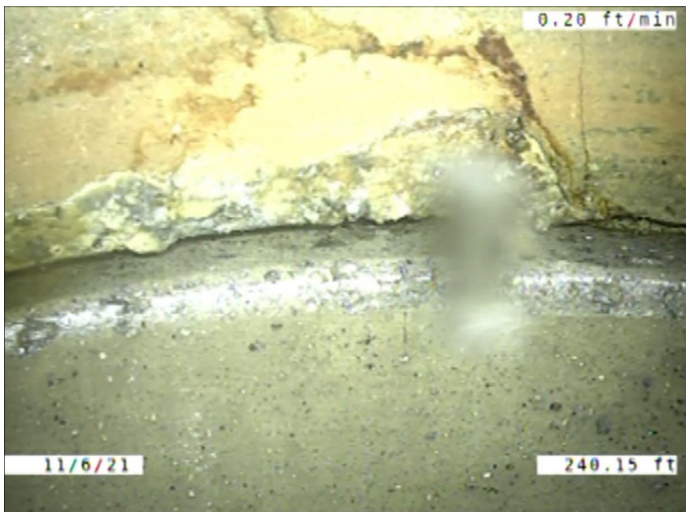
Code: **DAE**
Description: **Deposits Attached Encrustation**

Distance (ft): **240.1**
Structural Grade: **0**
O&M Grade: **2**
Clock Start/From: **3**
Clock To: **4**
1st Value:
2nd Value:
Value Percent: **5.000**
Continuous Index:
Within 8" of Joint: **YES**
Remarks:

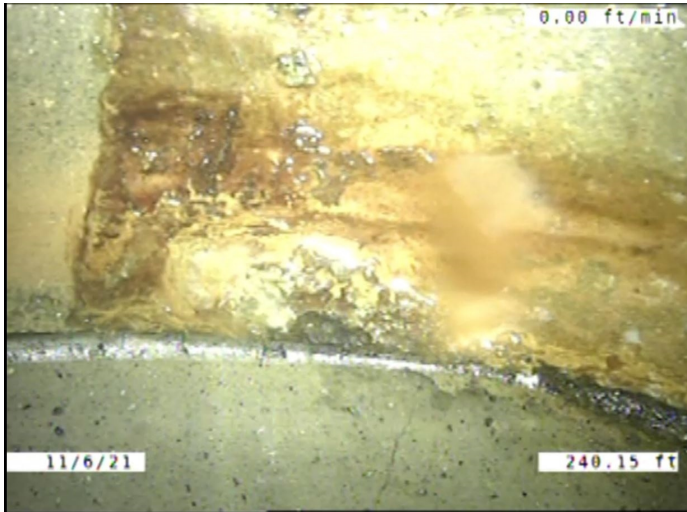
Code: **CL**
Description: **Crack Longitudinal**

Distance (ft): **240.2**
Structural Grade: **2**
O&M Grade: **0**
Clock Start/From: **9**
Clock To:
1st Value:
2nd Value:
Value Percent:
Continuous Index:
Within 8" of Joint: **YES**
Remarks:

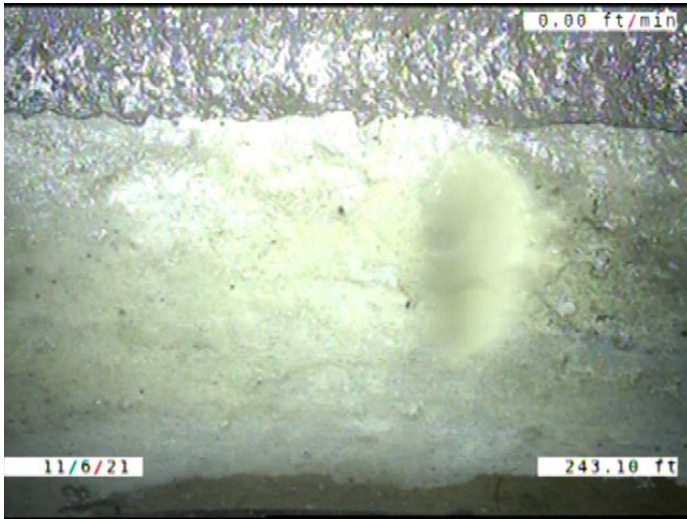
Code: **FM**
Description: **Fracture Multiple**

Distance (ft): **243.1**
Structural Grade: **4**
O&M Grade: **0**
Clock Start/From: **8**
Clock To: **4**
1st Value:
2nd Value:
Value Percent:
Continuous Index:
Within 8" of Joint: **YES**
Remarks:

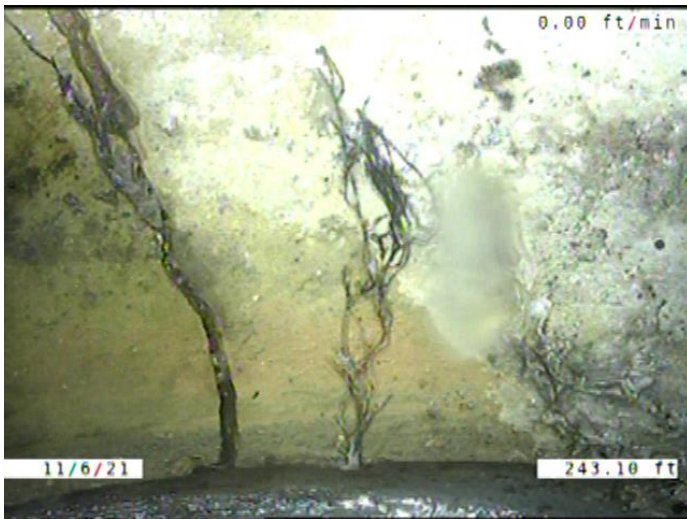
Code: **DAE**
 Description: **Deposits Attached Encrustation**

Distance (ft): **243.1**
 Structural Grade: **0**
 O&M Grade: **2**
 Clock Start/From: **8**
 Clock To: **4**
 1st Value:
 2nd Value:
 Value Percent: **5.000**
 Continuous Index:
 Within 8" of Joint: **YES**
 Remarks:

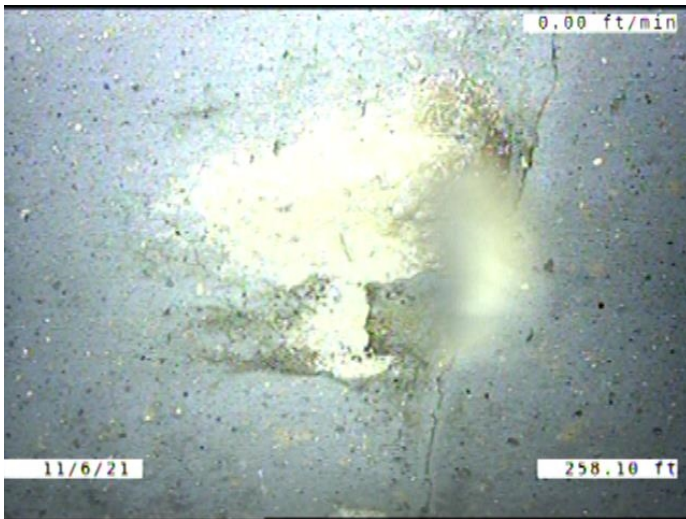
Code: **CL**
Description: **Crack Longitudinal**

Distance (ft): **258.1**
Structural Grade: **2**
O&M Grade: **0**
Clock Start/From: **11**
Clock To:
1st Value:
2nd Value:
Value Percent:
Continuous Index:
Within 8" of Joint: **YES**
Remarks:

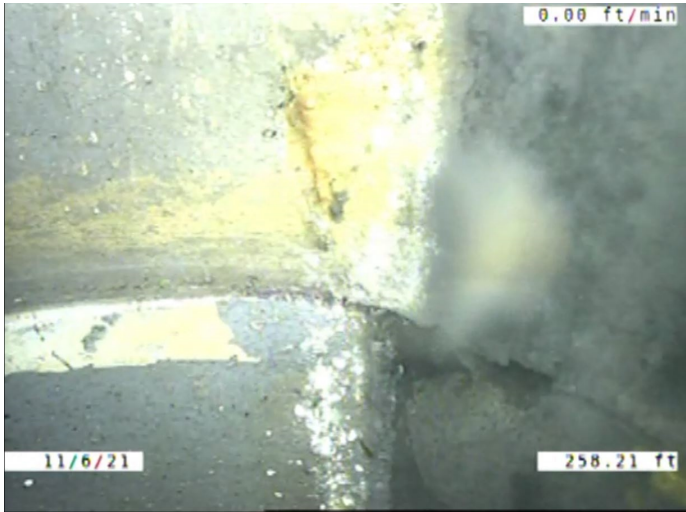
Code: **DAE**
Description: **Deposits Attached Encrustation**

Distance (ft): **258.1**
Structural Grade: **0**
O&M Grade: **2**
Clock Start/From: **11**
Clock To:
1st Value:
2nd Value:
Value Percent: **5.000**
Continuous Index:
Within 8" of Joint: **YES**
Remarks:

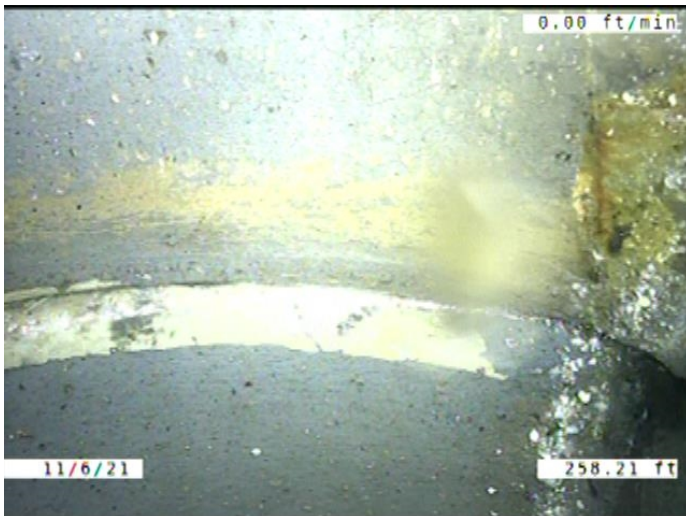
Code: **CL**
Description: **Crack Longitudinal**

Distance (ft): **258.2**
Structural Grade: **2**
O&M Grade: **0**
Clock Start/From: **4**
Clock To:
1st Value:
2nd Value:
Value Percent:
Continuous Index:
Within 8" of Joint: **YES**
Remarks:

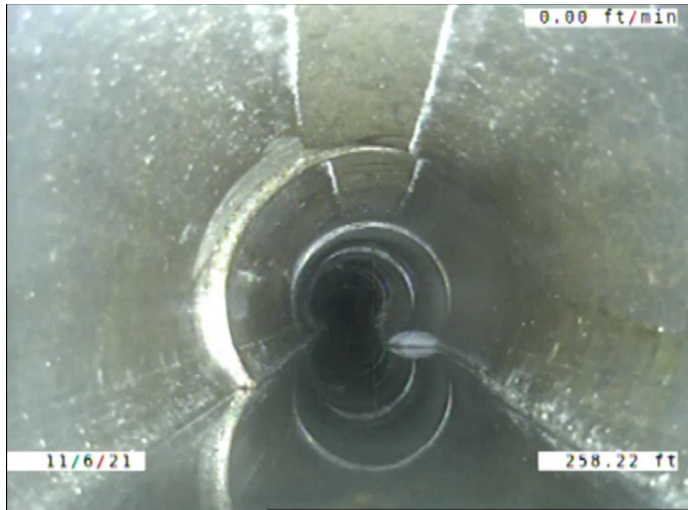
Code: **DAE**
Description: **Deposits Attached Encrustation**

Distance (ft): **258.2**
Structural Grade: **0**
O&M Grade: **2**
Clock Start/From: **8**
Clock To: **4**
1st Value:
2nd Value:
Value Percent: **5.000**
Continuous Index: **S07**
Within 8" of Joint: **YES**
Remarks:

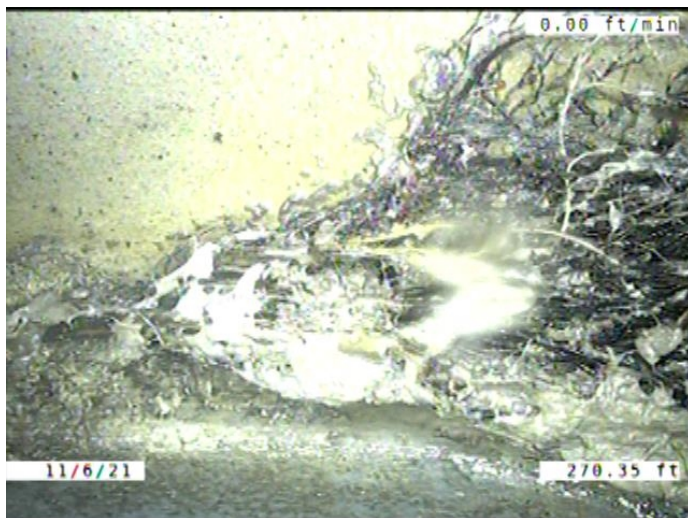
Code:	TFD
Description:	Tap Factory Defective
Distance (ft):	269.4
Structural Grade:	0
O&M Grade:	3
Clock Start/From:	11
Clock To:	
1st Value:	4.000
2nd Value:	
Value Percent:	
Continuous Index:	
Within 8" of Joint:	YES
Remarks:	OFFSET. ROOTS GROWING FROM THE JOINT. ENCUSTATION COMING

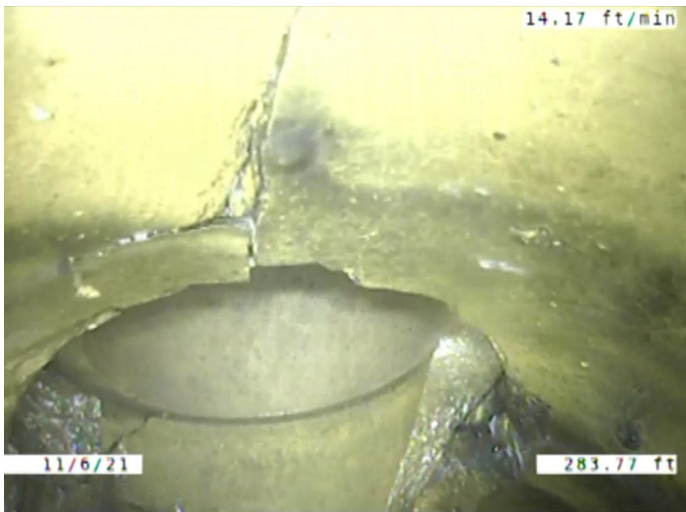
Code: **MWLS**
 Description: **Miscellaneous Water Level Sag**

Distance (ft): **281.1**
 Structural Grade: **2**
 O&M Grade: **0**
 Clock Start/From:
 Clock To:
 1st Value:
 2nd Value:
 Value Percent: **10.000**
 Continuous Index: **S08**
 Within 8" of Joint: **NO**
 Remarks:

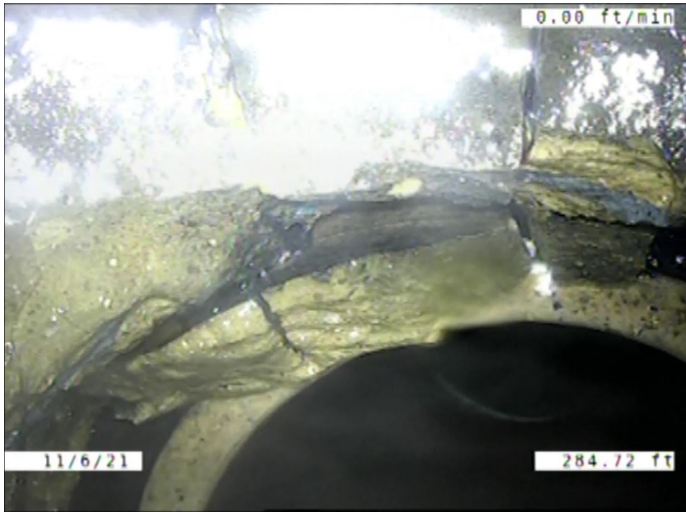
Code: **FL**
 Description: **Fracture Longitudinal**

Distance (ft): **283.8**
 Structural Grade: **3**
 O&M Grade: **0**
 Clock Start/From: **12**
 Clock To:
 1st Value:
 2nd Value:
 Value Percent:
 Continuous Index:
 Within 8" of Joint: **NO**
 Remarks:

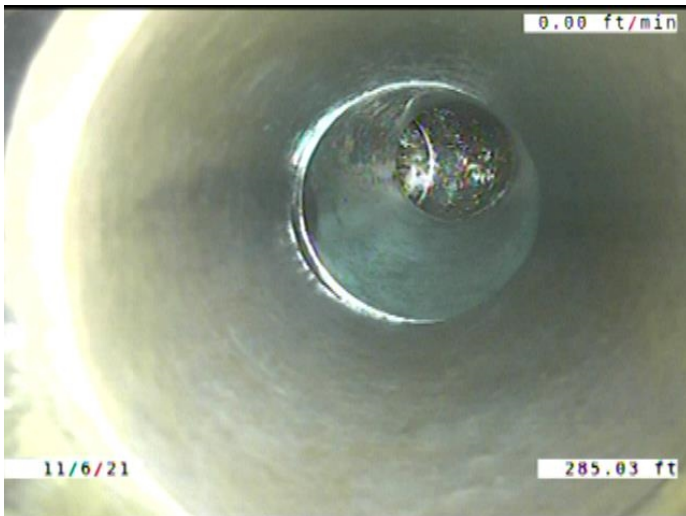
Code: **B**
Description: **Broken**

Distance (ft): **284.7**
Structural Grade: **4**
O&M Grade: **0**
Clock Start/From: **12**
Clock To:
1st Value:
2nd Value:
Value Percent:
Continuous Index:
Within 8" of Joint: **NO**
Remarks:

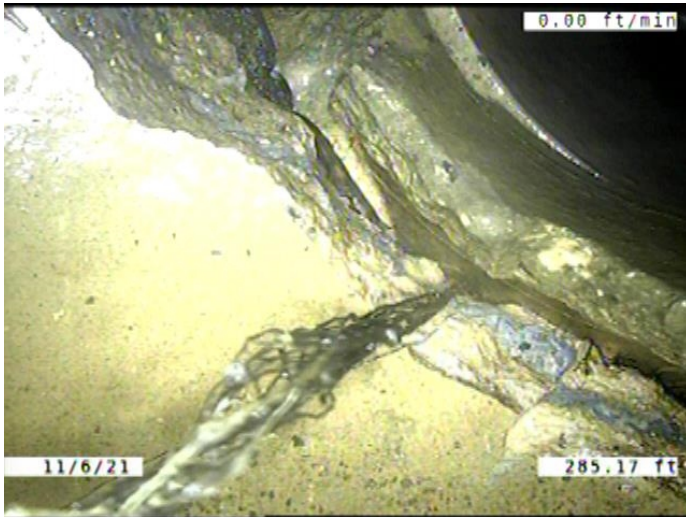
Code: **TBI**
Description: **Tap Break-in Intruding**

Distance (ft): **285.0**
Structural Grade: **0**
O&M Grade: **2**
Clock Start/From: **12**
Clock To:
1st Value: **4.000**
2nd Value: **1.000**
Value Percent:
Continuous Index:
Within 8" of Joint: **YES**
Remarks: **CONSTANTLY RUNNING WATER.**

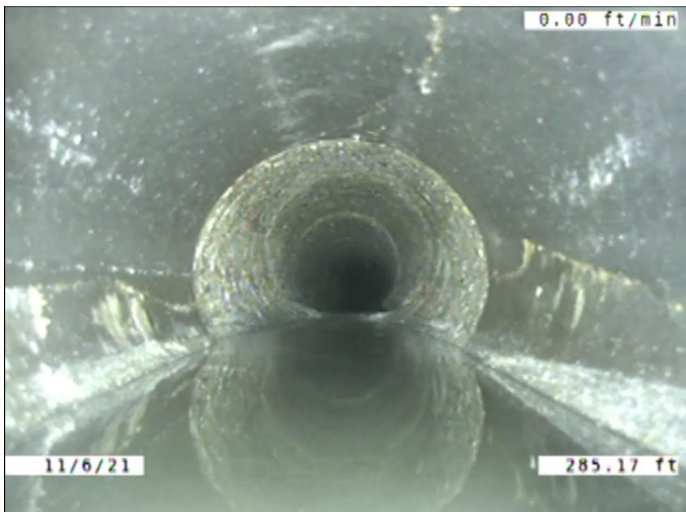
Code: **RFC**
 Description: **Roots Fine Connection**

Distance (ft): **285.2**
 Structural Grade: **0**
 O&M Grade: **1**
 Clock Start/From: **11**
 Clock To:
 1st Value:
 2nd Value:
 Value Percent:
 Continuous Index:
 Within 8" of Joint: **NO**
 Remarks:

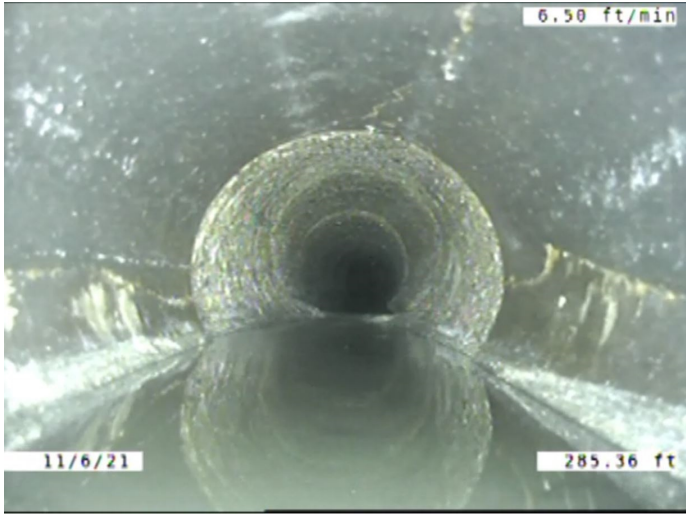
Code: **CM**
 Description: **Crack Multiple**

Distance (ft): **285.2**
 Structural Grade: **3**
 O&M Grade: **0**
 Clock Start/From: **8**
 Clock To: **4**
 1st Value:
 2nd Value:
 Value Percent:
 Continuous Index: **F22**
 Within 8" of Joint: **YES**
 Remarks: **Wandering**

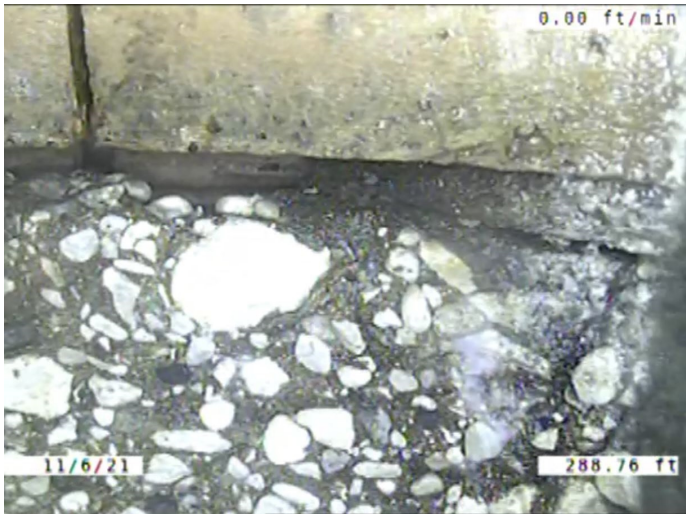
Code: **FM**
Description: **Fracture Multiple**

Distance (ft): **285.4**
Structural Grade: **4**
O&M Grade: **0**
Clock Start/From: **8**
Clock To: **4**
1st Value:
2nd Value:
Value Percent:
Continuous Index: **S23**
Within 8" of Joint: **YES**
Remarks:
