Profile/Photo Observation Report

Date:	11/06/2021	Weather:		Coding:	PACP 7.0
Pipe Length (ft):	658.6	Owner:	City of Hobart	Pre Clean:	Heavy Cleaning
P.O.#:	YES502259	Surveyor:	S. Bucklin	PSR:	P-404-006-005
Customer:	City of Hobart	Clean Date:	10/23/2021	Shape:	C

Street:	North Wabash Street	Flow Control:	Not Controlled
City:	Hobart, IN	Year Renewed:	
Location:	Alley	Tape/Media #:	
Purpose:	Routine Assessment	Dia/Height:	12"
Use:	Sanitary Sewage Pipe	Material:	VCP
Drain Area:		Lining:	None
Category:	NA		
Comment:			
Location Details:		Direction of Survey:	Upstream
US MH:	M-404-006	DS MH:	M-404-005
		Total Length Surveyed (ft):	658.6

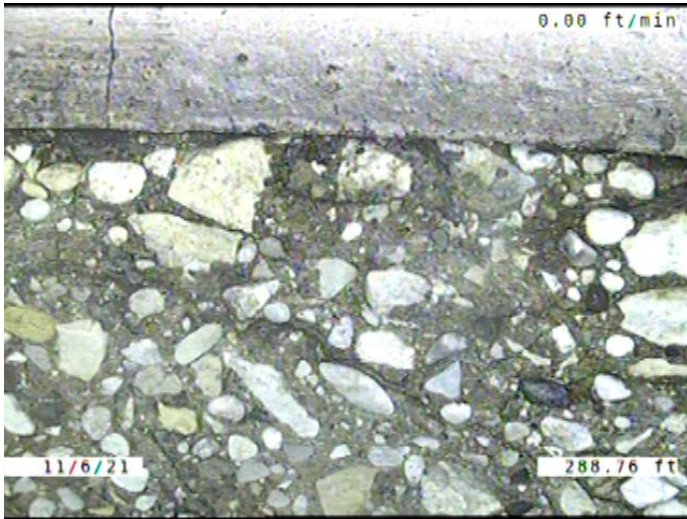
Code: **FM**
Description: **Fracture Multiple**

Distance (ft): **288.8**
Structural Grade: **4**
O&M Grade: **0**
Clock Start/From: **8**
Clock To: **4**
1st Value:
2nd Value:
Value Percent:
Continuous Index: **F23**
Within 8" of Joint: **YES**
Remarks:

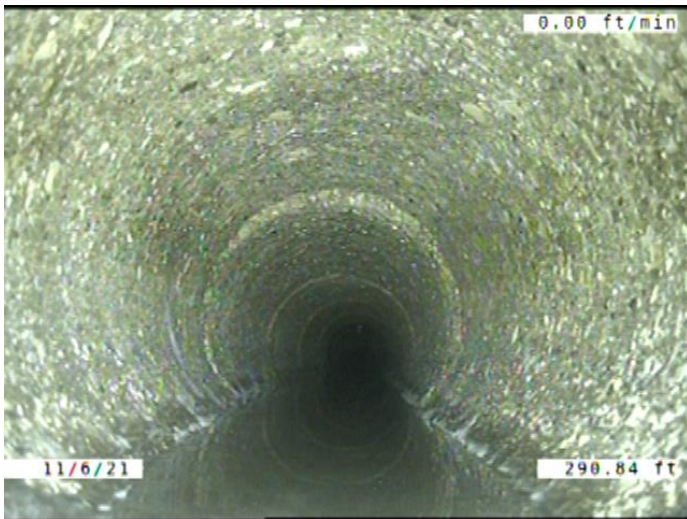
Code:	MMC
Description:	Miscellaneous Material Change
Distance (ft):	288.8
Structural Grade:	0
O&M Grade:	0
Clock Start/From:	
Clock To:	
1st Value:	
2nd Value:	
Value Percent:	
Continuous Index:	
Within 8" of Joint:	NO
Remarks:	VCP TO CONCRETE

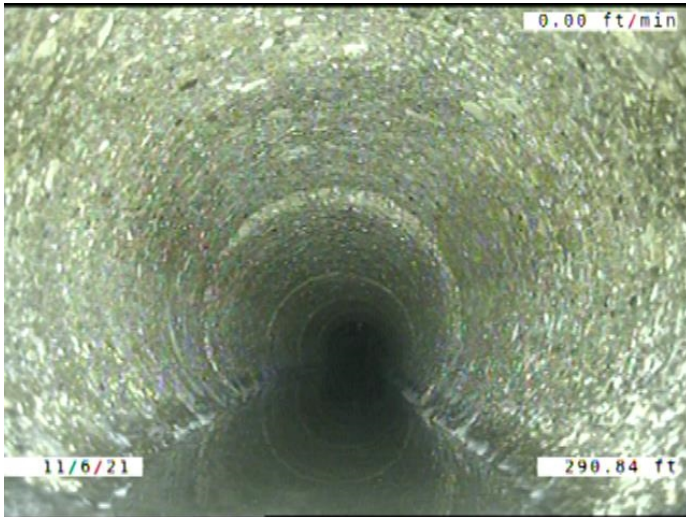
Code:	DAE
Description:	Deposits Attached Encrustation
Distance (ft):	290.8
Structural Grade:	0
O&M Grade:	2
Clock Start/From:	8
Clock To:	4
1st Value:	
2nd Value:	
Value Percent:	5.000
Continuous Index:	F07
Within 8" of Joint:	YES
Remarks:

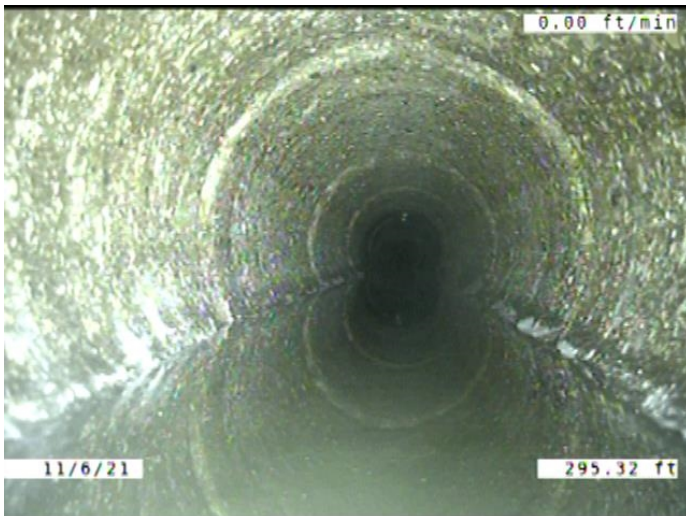
Code: **MWLS**
Description: **Miscellaneous Water Level Sag**

Distance (ft): **290.8**
Structural Grade: **2**
O&M Grade: **0**
Clock Start/From:
Clock To:
1st Value:
2nd Value:
Value Percent: **10.000**
Continuous Index: **F08**
Within 8" of Joint: **NO**
Remarks:

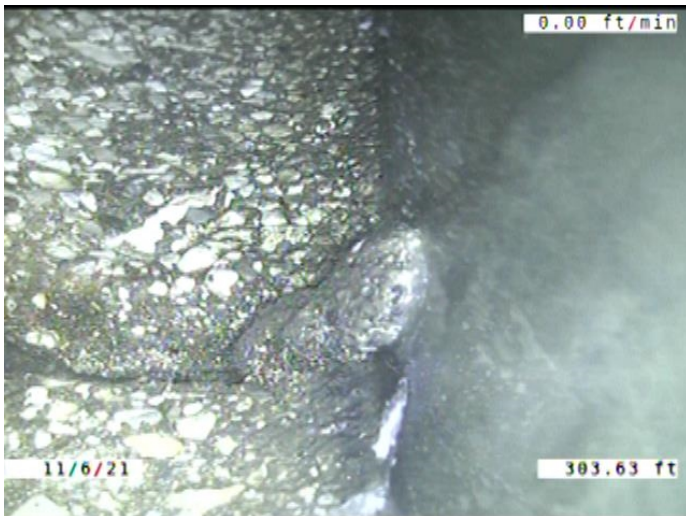
Code: **DAE**
Description: **Deposits Attached Encrustation**

Distance (ft): **300.8**
Structural Grade: **0**
O&M Grade: **2**
Clock Start/From: **3**
Clock To: **5**
1st Value:
2nd Value:
Value Percent: **5.000**
Continuous Index:
Within 8" of Joint: **YES**
Remarks:

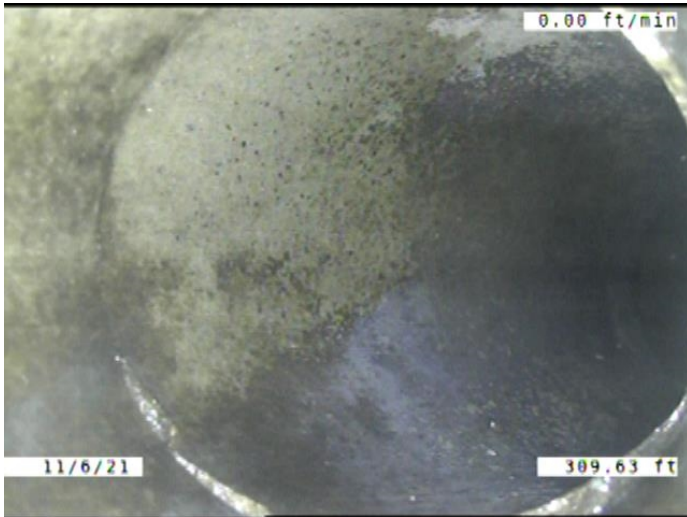
Code: **DAE**
Description: **Deposits Attached Encrustation**

Distance (ft): **303.6**
Structural Grade: **0**
O&M Grade: **2**
Clock Start/From: **7**
Clock To: **8**
1st Value:
2nd Value:
Value Percent: **5.000**
Continuous Index:
Within 8" of Joint: **YES**
Remarks:

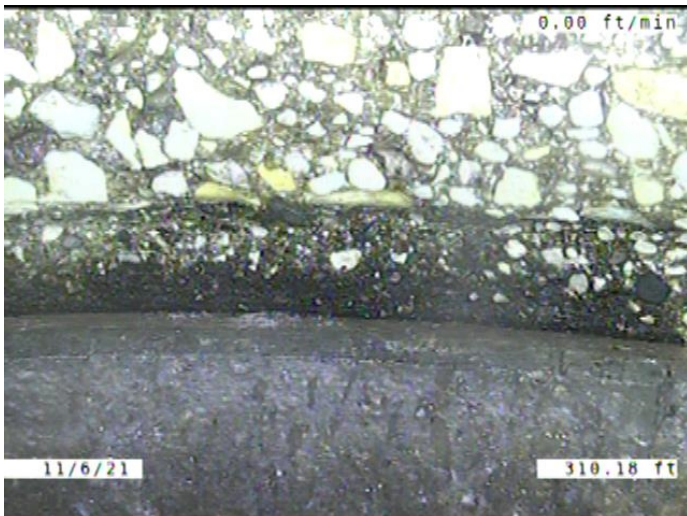
Code: **TBI**
Description: **Tap Break-in Intruding**

Distance (ft): **309.6**
Structural Grade: **0**
O&M Grade: **2**
Clock Start/From: **12**
Clock To:
1st Value: **6.000**
2nd Value: **1.000**
Value Percent:
Continuous Index:
Within 8" of Joint: **YES**
Remarks: **CONSTANTLY RUNNING WATER.**

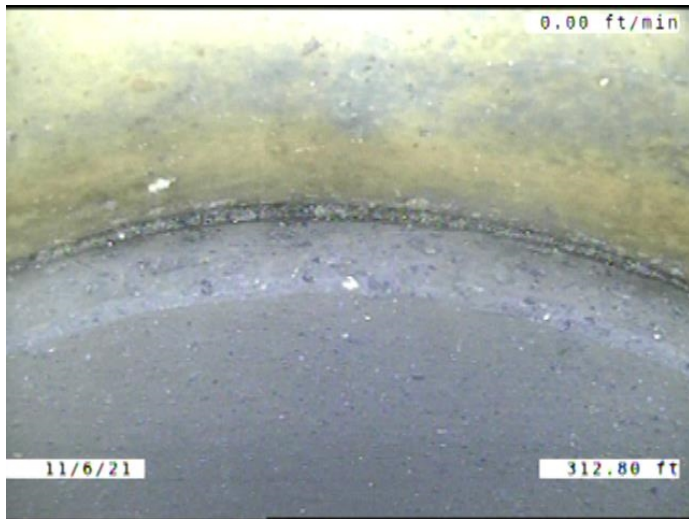
Code:	CL
Description:	Crack Longitudinal
Distance (ft):	310.2
Structural Grade:	2
O&M Grade:	0
Clock Start/From:	3
Clock To:	
1st Value:	
2nd Value:	
Value Percent:	
Continuous Index:	
Within 8" of Joint:	YES
Remarks:

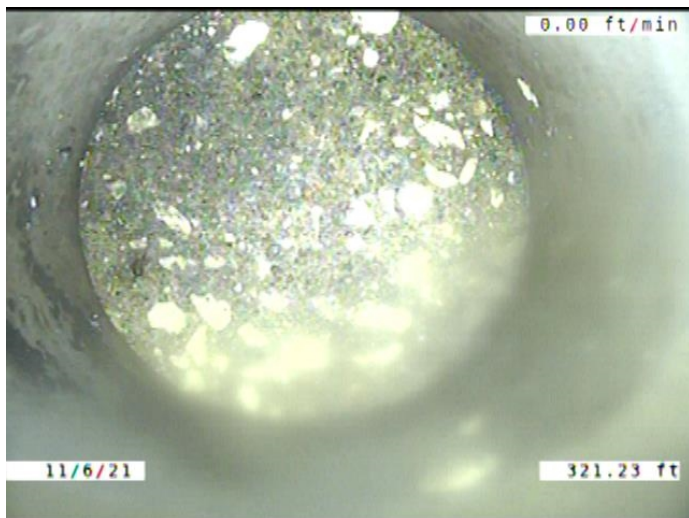
Code: **JOM**
Description: **Joint Offset Medium**

Distance (ft): **312.8**
Structural Grade: **3**
O&M Grade: **0**
Clock Start/From:
Clock To:
1st Value:
2nd Value:
Value Percent:
Continuous Index: **S10**
Within 8" of Joint: **NO**
Remarks:

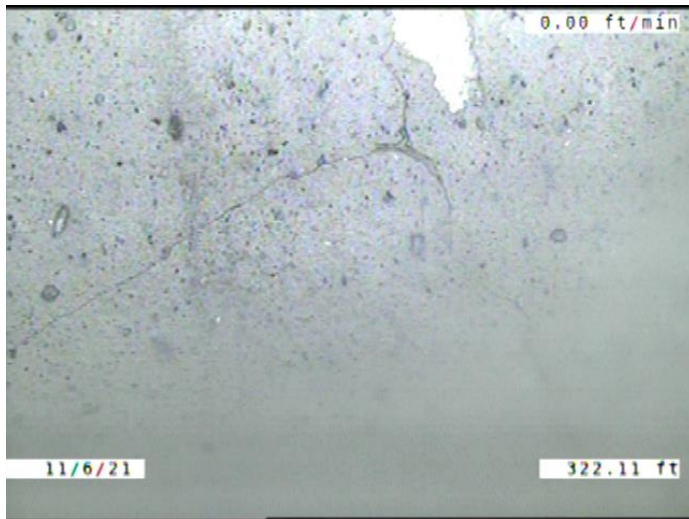
Code: **TFC**
Description: **Tap Factory Capped**

Distance (ft): **321.2**
Structural Grade: **0**
O&M Grade: **0**
Clock Start/From: **1**
Clock To:
1st Value: **4.000**
2nd Value:
Value Percent:
Continuous Index:
Within 8" of Joint: **YES**
Remarks:

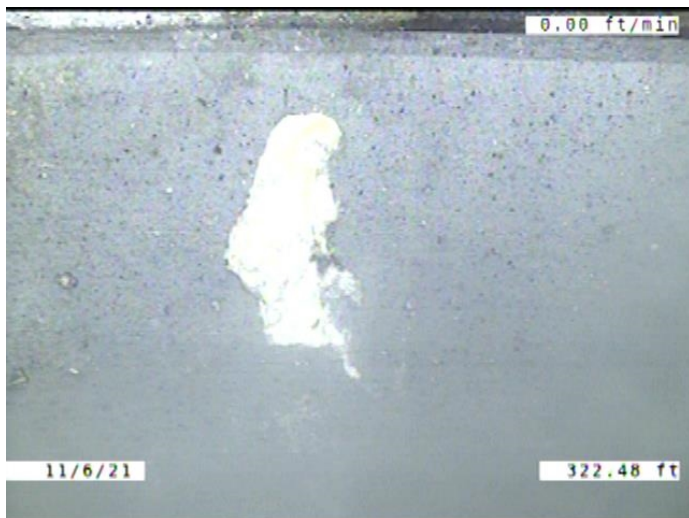
Code: **CM**
Description: **Crack Multiple**

Distance (ft): **322.1**
Structural Grade: **3**
O&M Grade: **0**
Clock Start/From: **7**
Clock To: **5**
1st Value:
2nd Value:
Value Percent:
Continuous Index: **S24**
Within 8" of Joint: **YES**
Remarks: **Wandering**

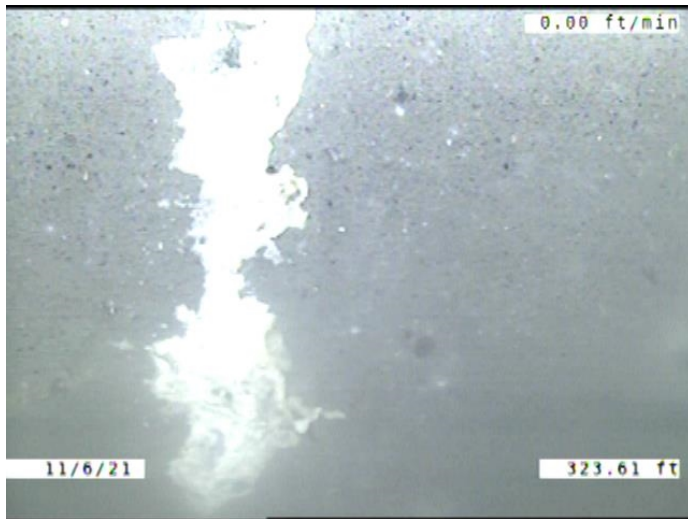
Code: **DAE**
Description: **Deposits Attached Encrustation**

Distance (ft): **322.5**
Structural Grade: **0**
O&M Grade: **2**
Clock Start/From: **1**
Clock To:
1st Value:
2nd Value:
Value Percent: **5.000**
Continuous Index:
Within 8" of Joint: **YES**
Remarks:

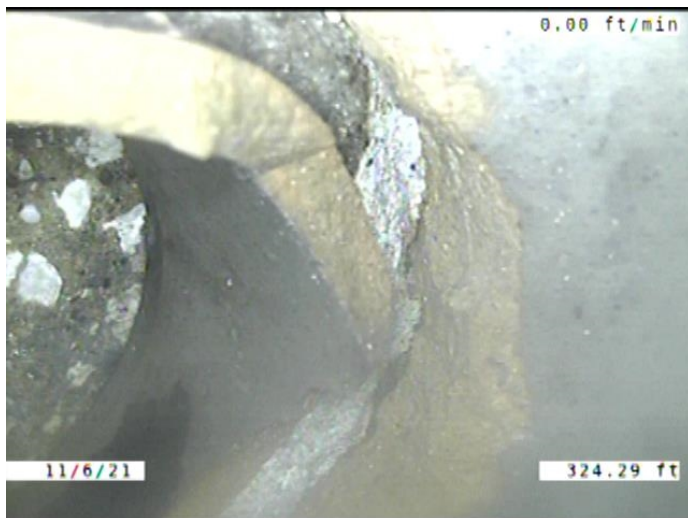
Code: **DAGS**
Description: **Deposits Attached Grease**

Distance (ft): **323.6**
Structural Grade: **0**
O&M Grade: **2**
Clock Start/From: **12**
Clock To:
1st Value:
2nd Value:
Value Percent: **5.000**
Continuous Index:
Within 8" of Joint: **NO**
Remarks:

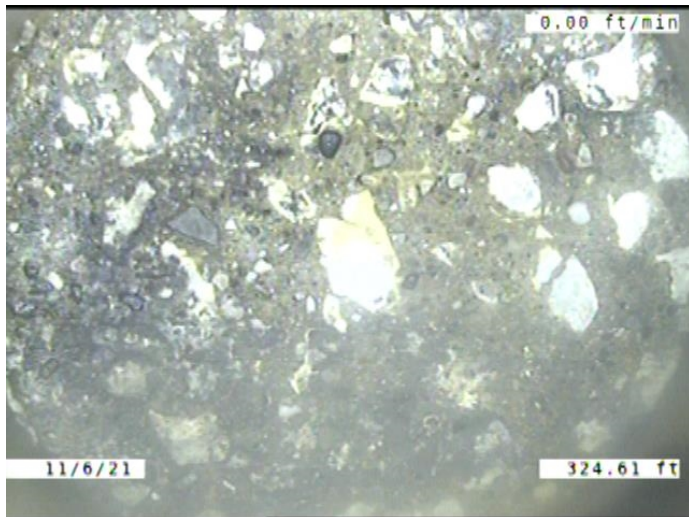
Code: **SSS**
Description: **Surface Damage Surface Spalling**

Distance (ft): **324.3**
Structural Grade: **2**
O&M Grade: **0**
Clock Start/From: **10**
Clock To: **12**
1st Value:
2nd Value:
Value Percent:
Continuous Index:
Within 8" of Joint: **YES**
Remarks:

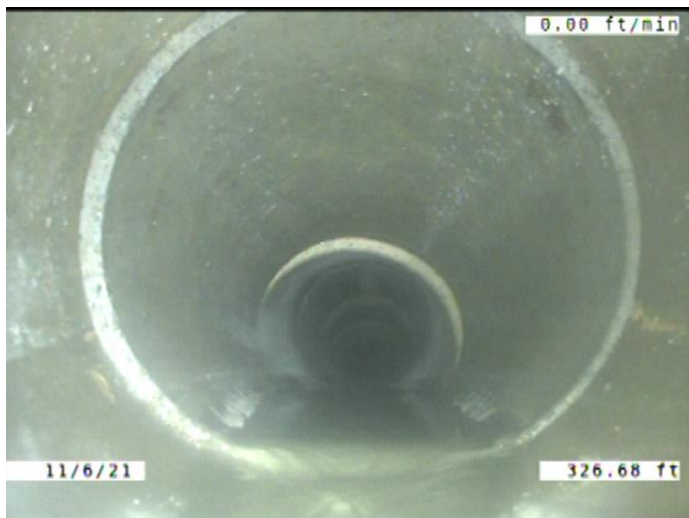
Code: **TBI**
 Description: **Tap Break-in Intruding**

Distance (ft): **324.6**
 Structural Grade: **0**
 O&M Grade: **2**
 Clock Start/From: **11**
 Clock To:
 1st Value: **6.000**
 2nd Value: **2.000**
 Value Percent:
 Continuous Index:
 Within 8" of Joint: **YES**
 Remarks:

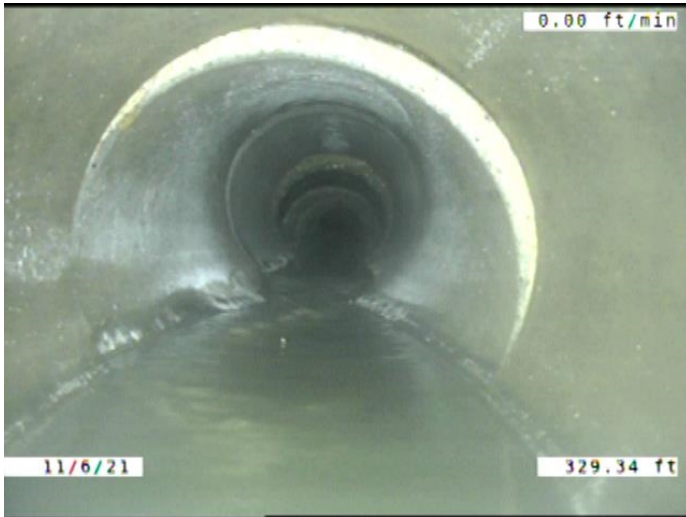
Code: **MWLS**
 Description: **Miscellaneous Water Level Sag**

Distance (ft): **326.7**
 Structural Grade: **2**
 O&M Grade: **0**
 Clock Start/From:
 Clock To:
 1st Value:
 2nd Value:
 Value Percent: **15.000**
 Continuous Index: **F09**
 Within 8" of Joint: **NO**
 Remarks:

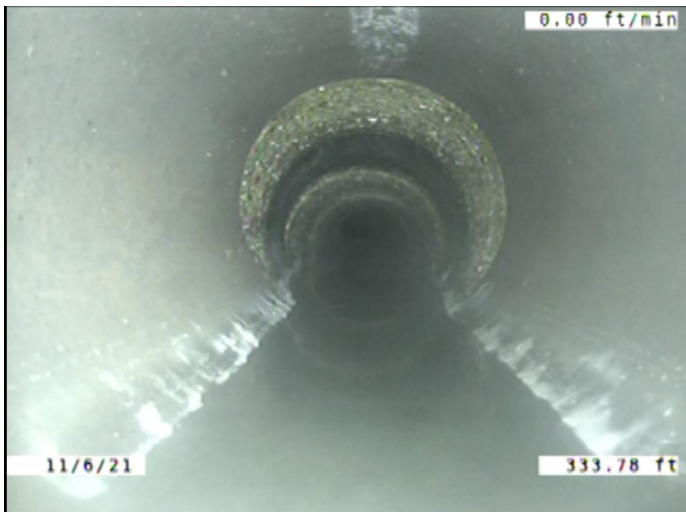
Code: **MWLS**
Description: **Miscellaneous Water Level Sag**

Distance (ft): **329.3**
Structural Grade: **2**
O&M Grade: **0**
Clock Start/From:
Clock To:
1st Value:
2nd Value:
Value Percent: **5.000**
Continuous Index:
Within 8" of Joint: **NO**
Remarks:

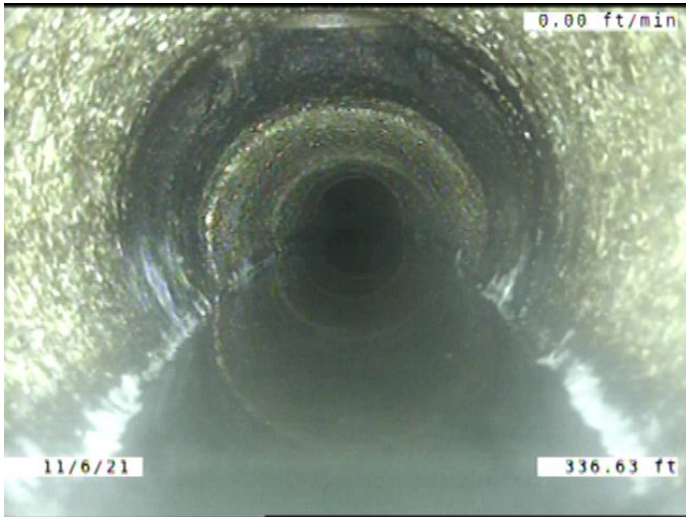
Code: **CM**
Description: **Crack Multiple**

Distance (ft): **333.8**
Structural Grade: **3**
O&M Grade: **0**
Clock Start/From: **7**
Clock To: **5**
1st Value:
2nd Value:
Value Percent:
Continuous Index: **F24**
Within 8" of Joint: **YES**
Remarks: **Wandering**

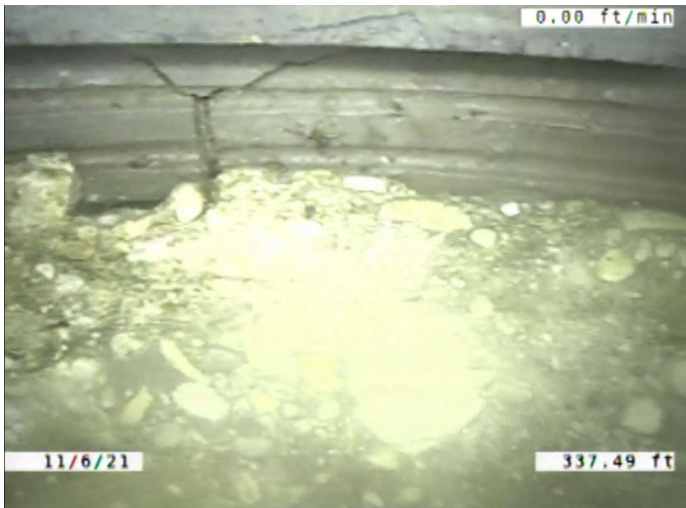
Code: **MWLS**
 Description: **Miscellaneous Water Level Sag**

Distance (ft): **336.6**
 Structural Grade: **2**
 O&M Grade: **0**
 Clock Start/From:
 Clock To:
 1st Value:
 2nd Value:
 Value Percent: **20.000**
 Continuous Index: **S12**
 Within 8" of Joint: **NO**
 Remarks:

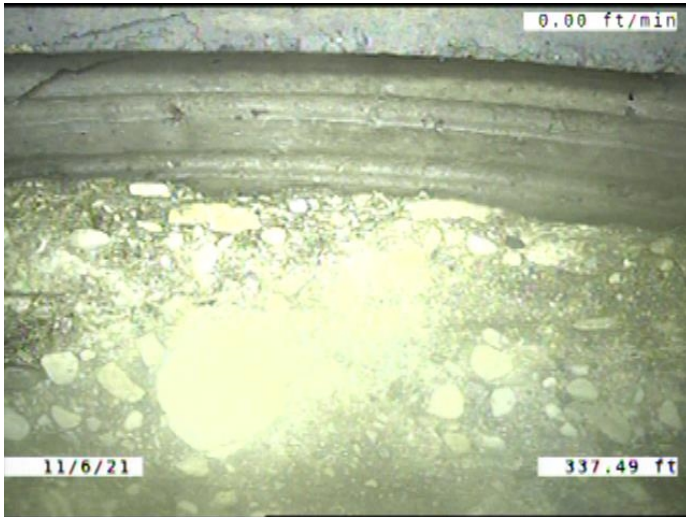
Code: **FM**
 Description: **Fracture Multiple**

Distance (ft): **337.5**
 Structural Grade: **4**
 O&M Grade: **0**
 Clock Start/From: **8**
 Clock To: **12**
 1st Value:
 2nd Value:
 Value Percent:
 Continuous Index:
 Within 8" of Joint: **YES**
 Remarks:

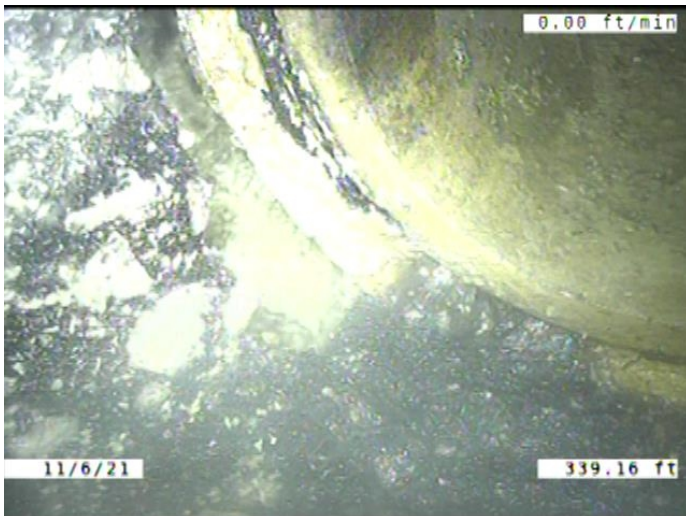
Code: **MMC**
Description: **Miscellaneous Material Change**

Distance (ft): **337.5**
Structural Grade: **0**
O&M Grade: **0**
Clock Start/From:
Clock To:
1st Value:
2nd Value:
Value Percent:
Continuous Index:
Within 8" of Joint: **NO**
Remarks: **VCP TO CONCRETE**

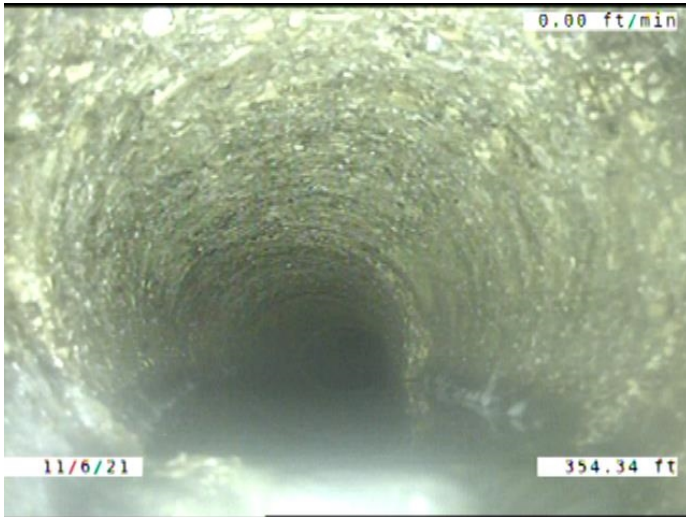
Code:	SMW
Description:	Surface Damage Missing Wall
Distance (ft):	343.5
Structural Grade:	5
O&M Grade:	0
Clock Start/From:	12
Clock To:	1
1st Value:	
2nd Value:	
Value Percent:	
Continuous Index:	
Within 8" of Joint:	YES
Remarks:	INSIDE OF THE JOINT

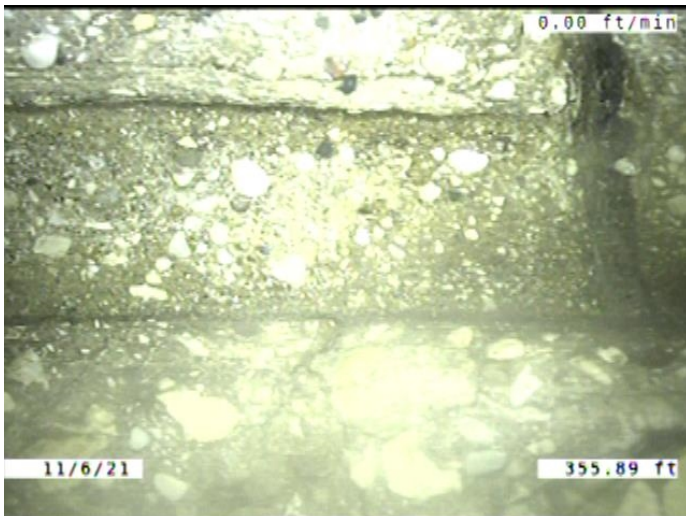
Code: **MWLS**
Description: **Miscellaneous Water Level Sag**

Distance (ft): **354.3**
Structural Grade: **2**
O&M Grade: **0**
Clock Start/From:
Clock To:
1st Value:
2nd Value:
Value Percent: **20.000**
Continuous Index: **F12**
Within 8" of Joint: **NO**
Remarks:

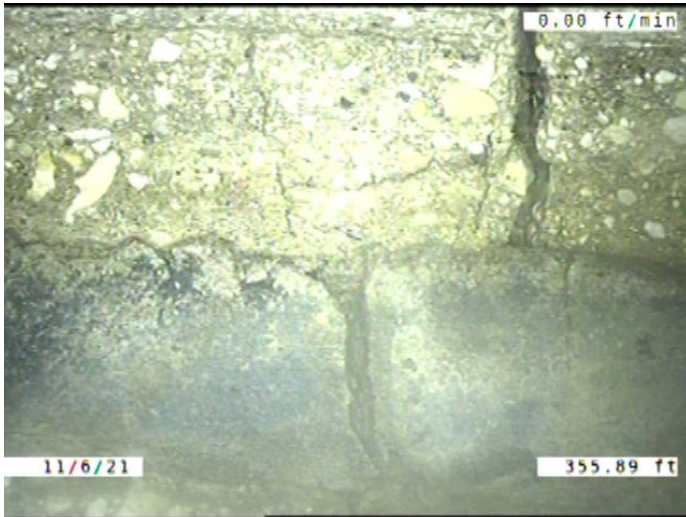
Code: **JAL**
Description: **Joint Angular Large**

Distance (ft): **355.9**
Structural Grade: **4**
O&M Grade: **0**
Clock Start/From:
Clock To:
1st Value:
2nd Value:
Value Percent:
Continuous Index:
Within 8" of Joint: **NO**
Remarks:

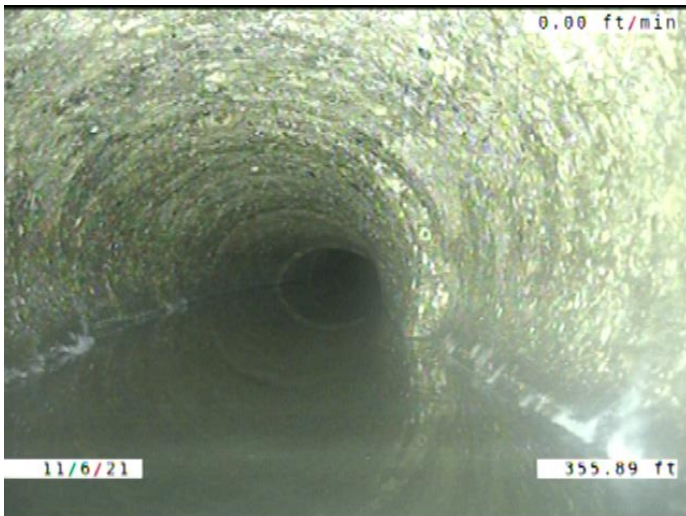
Code: **SMW**
Description: **Surface Damage Missing Wall**

Distance (ft): **355.9**
Structural Grade: **5**
O&M Grade: **0**
Clock Start/From: **9**
Clock To: **1**
1st Value:
2nd Value:
Value Percent:
Continuous Index:
Within 8" of Joint: **YES**
Remarks: **INSIDE OF THE JOINT**

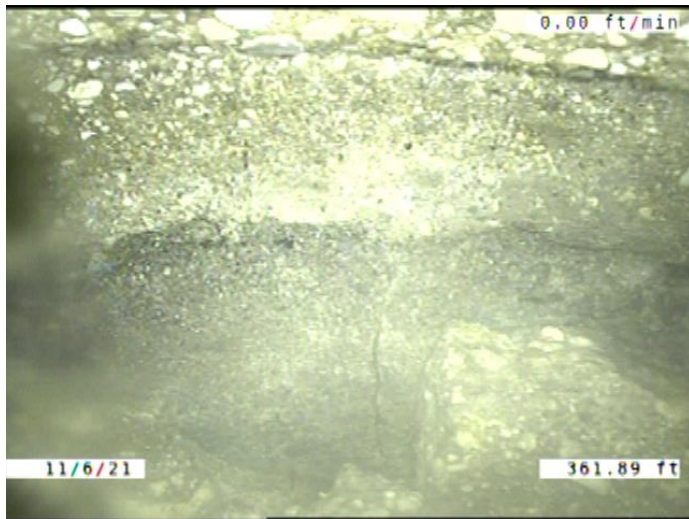
Code: **MWLS**
Description: **Miscellaneous Water Level Sag**

Distance (ft): **355.9**
Structural Grade: **3**
O&M Grade: **0**
Clock Start/From:
Clock To:
1st Value:
2nd Value:
Value Percent: **35.000**
Continuous Index: **S13**
Within 8" of Joint: **NO**
Remarks:

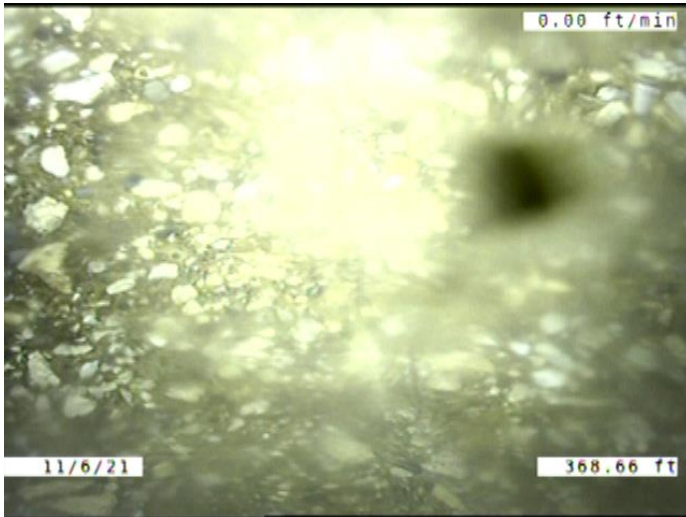
Code: **MCU**
 Description: **Miscellaneous Camera Underwater**

Distance (ft): **362.7**
 Structural Grade: **0**
 O&M Grade: **4**
 Clock Start/From:
 Clock To:
 1st Value:
 2nd Value:
 Value Percent:
 Continuous Index: **S14**
 Within 8" of Joint: **NO**
 Remarks:

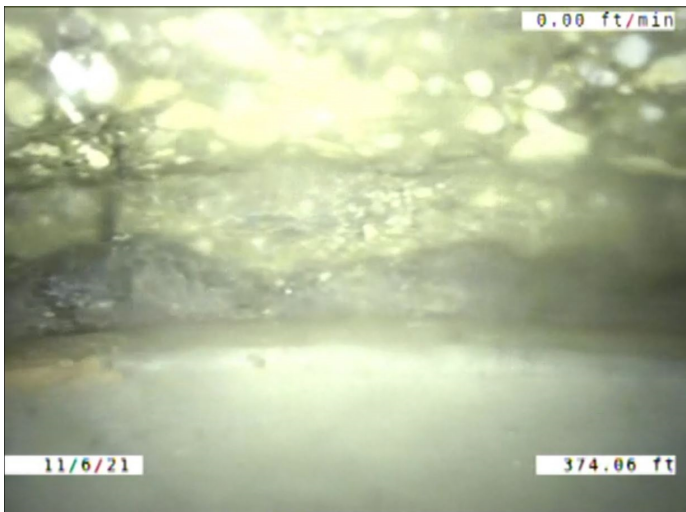
Code: **MCU**
Description: **Miscellaneous Camera Underwater**

Distance (ft): **368.7**
Structural Grade: **0**
O&M Grade: **4**
Clock Start/From:
Clock To:
1st Value:
2nd Value:
Value Percent:
Continuous Index: **F14**
Within 8" of Joint: **NO**
Remarks:

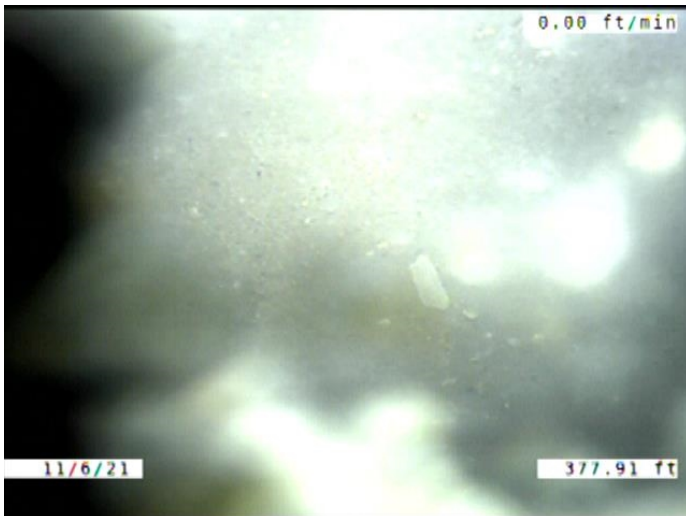
Code: **MMC**
 Description: **Miscellaneous Material Change**

Distance (ft): **374.1**
 Structural Grade: **0**
 O&M Grade: **0**
 Clock Start/From:
 Clock To:
 1st Value:
 2nd Value:
 Value Percent:
 Continuous Index:
 Within 8" of Joint: **NO**
 Remarks: **CONCRETE TO VCP**

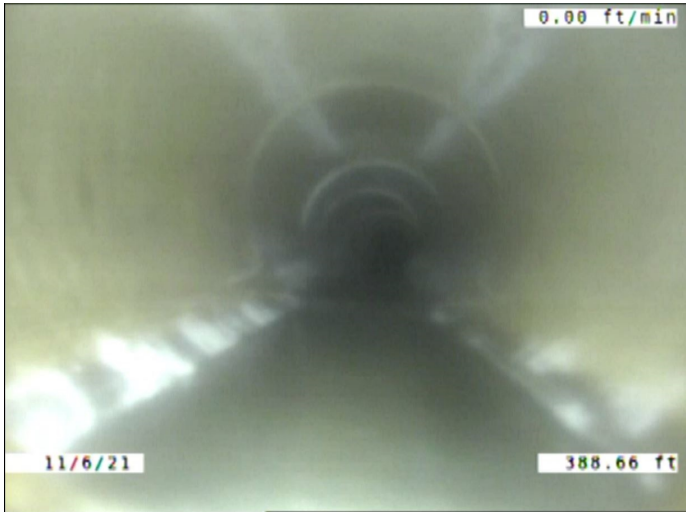
Code: **MCU**
 Description: **Miscellaneous Camera Underwater**

Distance (ft): **377.9**
 Structural Grade: **0**
 O&M Grade: **4**
 Clock Start/From:
 Clock To:
 1st Value:
 2nd Value:
 Value Percent:
 Continuous Index: **S25**
 Within 8" of Joint: **NO**
 Remarks:

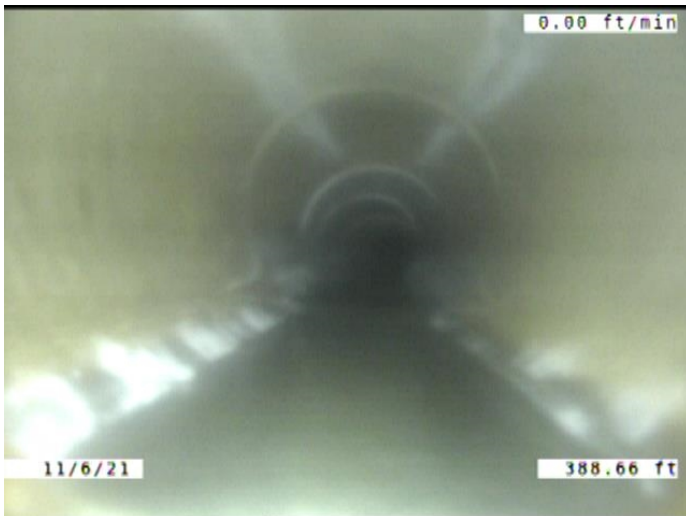
Code: **MCU**
Description: **Miscellaneous Camera Underwater**

Distance (ft): **388.7**
Structural Grade: **0**
O&M Grade: **4**
Clock Start/From:
Clock To:
1st Value:
2nd Value:
Value Percent:
Continuous Index: **F25**
Within 8" of Joint: **NO**
Remarks:

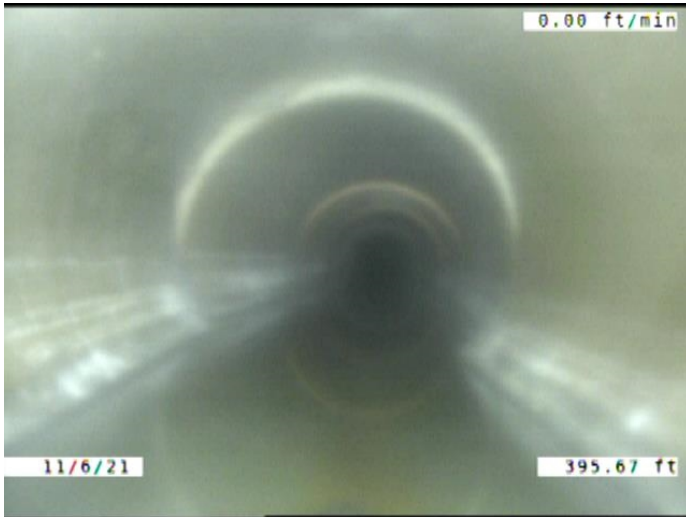
Code: **MWLS**
Description: **Miscellaneous Water Level Sag**

Distance (ft): **388.7**
Structural Grade: **3**
O&M Grade: **0**
Clock Start/From:
Clock To:
1st Value:
2nd Value:
Value Percent: **35.000**
Continuous Index: **F13**
Within 8" of Joint: **NO**
Remarks:

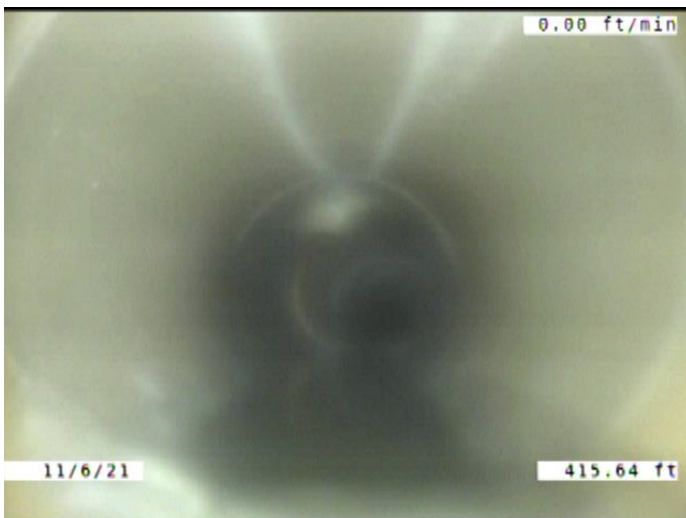
Code: **MWLS**
Description: **Miscellaneous Water Level Sag**

Distance (ft): **395.7**
Structural Grade: **2**
O&M Grade: **0**
Clock Start/From:
Clock To:
1st Value:
2nd Value:
Value Percent: **15.000**
Continuous Index: **S15**
Within 8" of Joint: **NO**
Remarks:

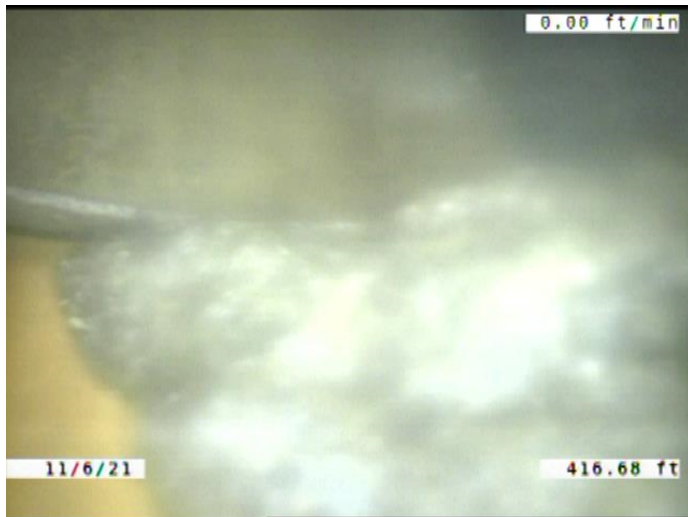
Code: **MWLS**
Description: **Miscellaneous Water Level Sag**

Distance (ft): **415.6**
Structural Grade: **2**
O&M Grade: **0**
Clock Start/From:
Clock To:
1st Value:
2nd Value:
Value Percent: **15.000**
Continuous Index: **F15**
Within 8" of Joint: **NO**
Remarks:

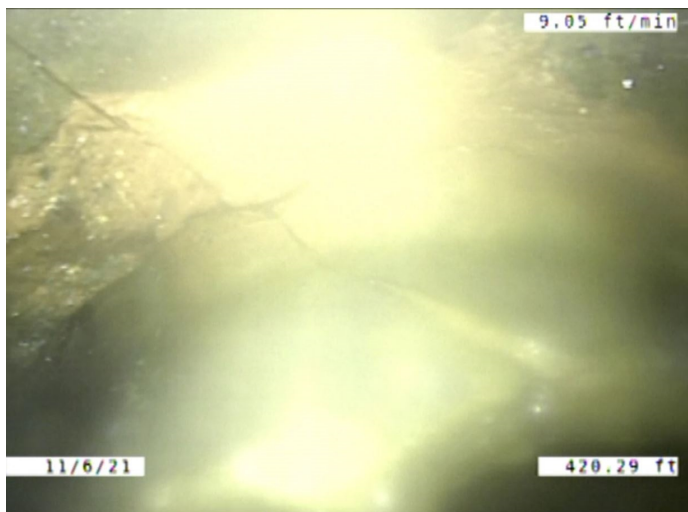
Code:	DAE
Description:	Deposits Attached Encrustation
Distance (ft):	416.7
Structural Grade:	0
O&M Grade:	2
Clock Start/From:	6
Clock To:	8
1st Value:	
2nd Value:	
Value Percent:	5.000
Continuous Index:	
Within 8" of Joint:	YES
Remarks:

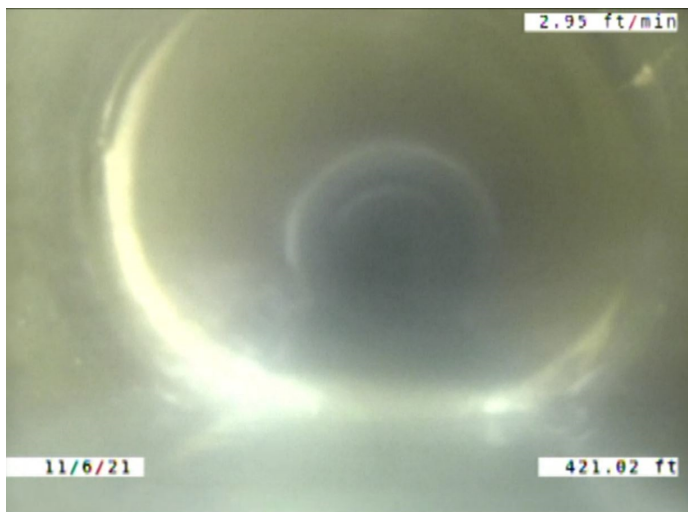
Code: **TBI**
 Description: **Tap Break-in Intruding**

Distance (ft): **420.9**
 Structural Grade: **0**
 O&M Grade: **2**
 Clock Start/From: **11**
 Clock To:
 1st Value: **4.000**
 2nd Value: **3.000**
 Value Percent:
 Continuous Index:
 Within 8" of Joint: **YES**
 Remarks: **BROKEN. CONSTANTLY DRIPPING WATER.**

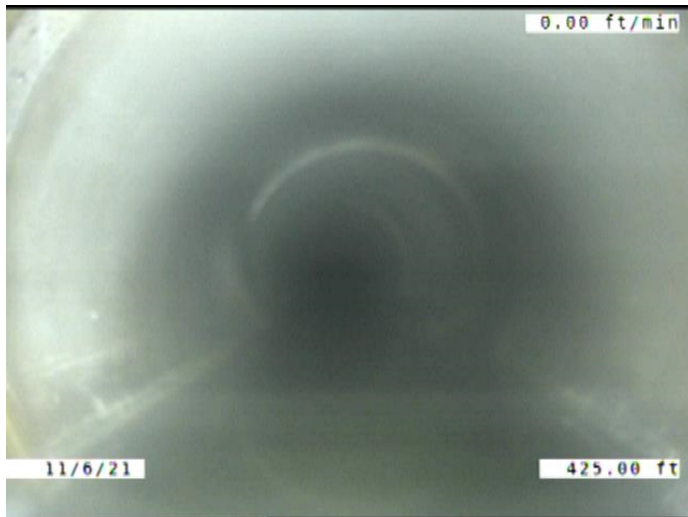
Code: **B**
 Description: **Broken**

Distance (ft): **421.0**
 Structural Grade: **4**
 O&M Grade: **0**
 Clock Start/From: **10**
 Clock To: **11**
 1st Value:
 2nd Value:
 Value Percent:
 Continuous Index:
 Within 8" of Joint: **YES**
 Remarks:

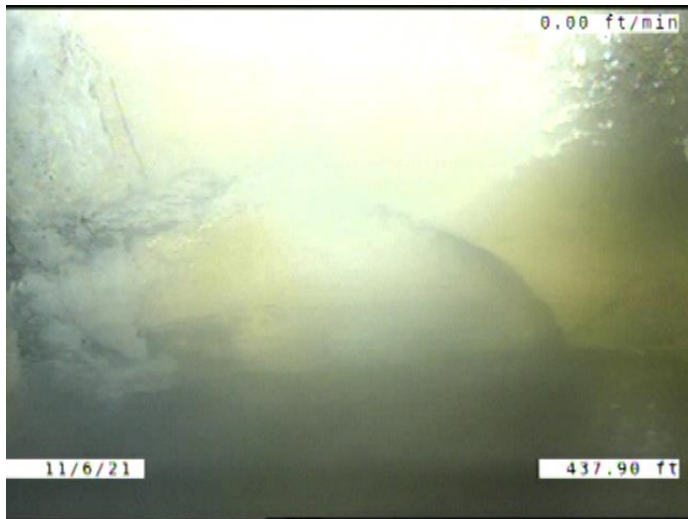
Code: **TFD**
 Description: **Tap Factory Defective**

Distance (ft): **428.0**
 Structural Grade: **0**
 O&M Grade: **3**
 Clock Start/From: **1**
 Clock To:
 1st Value: **4.000**
 2nd Value:
 Value Percent:
 Continuous Index:
 Within 8" of Joint: **YES**
 Remarks: **CONSTANTLY RUNNING WATER. BROKEN. OFFSET**

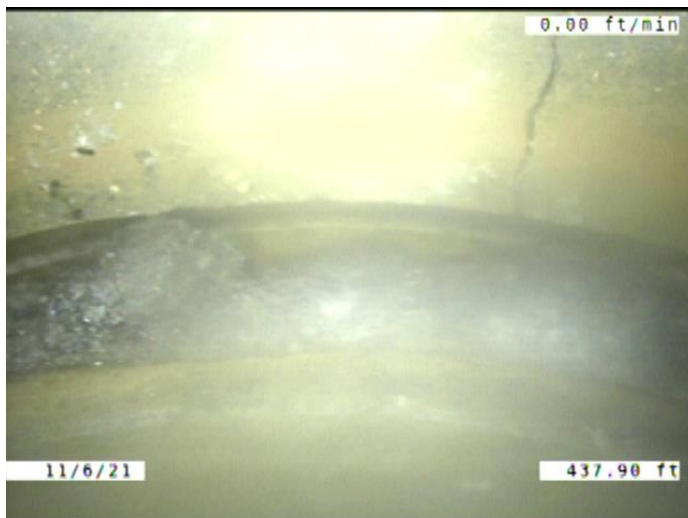
Code: **B**
Description: **Broken**

Distance (ft): **437.9**
Structural Grade: **4**
O&M Grade: **0**
Clock Start/From: **4**
Clock To: **8**
1st Value:
2nd Value:
Value Percent:
Continuous Index:
Within 8" of Joint: **YES**
Remarks:

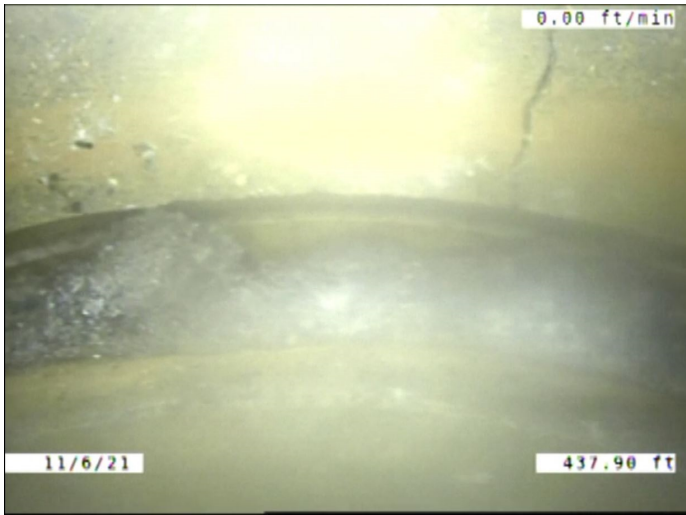
Code: **JAL**
Description: **Joint Angular Large**

Distance (ft): **437.9**
Structural Grade: **4**
O&M Grade: **0**
Clock Start/From:
Clock To:
1st Value:
2nd Value:
Value Percent:
Continuous Index:
Within 8" of Joint: **NO**
Remarks:

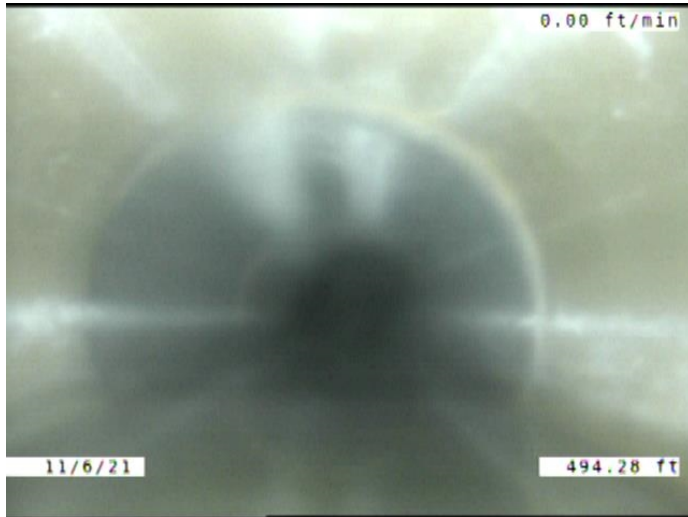
Code: **MCU**
Description: **Miscellaneous Camera Underwater**

Distance (ft): **491.0**
Structural Grade: **0**
O&M Grade: **4**
Clock Start/From:
Clock To:
1st Value:
2nd Value:
Value Percent:
Continuous Index:
Within 8" of Joint: **NO**
Remarks: **Out at 492**

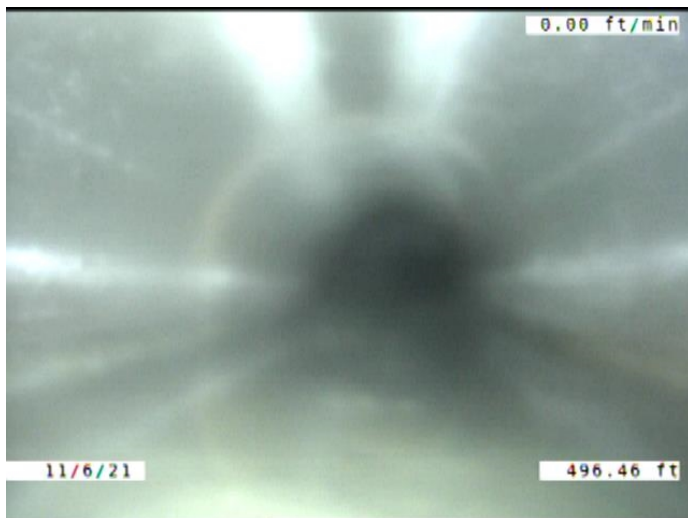
Code: **MWLS**
Description: **Miscellaneous Water Level Sag**

Distance (ft): **494.3**
Structural Grade: **2**
O&M Grade: **0**
Clock Start/From:
Clock To:
1st Value:
2nd Value:
Value Percent: **15.000**
Continuous Index: **F16**
Within 8" of Joint: **NO**
Remarks:

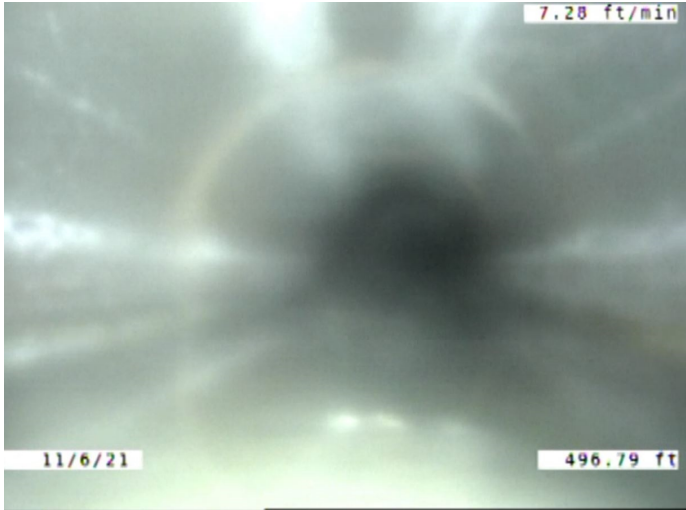
Code: **MWLS**
Description: **Miscellaneous Water Level Sag**

Distance (ft): **496.5**
Structural Grade: **2**
O&M Grade: **0**
Clock Start/From:
Clock To:
1st Value:
2nd Value:
Value Percent: **10.000**
Continuous Index: **S17**
Within 8" of Joint: **NO**
Remarks:

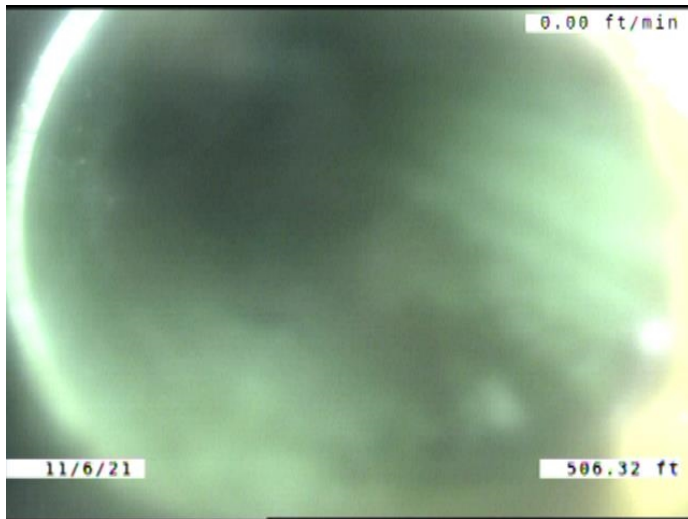
Code:	MWLS
Description:	Miscellaneous Water Level Sag
Distance (ft):	504.8
Structural Grade:	2
O&M Grade:	0
Clock Start/From:	
Clock To:	
1st Value:	
2nd Value:	
Value Percent:	10.000
Continuous Index:	F17
Within 8" of Joint:	NO
Remarks:

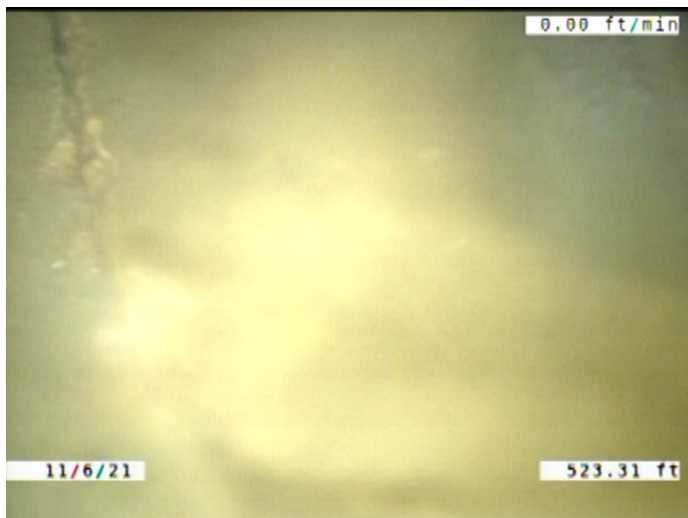
Code: **TB**
Description: **Tap Break-in/Hammer**

Distance (ft): **506.3**
Structural Grade: **0**
O&M Grade: **0**
Clock Start/From: **2**
Clock To:
1st Value: **4.000**
2nd Value:
Value Percent:
Continuous Index:
Within 8" of Joint: **YES**
Remarks:

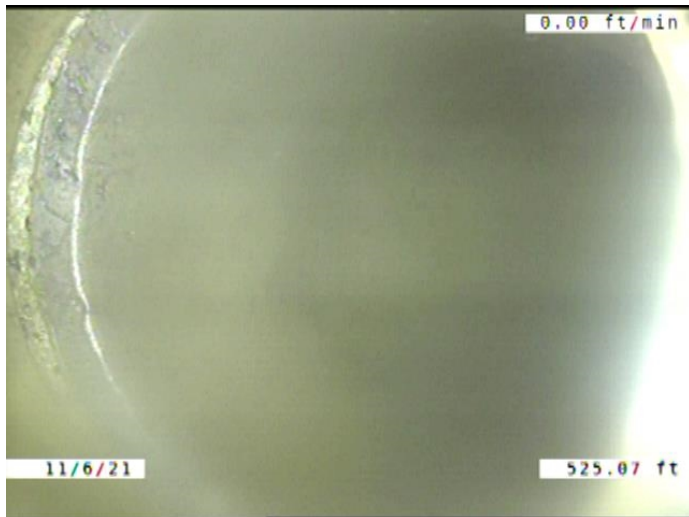
Code: **B**
Description: **Broken**

Distance (ft): **523.3**
Structural Grade: **4**
O&M Grade: **0**
Clock Start/From: **5**
Clock To: **8**
1st Value:
2nd Value:
Value Percent:
Continuous Index:
Within 8" of Joint: **YES**
Remarks:

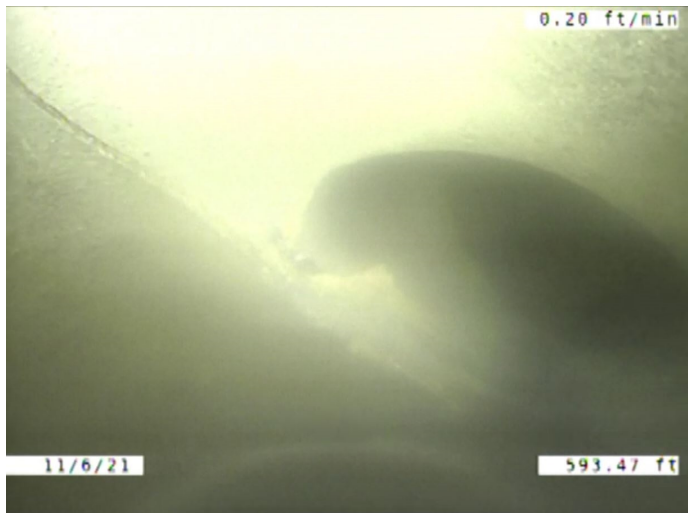
Code: **TBI**
 Description: **Tap Break-in Intruding**

Distance (ft): **593.5**
 Structural Grade: **0**
 O&M Grade: **2**
 Clock Start/From: **11**
 Clock To:
 1st Value: **4.000**
 2nd Value: **1.000**
 Value Percent:
 Continuous Index:
 Within 8" of Joint: **YES**
 Remarks: **CONSTANTLY DRIPPING WATER.**

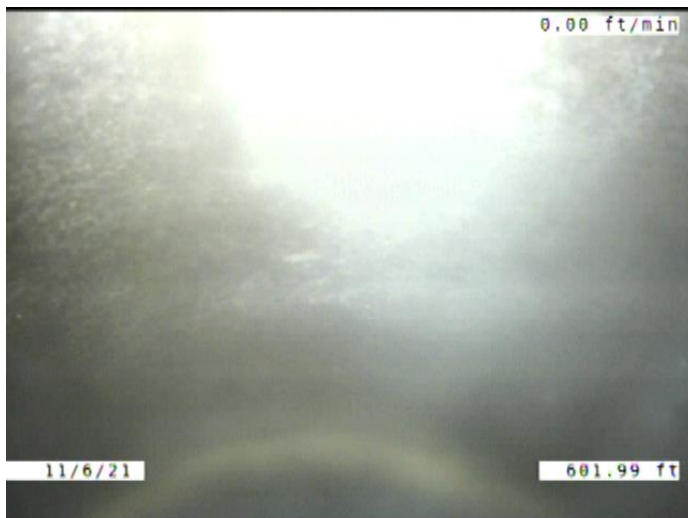
Code: **MWLS**
Description: **Miscellaneous Water Level Sag**

Distance (ft): **601.9**
Structural Grade: **2**
O&M Grade: **0**
Clock Start/From:
Clock To:
1st Value:
2nd Value:
Value Percent: **30.000**
Continuous Index:
Within 8" of Joint: **NO**
Remarks:

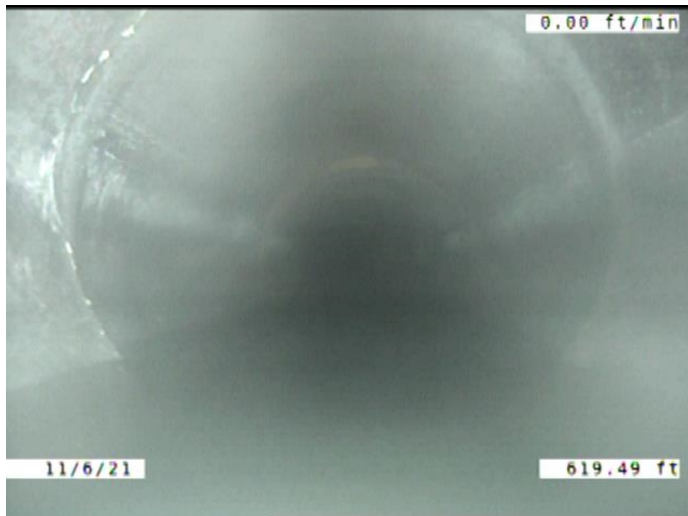
Code:	MCU
Description:	Miscellaneous Camera Underwater
Distance (ft):	614.1
Structural Grade:	0
O&M Grade:	4
Clock Start/From:	
Clock To:	
1st Value:	
2nd Value:	
Value Percent:	
Continuous Index:	
Within 8" of Joint:	NO
Remarks:	Out at 616.3

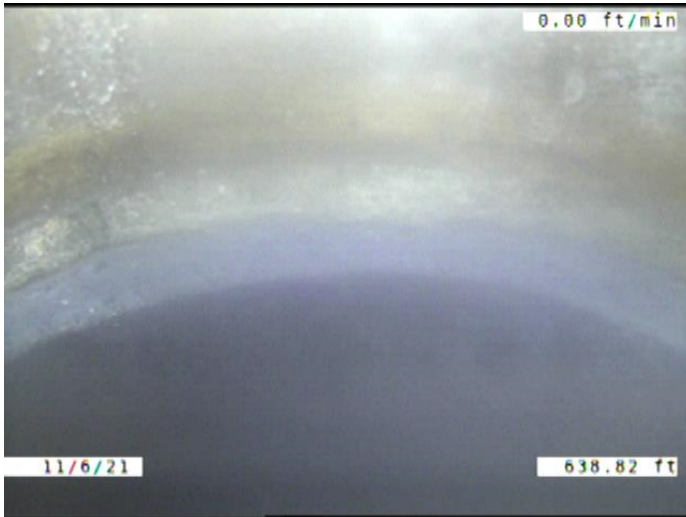
Code:	MWL
Description:	Miscellaneous Water Level
Distance (ft):	619.5
Structural Grade:	0
O&M Grade:	0
Clock Start/From:	
Clock To:	
1st Value:	
2nd Value:	
Value Percent:	5.000
Continuous Index:	
Within 8" of Joint:	NO
Remarks:

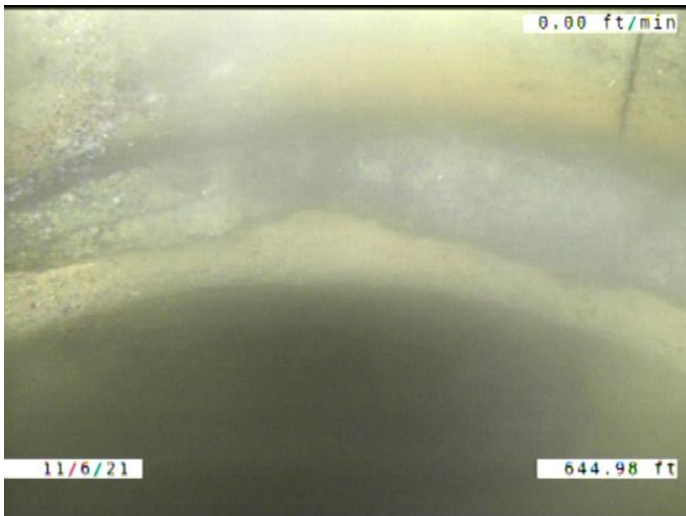
Code: **JOLD**
Description: **Joint Offset Large Defective**

Distance (ft): **638.8**
Structural Grade: **4**
O&M Grade: **0**
Clock Start/From:
Clock To:
1st Value:
2nd Value:
Value Percent:
Continuous Index:
Within 8" of Joint: **NO**
Remarks:

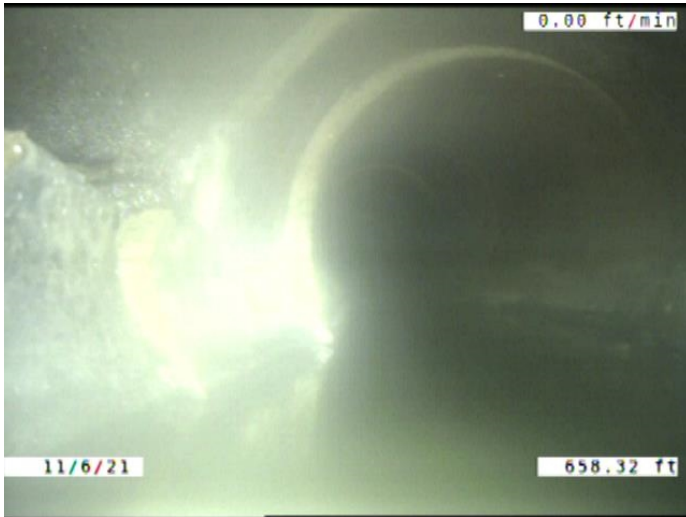
Code: **JOMD**
Description: **Joint Offset Medium Defective**

Distance (ft): **645.0**
Structural Grade: **3**
O&M Grade: **0**
Clock Start/From:
Clock To:
1st Value:
2nd Value:
Value Percent:
Continuous Index:
Within 8" of Joint: **NO**
Remarks:

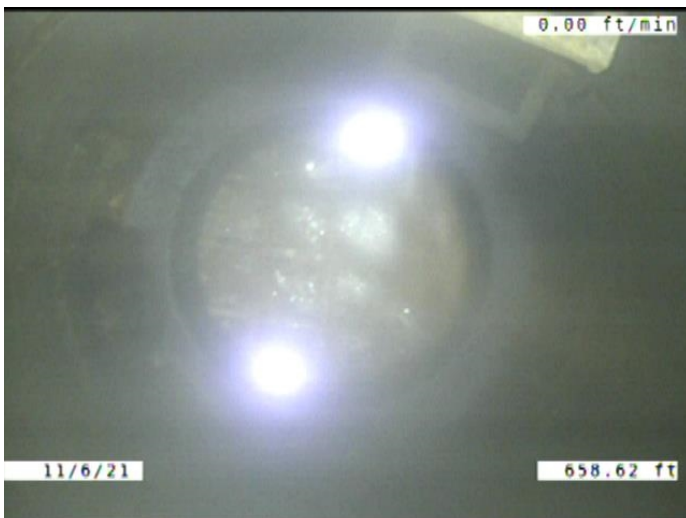
Code: **JOM**
Description: **Joint Offset Medium**

Distance (ft): **658.3**
Structural Grade: **3**
O&M Grade: **0**
Clock Start/From:
Clock To:
1st Value:
2nd Value:
Value Percent:
Continuous Index: **F10**
Within 8" of Joint: **NO**
Remarks:
