RedZone
ROBOTICS

Street:	North Wabash Street		Flow Control:	Not Controlled	
City:	Hobart, IN		Year Renewed:		
Location:	Alley		Tape/Media #:		
Purpose:	Routine Assessment		Dia/Height:	12"	
Use:	Sanitary Sewage Pipe		Material:	VCP	
Drain Area:			Lining:	None	
Category:	NA				
Comment:					
Location Details:			Direction of Survey:	Upstream	
US MH:	M-404-006	DS MH:	M-404-005	Total Length Surveyed (ft):	658.6

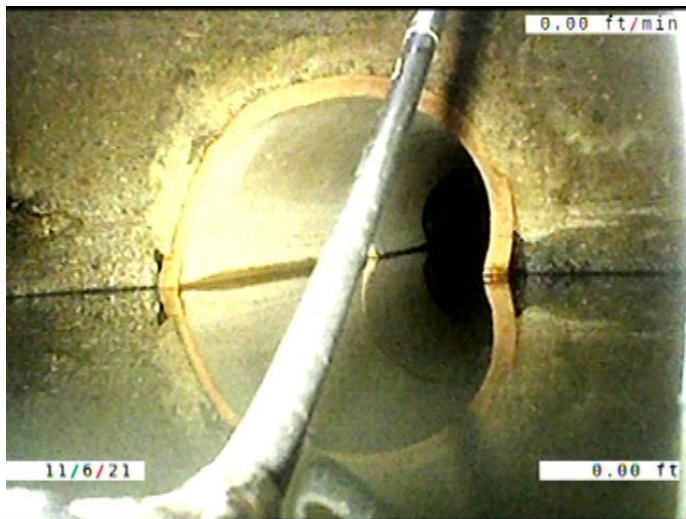
Code: **AMH**
Description: **Manhole**

Distance (ft): **.0**
Structural Grade: **0**
O&M Grade: **0**
Clock Start/From:
Clock To:
1st Value:
2nd Value:
Value Percent:
Continuous Index:
Within 8" of Joint: **NO**
Remarks: **M-404-005**

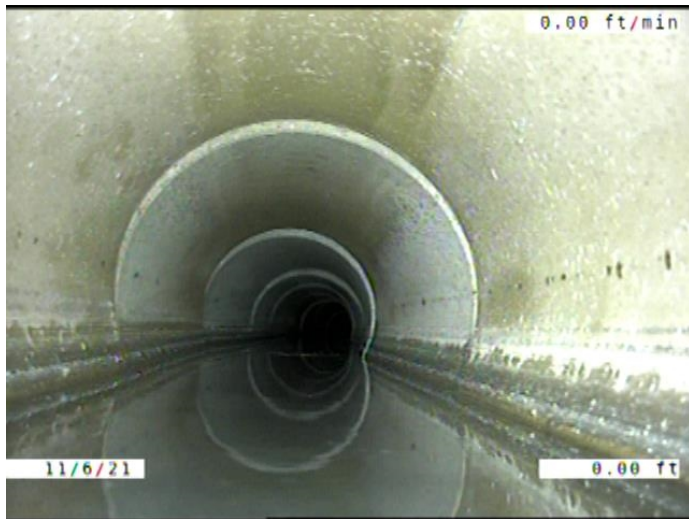
Code: **MWL**
 Description: **Miscellaneous Water Level**

Distance (ft): **.0**
 Structural Grade: **0**
 O&M Grade: **0**
 Clock Start/From:
 Clock To:
 1st Value:
 2nd Value:
 Value Percent: **10.000**
 Continuous Index:
 Within 8" of Joint: **NO**
 Remarks:

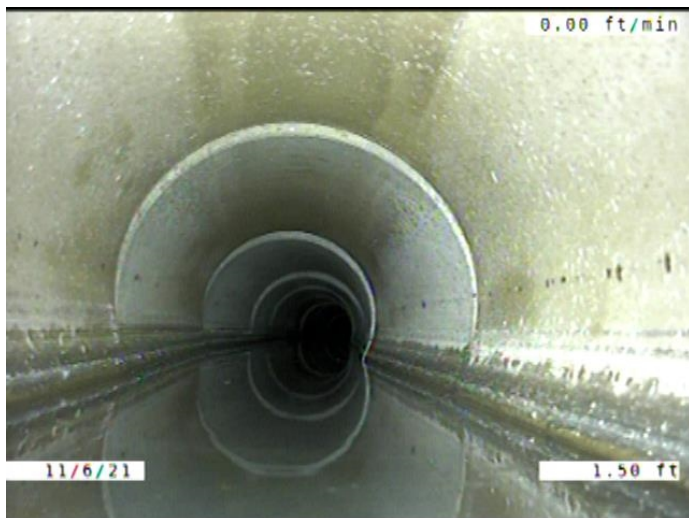
Code: **MGO**
 Description: **Miscellaneous General Observation**

Distance (ft): **1.5**
 Structural Grade: **0**
 O&M Grade: **0**
 Clock Start/From:
 Clock To:
 1st Value:
 2nd Value:
 Value Percent:
 Continuous Index:
 Within 8" of Joint: **NO**
 Remarks: **DROP INTO THE MANHOLE. HAD TO START IN THE PIPE.**

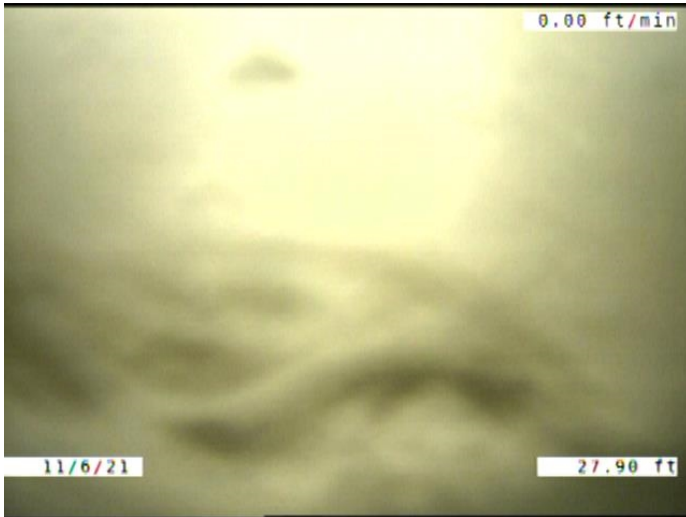
Code: **MWL**
 Description: **Miscellaneous Water Level**

Distance (ft): **27.9**
 Structural Grade: **0**
 O&M Grade: **0**
 Clock Start/From:
 Clock To:
 1st Value:
 2nd Value:
 Value Percent: **30.000**
 Continuous Index:
 Within 8" of Joint: **NO**
 Remarks:

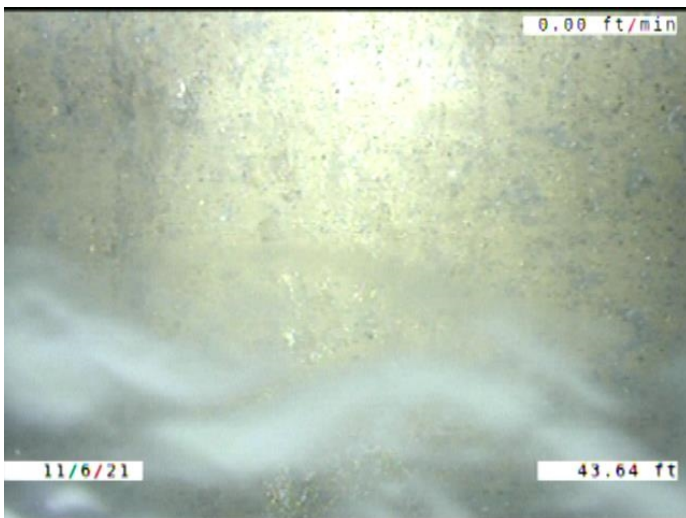
Code: **MCU**
Description: **Miscellaneous Camera Underwater**

Distance (ft): **43.6**
Structural Grade: **0**
O&M Grade: **4**
Clock Start/From:
Clock To:
1st Value:
2nd Value:
Value Percent:
Continuous Index:
Within 8" of Joint: **NO**
Remarks: **Out at 45**

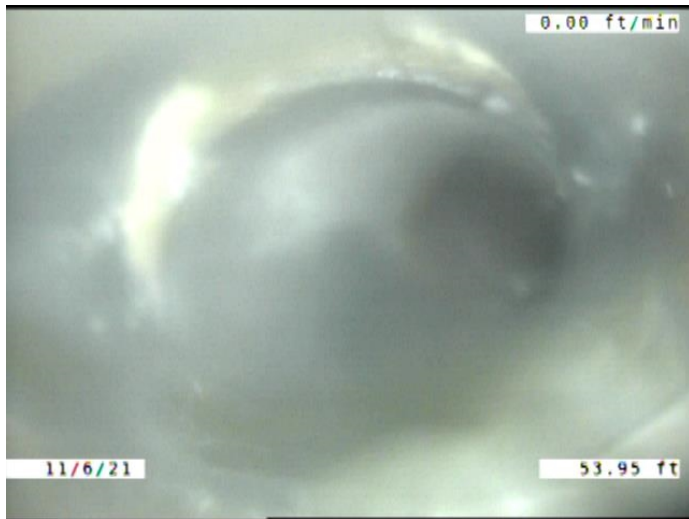
Code: **TF**
 Description: **Tap Factory**

Distance (ft): **54.0**
 Structural Grade: **0**
 O&M Grade: **0**
 Clock Start/From: **1**
 Clock To:
 1st Value: **4.000**
 2nd Value:
 Value Percent:
 Continuous Index:
 Within 8" of Joint: **YES**
 Remarks:

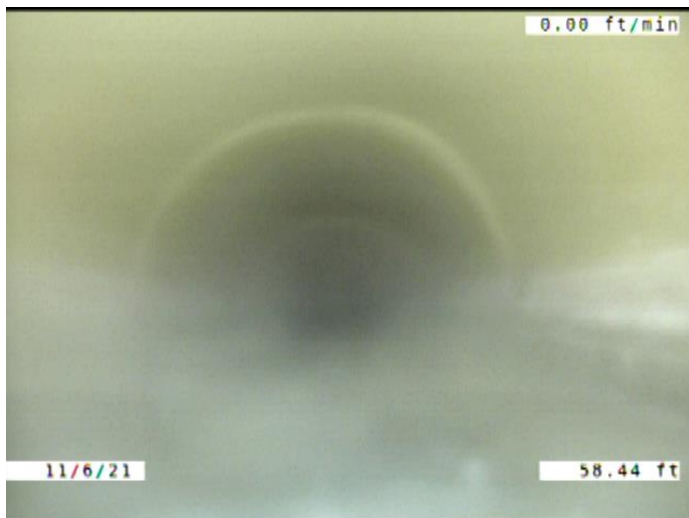
Code: **MWL**
 Description: **Miscellaneous Water Level**

Distance (ft): **58.4**
 Structural Grade: **0**
 O&M Grade: **0**
 Clock Start/From:
 Clock To:
 1st Value:
 2nd Value:
 Value Percent: **15.000**
 Continuous Index:
 Within 8" of Joint: **NO**
 Remarks:

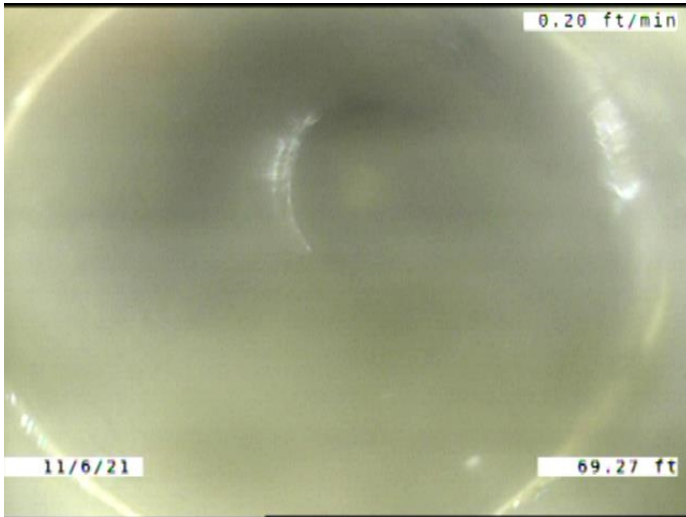
Code: **TB**
 Description: **Tap Break-in/Hammer**

Distance (ft): **69.3**
 Structural Grade: **0**
 O&M Grade: **0**
 Clock Start/From: **12**
 Clock To:
 1st Value: **4.000**
 2nd Value:
 Value Percent:
 Continuous Index:
 Within 8" of Joint: **YES**
 Remarks:

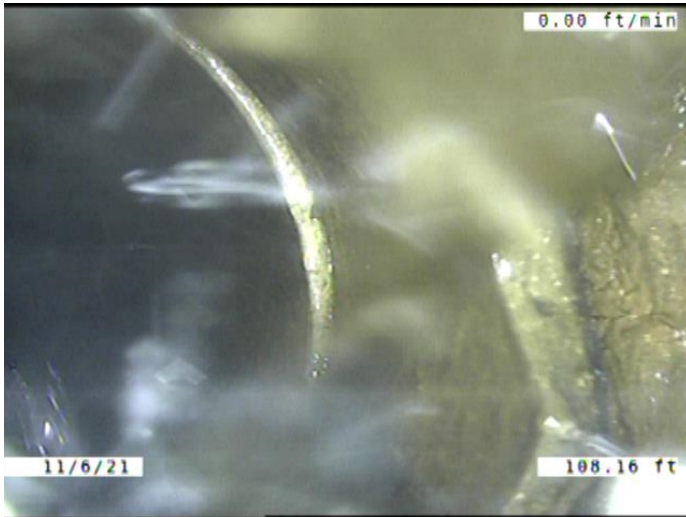
Code: **TBA**
 Description: **Tap Break-in Activity**

Distance (ft): **108.2**
 Structural Grade: **0**
 O&M Grade: **0**
 Clock Start/From: **12**
 Clock To:
 1st Value: **4.000**
 2nd Value:
 Value Percent:
 Continuous Index:
 Within 8" of Joint: **YES**
 Remarks:

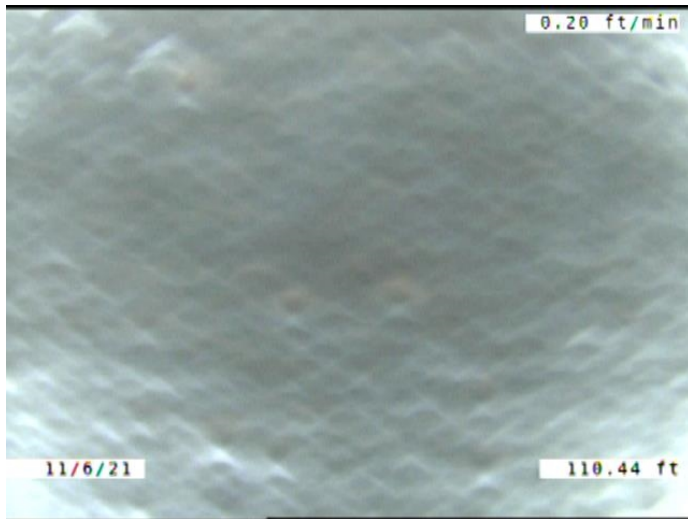
Code:	MCU
Description:	Miscellaneous Camera Underwater
Distance (ft):	110.4
Structural Grade:	0
O&M Grade:	4
Clock Start/From:	
Clock To:	
1st Value:	
2nd Value:	
Value Percent:	
Continuous Index:	
Within 8" of Joint:	NO
Remarks:	Out at 112.1

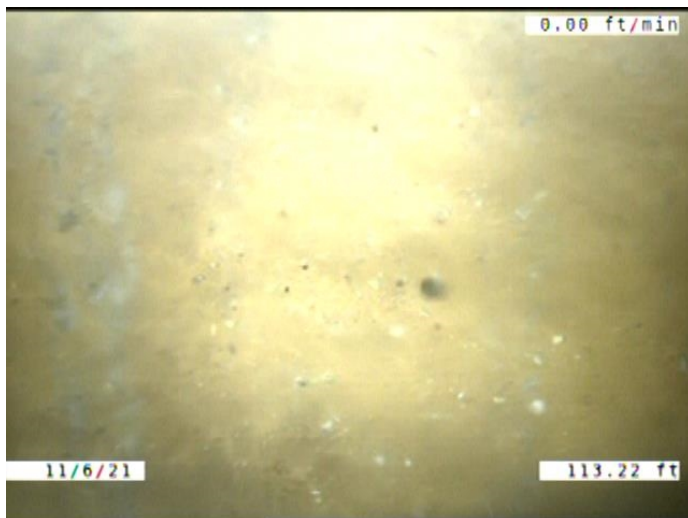
Code:	CL
Description:	Crack Longitudinal
Distance (ft):	113.2
Structural Grade:	2
O&M Grade:	0
Clock Start/From:	12
Clock To:	
1st Value:	
2nd Value:	
Value Percent:	
Continuous Index:	F03
Within 8" of Joint:	YES
Remarks:

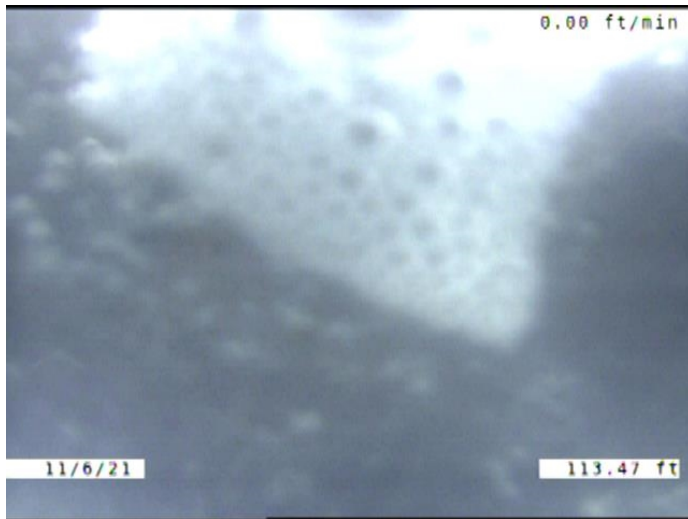
Code: **MCU**
Description: **Miscellaneous Camera Underwater**

Distance (ft): **113.5**
Structural Grade: **0**
O&M Grade: **4**
Clock Start/From:
Clock To:
1st Value:
2nd Value:
Value Percent:
Continuous Index: **S20**
Within 8" of Joint: **NO**
Remarks:

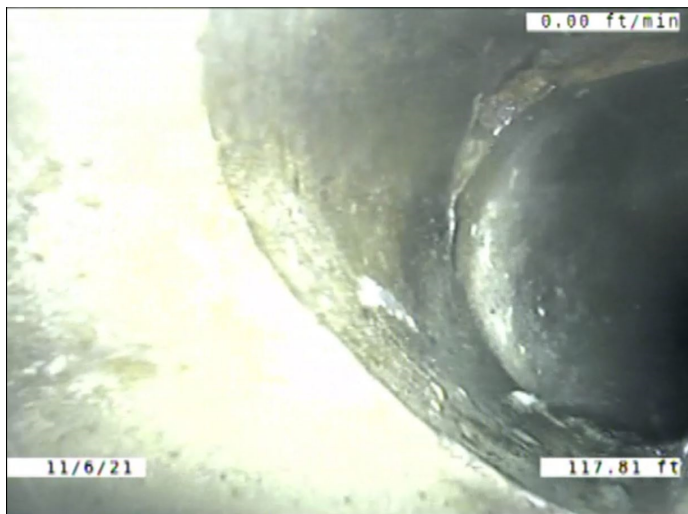
Code: **MCU**
Description: **Miscellaneous Camera Underwater**

Distance (ft): **117.8**
Structural Grade: **0**
O&M Grade: **4**
Clock Start/From:
Clock To:
1st Value:
2nd Value:
Value Percent:
Continuous Index: **F20**
Within 8" of Joint: **NO**
Remarks:

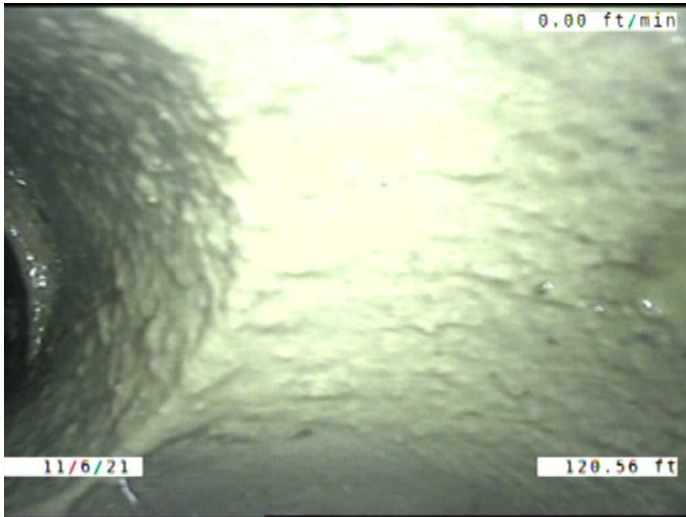
Code:	DAE
Description:	Deposits Attached Encrustation
Distance (ft):	120.6
Structural Grade:	0
O&M Grade:	2
Clock Start/From:	9
Clock To:	3
1st Value:	
2nd Value:	
Value Percent:	5.000
Continuous Index:	
Within 8" of Joint:	YES
Remarks:

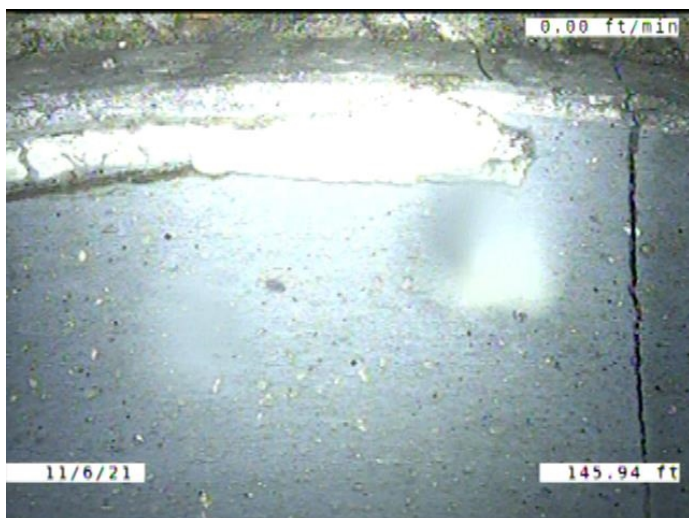
Code: **DAE**
 Description: **Deposits Attached Encrustation**

Distance (ft): **145.9**
 Structural Grade: **0**
 O&M Grade: **2**
 Clock Start/From: **9**
 Clock To: **11**
 1st Value:
 2nd Value:
 Value Percent: **5.000**
 Continuous Index:
 Within 8" of Joint: **YES**
 Remarks:

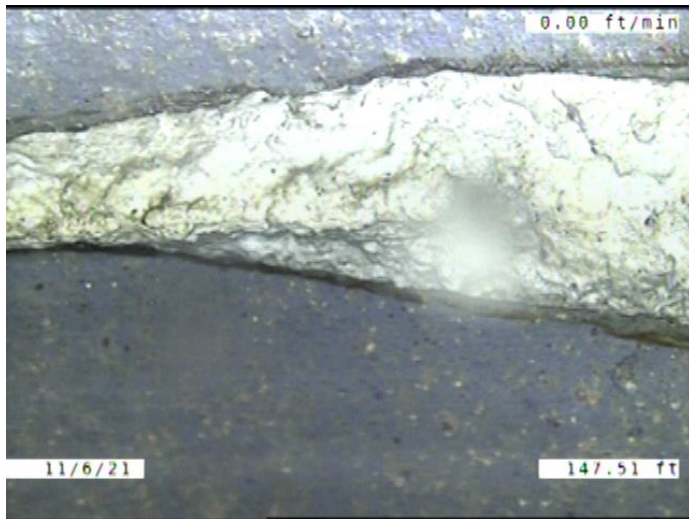
Code: **DAE**
 Description: **Deposits Attached Encrustation**

Distance (ft): **147.5**
 Structural Grade: **0**
 O&M Grade: **2**
 Clock Start/From: **12**
 Clock To: **4**
 1st Value:
 2nd Value:
 Value Percent: **5.000**
 Continuous Index:
 Within 8" of Joint: **NO**
 Remarks:

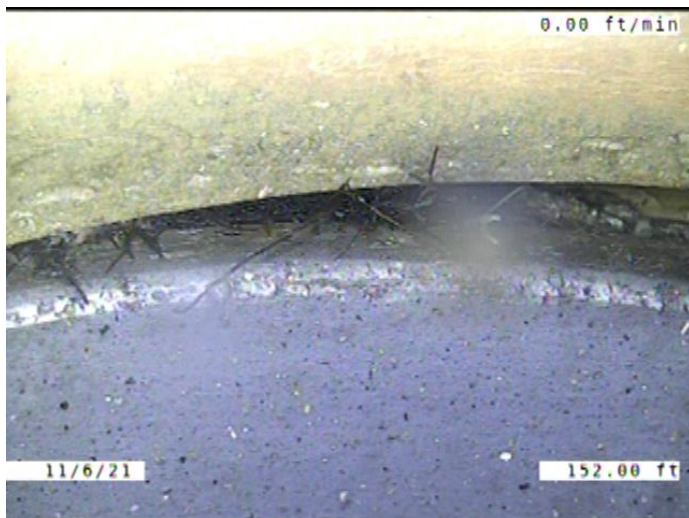
Code: **RFJ**
 Description: **Roots Fine Joint**

Distance (ft): **152.0**
 Structural Grade: **0**
 O&M Grade: **1**
 Clock Start/From: **9**
 Clock To: **10**
 1st Value:
 2nd Value:
 Value Percent:
 Continuous Index:
 Within 8" of Joint: **YES**
 Remarks:

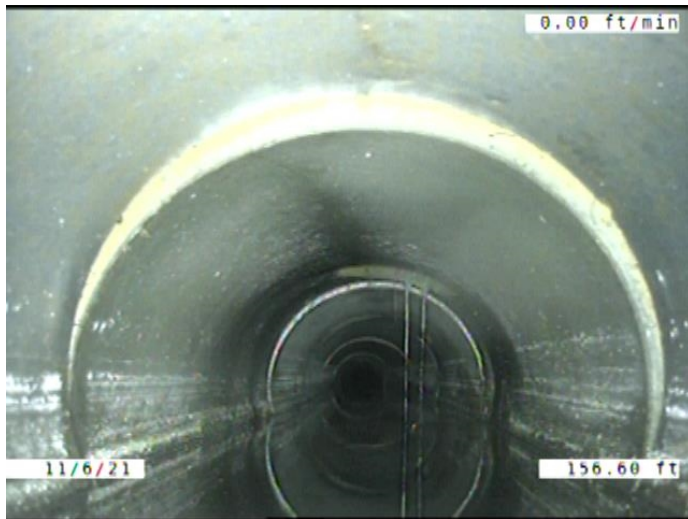
Code: **MWLS**
Description: **Miscellaneous Water Level Sag**

Distance (ft): **156.6**
Structural Grade: **2**
O&M Grade: **0**
Clock Start/From:
Clock To:
1st Value:
2nd Value:
Value Percent: **20.000**
Continuous Index: **S05**
Within 8" of Joint: **NO**
Remarks:

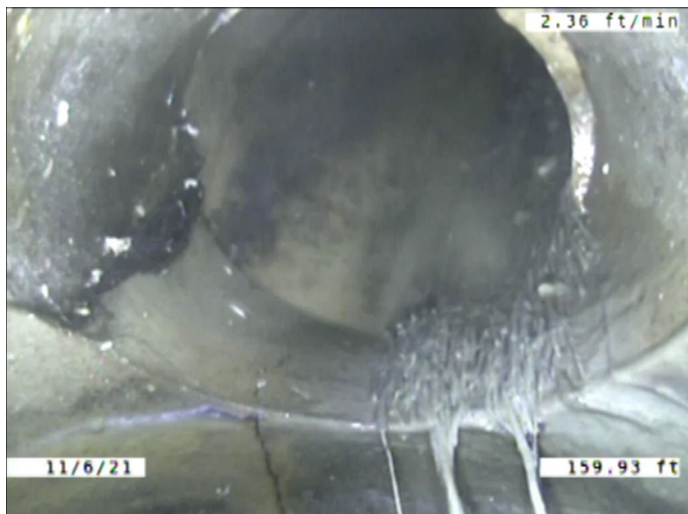
Code: **RFL**
Description: **Roots Fine Lateral**

Distance (ft): **159.9**
Structural Grade: **0**
O&M Grade: **1**
Clock Start/From: **1**
Clock To:
1st Value:
2nd Value:
Value Percent:
Continuous Index:
Within 8" of Joint: **NO**
Remarks:

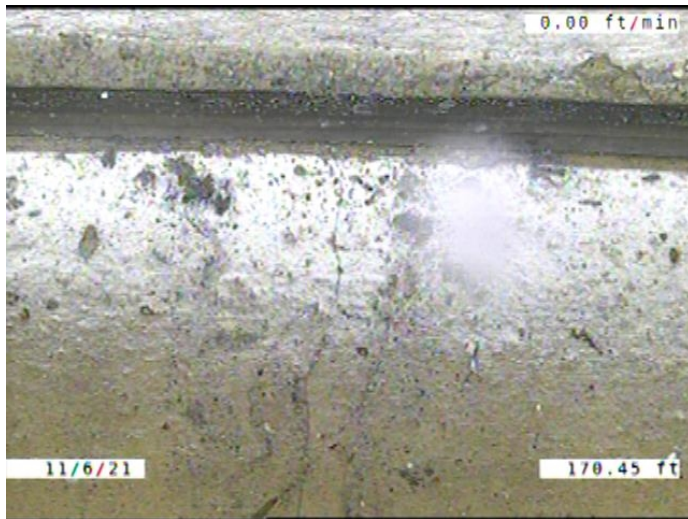
Code: **CL**
 Description: **Crack Longitudinal**

Distance (ft): **170.4**
 Structural Grade: **2**
 O&M Grade: **0**
 Clock Start/From: **12**
 Clock To:
 1st Value:
 2nd Value:
 Value Percent:
 Continuous Index:
 Within 8" of Joint: **YES**
 Remarks:

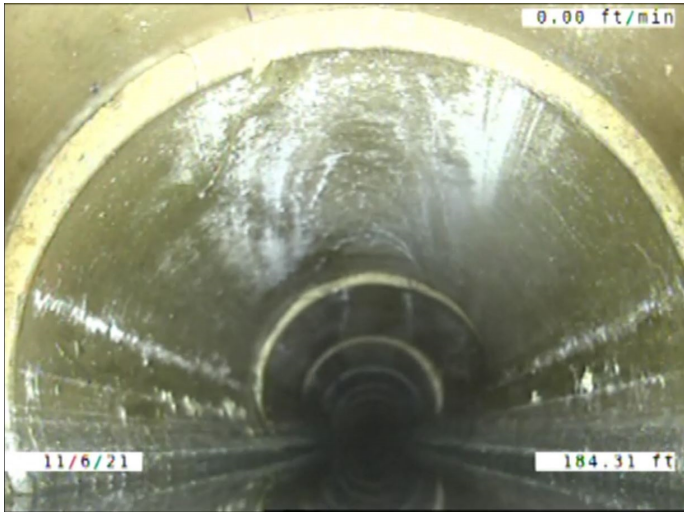
Code: **FM**
Description: **Fracture Multiple**

Distance (ft): **184.3**
Structural Grade: **4**
O&M Grade: **0**
Clock Start/From: **8**
Clock To: **4**
1st Value:
2nd Value:
Value Percent:
Continuous Index: **S21**
Within 8" of Joint: **YES**
Remarks:

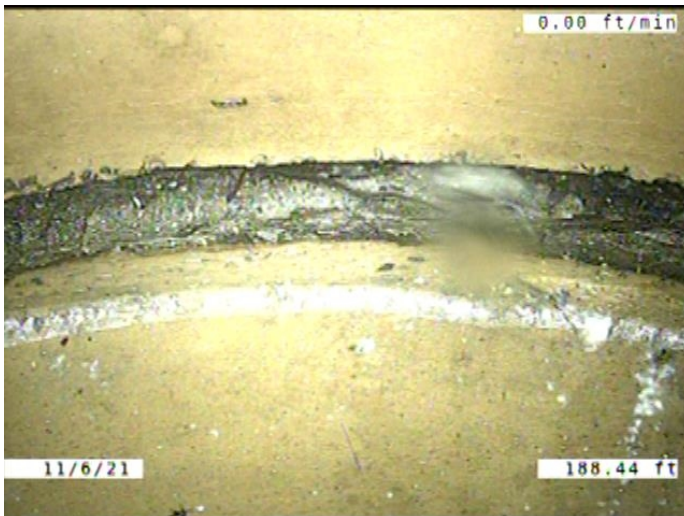
Code: **RFJ**
Description: **Roots Fine Joint**

Distance (ft): **188.4**
Structural Grade: **0**
O&M Grade: **1**
Clock Start/From: **9**
Clock To: **2**
1st Value:
2nd Value:
Value Percent:
Continuous Index:
Within 8" of Joint: **YES**
Remarks:

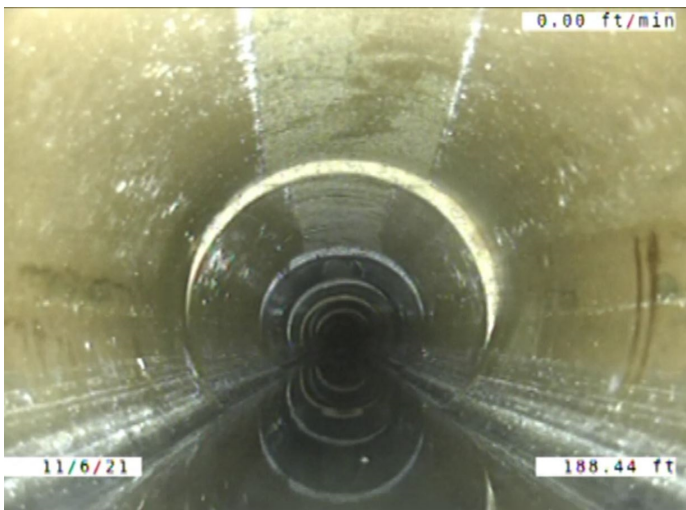
Code: **IS**
 Description: **Infiltration Stain**

Distance (ft): **188.4**
 Structural Grade: **0**
 O&M Grade: **1**
 Clock Start/From: **2**
 Clock To: **4**
 1st Value:
 2nd Value:
 Value Percent:
 Continuous Index:
 Within 8" of Joint: **NO**
 Remarks:

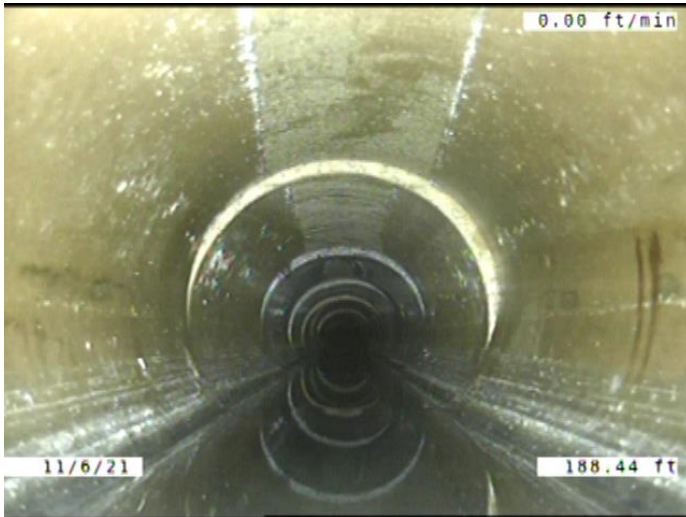
Code: **ISB**
Description: **Infiltration Stain Barrel**

Distance (ft): **188.4**
Structural Grade: **0**
O&M Grade: **1**
Clock Start/From: **8**
Clock To: **9**
1st Value:
2nd Value:
Value Percent:
Continuous Index:
Within 8" of Joint: **NO**
Remarks:

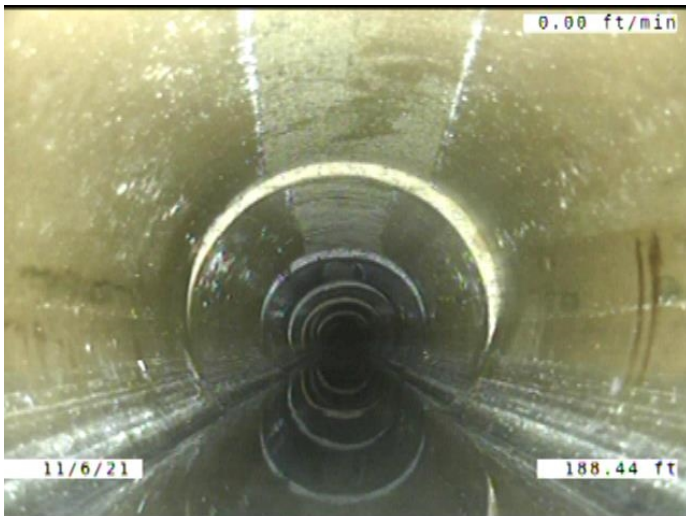
Code: **MWLS**
Description: **Miscellaneous Water Level Sag**

Distance (ft): **188.4**
Structural Grade: **2**
O&M Grade: **0**
Clock Start/From:
Clock To:
1st Value:
2nd Value:
Value Percent: **20.000**
Continuous Index: **F05**
Within 8" of Joint: **NO**
Remarks:

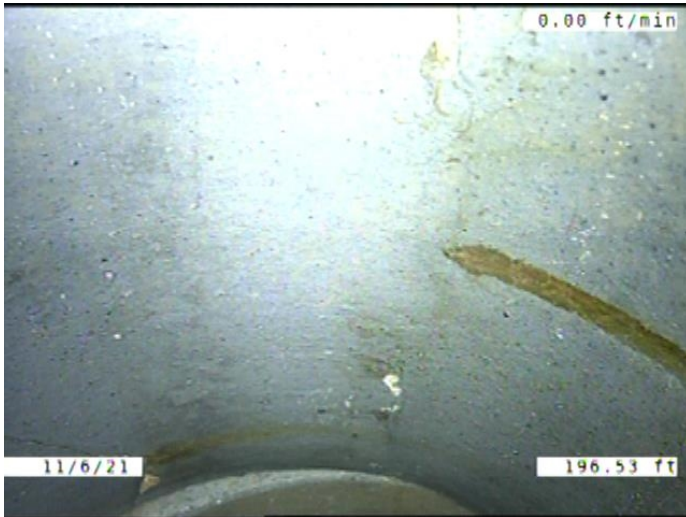
Code: **ISB**
Description: **Infiltration Stain Barrel**

Distance (ft): **196.5**
Structural Grade: **0**
O&M Grade: **1**
Clock Start/From: **8**
Clock To: **10**
1st Value:
2nd Value:
Value Percent:
Continuous Index:
Within 8" of Joint: **NO**
Remarks:

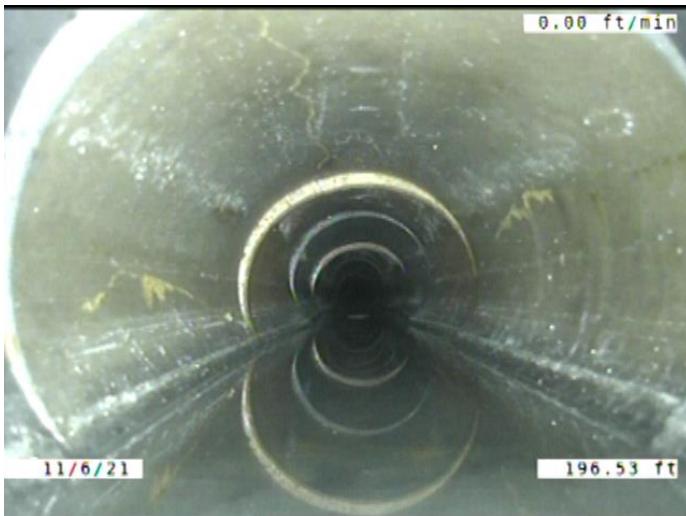
Code: **ISB**
Description: **Infiltration Stain Barrel**

Distance (ft): **196.5**
Structural Grade: **0**
O&M Grade: **1**
Clock Start/From: **1**
Clock To: **4**
1st Value:
2nd Value:
Value Percent:
Continuous Index:
Within 8" of Joint: **YES**
Remarks:

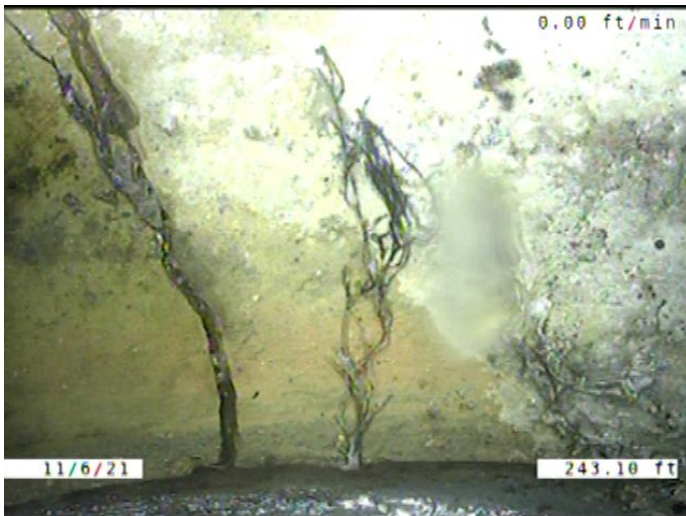
Code: **DAE**
 Description: **Deposits Attached Encrustation**

Distance (ft): **243.1**
 Structural Grade: **0**
 O&M Grade: **2**
 Clock Start/From: **8**
 Clock To: **4**
 1st Value:
 2nd Value:
 Value Percent: **5.000**
 Continuous Index:
 Within 8" of Joint: **YES**
 Remarks:

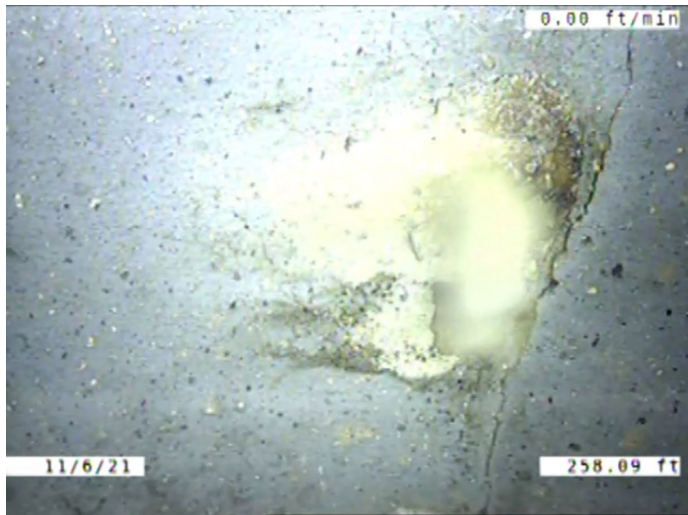
Code: **RFJ**
 Description: **Roots Fine Joint**

Distance (ft): **243.1**
 Structural Grade: **0**
 O&M Grade: **1**
 Clock Start/From: **9**
 Clock To:
 1st Value:
 2nd Value:
 Value Percent:
 Continuous Index:
 Within 8" of Joint: **YES**
 Remarks:

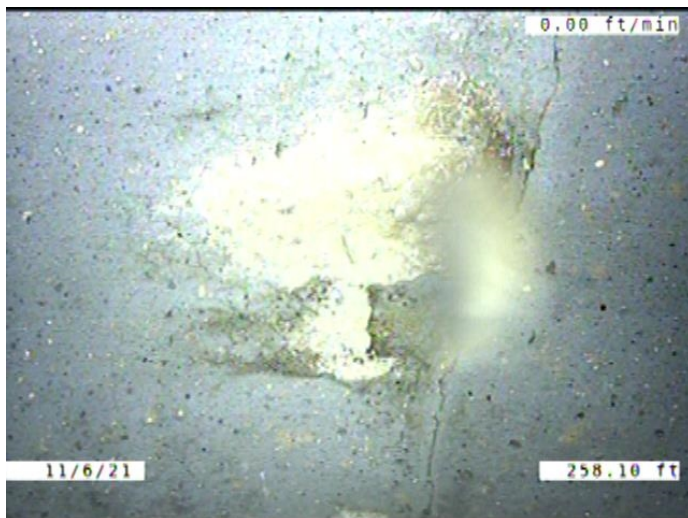
Code: **CL**
 Description: **Crack Longitudinal**

Distance (ft): **258.1**
 Structural Grade: **2**
 O&M Grade: **0**
 Clock Start/From: **11**
 Clock To:
 1st Value:
 2nd Value:
 Value Percent:
 Continuous Index:
 Within 8" of Joint: **YES**
 Remarks:

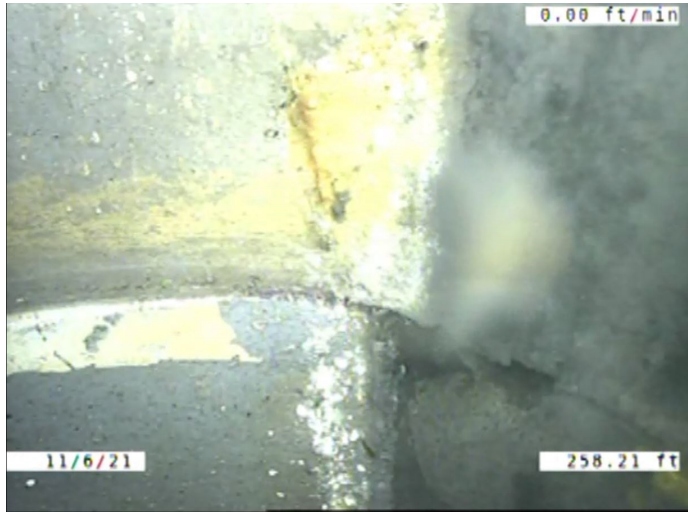
Code: **DAE**
 Description: **Deposits Attached Encrustation**

Distance (ft): **258.1**
 Structural Grade: **0**
 O&M Grade: **2**
 Clock Start/From: **11**
 Clock To:
 1st Value:
 2nd Value:
 Value Percent: **5.000**
 Continuous Index:
 Within 8" of Joint: **YES**
 Remarks:

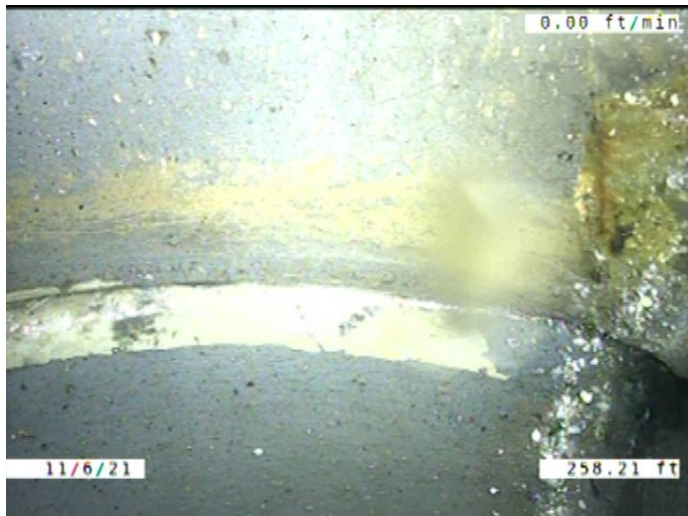
Code: **CL**
Description: **Crack Longitudinal**

Distance (ft): **258.2**
Structural Grade: **2**
O&M Grade: **0**
Clock Start/From: **4**
Clock To:
1st Value:
2nd Value:
Value Percent:
Continuous Index:
Within 8" of Joint: **YES**
Remarks:

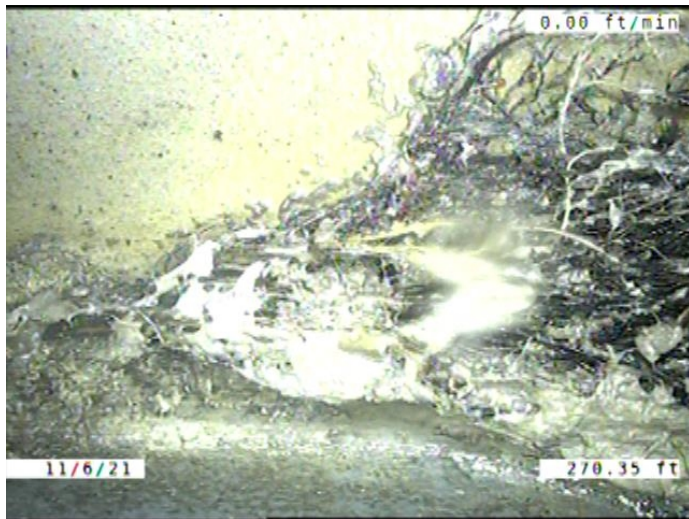
Code:	TFD
Description:	Tap Factory Defective
Distance (ft):	269.4
Structural Grade:	0
O&M Grade:	3
Clock Start/From:	11
Clock To:	
1st Value:	4.000
2nd Value:	
Value Percent:	
Continuous Index:	
Within 8" of Joint:	YES
Remarks:	OFFSET. ROOTS GROWING FROM THE JOINT. ENCUSTATION COMING

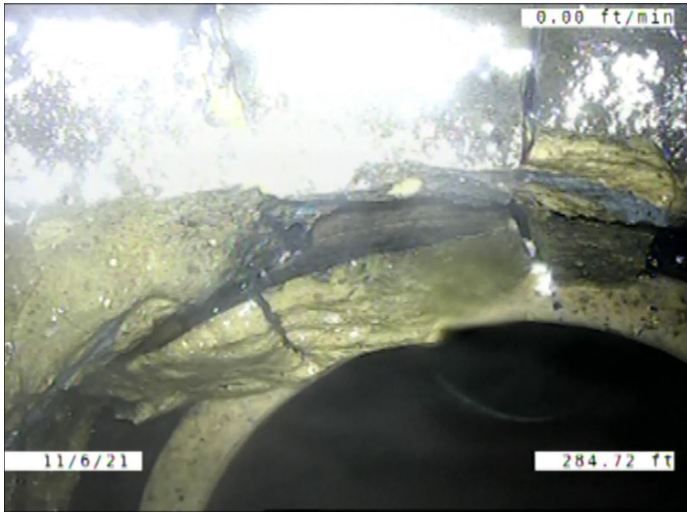
Code: **FL**
Description: **Fracture Longitudinal**

Distance (ft): **283.8**
Structural Grade: **3**
O&M Grade: **0**
Clock Start/From: **12**
Clock To:
1st Value:
2nd Value:
Value Percent:
Continuous Index:
Within 8" of Joint: **NO**
Remarks:

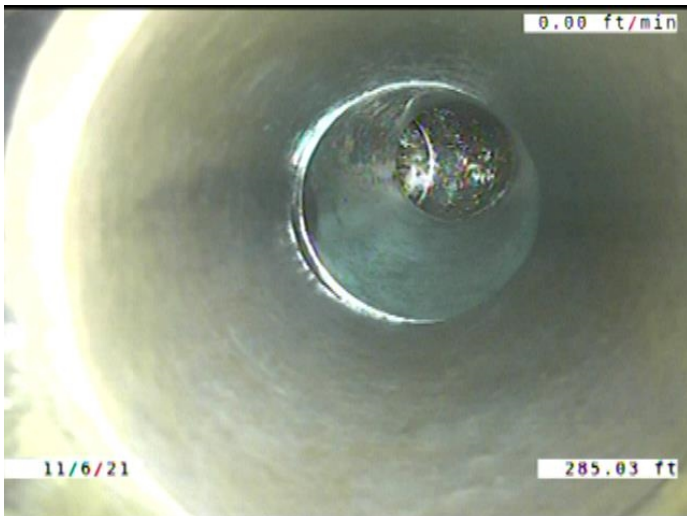
Code: **B**
Description: **Broken**

Distance (ft): **284.7**
Structural Grade: **4**
O&M Grade: **0**
Clock Start/From: **12**
Clock To:
1st Value:
2nd Value:
Value Percent:
Continuous Index:
Within 8" of Joint: **NO**
Remarks:

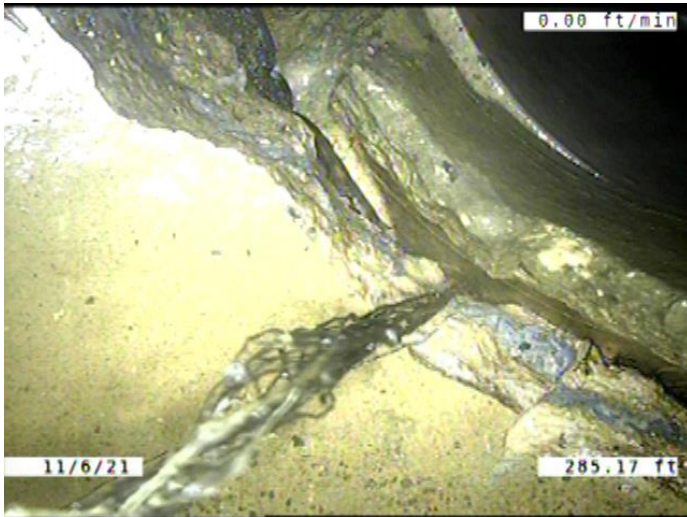
Code: **TBI**
Description: **Tap Break-in Intruding**

Distance (ft): **285.0**
Structural Grade: **0**
O&M Grade: **2**
Clock Start/From: **12**
Clock To:
1st Value: **4.000**
2nd Value: **1.000**
Value Percent:
Continuous Index:
Within 8" of Joint: **YES**
Remarks: **CONSTANTLY RUNNING WATER.**

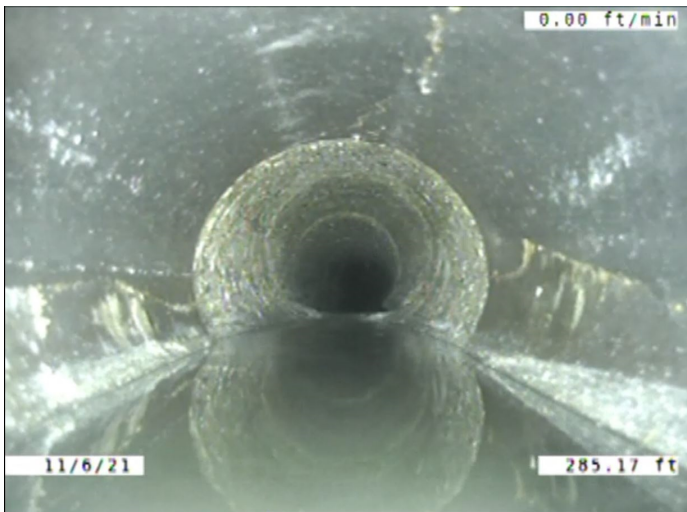
Code: **RFC**
 Description: **Roots Fine Connection**

Distance (ft): **285.2**
 Structural Grade: **0**
 O&M Grade: **1**
 Clock Start/From: **11**
 Clock To:
 1st Value:
 2nd Value:
 Value Percent:
 Continuous Index:
 Within 8" of Joint: **NO**
 Remarks:

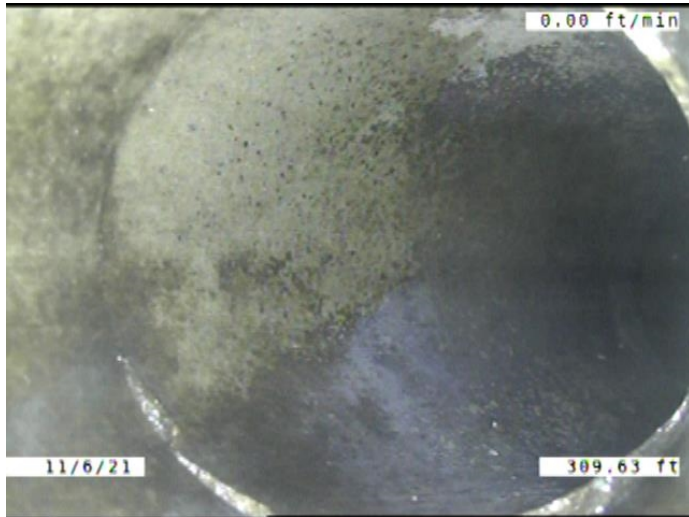
Code: **DAE**
Description: **Deposits Attached Encrustation**

Distance (ft): **303.6**
Structural Grade: **0**
O&M Grade: **2**
Clock Start/From: **7**
Clock To: **8**
1st Value:
2nd Value:
Value Percent: **5.000**
Continuous Index:
Within 8" of Joint: **YES**
Remarks:

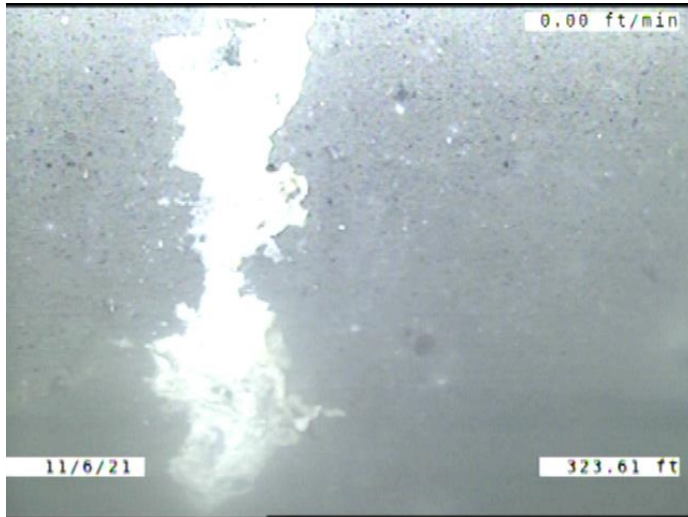
Code: **DAE**
 Description: **Deposits Attached Encrustation**

Distance (ft): **322.5**
 Structural Grade: **0**
 O&M Grade: **2**
 Clock Start/From: **1**
 Clock To:
 1st Value:
 2nd Value:
 Value Percent: **5.000**
 Continuous Index:
 Within 8" of Joint: **YES**
 Remarks:

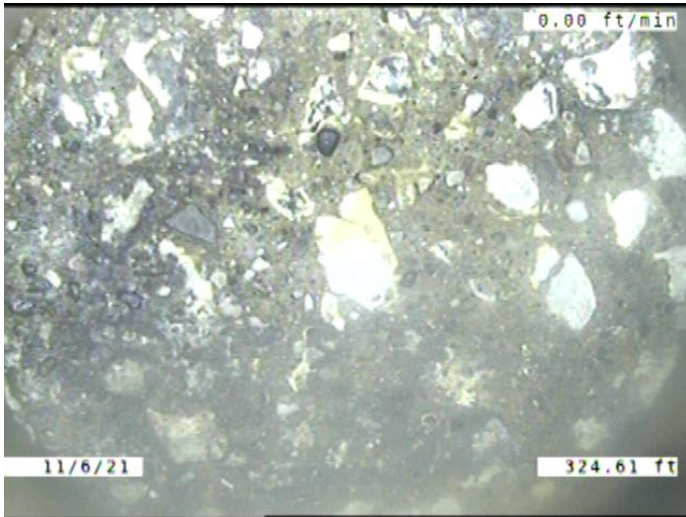
Code: **SSS**
Description: **Surface Damage Surface Spalling**

Distance (ft): **324.3**
Structural Grade: **2**
O&M Grade: **0**
Clock Start/From: **10**
Clock To: **12**
1st Value:
2nd Value:
Value Percent:
Continuous Index:
Within 8" of Joint: **YES**
Remarks:

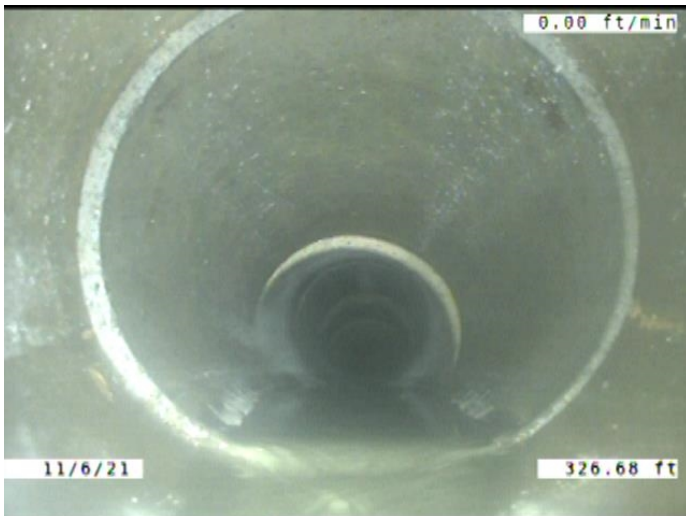
Code: **TBI**
Description: **Tap Break-in Intruding**

Distance (ft): **324.6**
Structural Grade: **0**
O&M Grade: **2**
Clock Start/From: **11**
Clock To:
1st Value: **6.000**
2nd Value: **2.000**
Value Percent:
Continuous Index:
Within 8" of Joint: **YES**
Remarks:

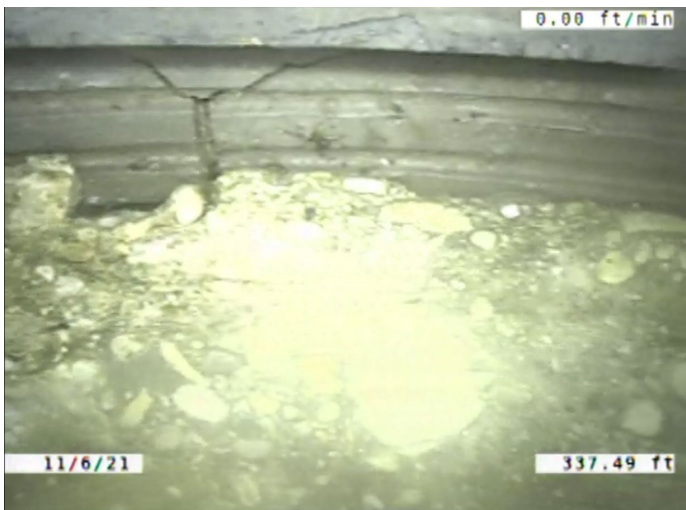
Code: **MWLS**
 Description: **Miscellaneous Water Level Sag**

Distance (ft): **336.6**
 Structural Grade: **2**
 O&M Grade: **0**
 Clock Start/From:
 Clock To:
 1st Value:
 2nd Value:
 Value Percent: **20.000**
 Continuous Index: **S12**
 Within 8" of Joint: **NO**
 Remarks:

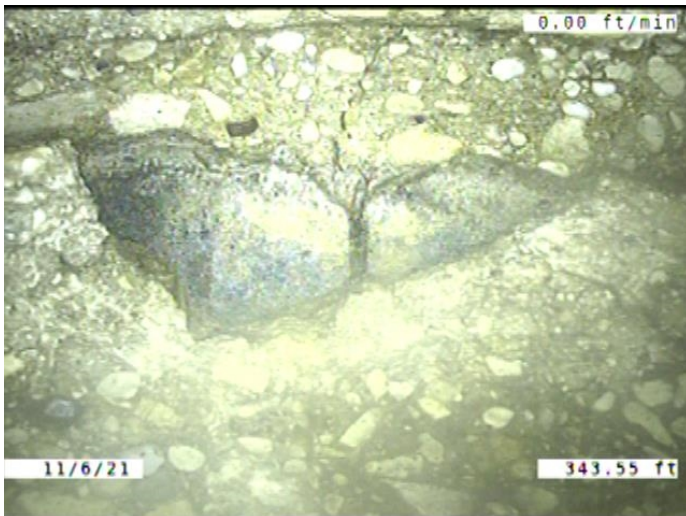
Code: **TBD**
 Description: **Tap Break-in/Hammer Defective**

Distance (ft): **339.4**
 Structural Grade: **0**
 O&M Grade: **3**
 Clock Start/From: **12**
 Clock To:
 1st Value: **4.000**
 2nd Value:
 Value Percent:
 Continuous Index:
 Within 8" of Joint: **YES**
 Remarks: **Defective**

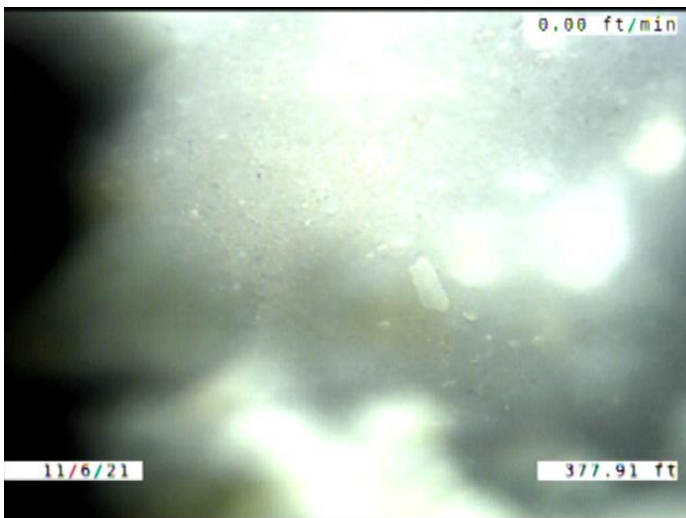
Code: **MMC**
Description: **Miscellaneous Material Change**

Distance (ft): **374.1**
Structural Grade: **0**
O&M Grade: **0**
Clock Start/From:
Clock To:
1st Value:
2nd Value:
Value Percent:
Continuous Index:
Within 8" of Joint: **NO**
Remarks: **CONCRETE TO VCP**

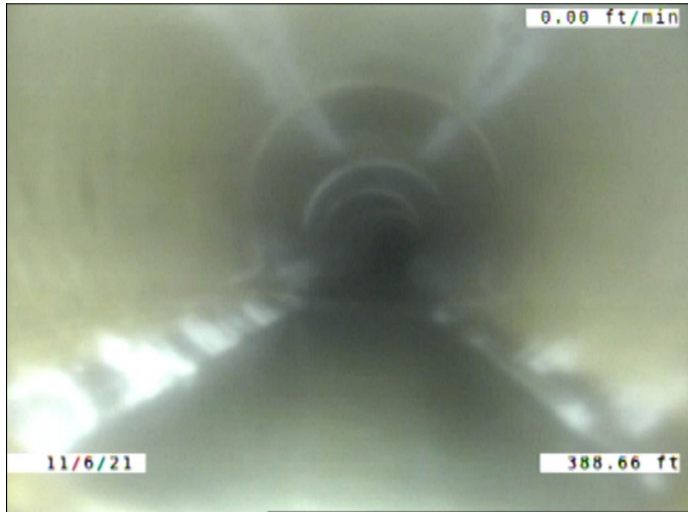
Code: **MCU**
Description: **Miscellaneous Camera Underwater**

Distance (ft): **377.9**
Structural Grade: **0**
O&M Grade: **4**
Clock Start/From:
Clock To:
1st Value:
2nd Value:
Value Percent:
Continuous Index: **S25**
Within 8" of Joint: **NO**
Remarks:

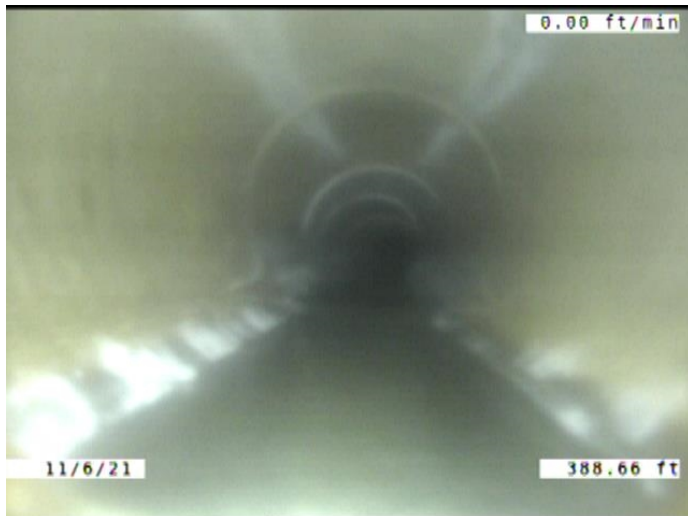
Code: **MCU**
Description: **Miscellaneous Camera Underwater**

Distance (ft): **388.7**
Structural Grade: **0**
O&M Grade: **4**
Clock Start/From:
Clock To:
1st Value:
2nd Value:
Value Percent:
Continuous Index: **F25**
Within 8" of Joint: **NO**
Remarks:

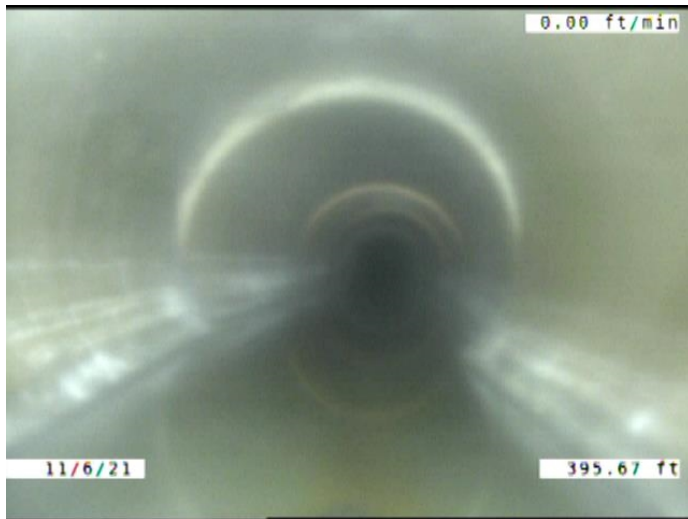
Code: **MWLS**
Description: **Miscellaneous Water Level Sag**

Distance (ft): **388.7**
Structural Grade: **3**
O&M Grade: **0**
Clock Start/From:
Clock To:
1st Value:
2nd Value:
Value Percent: **35.000**
Continuous Index: **F13**
Within 8" of Joint: **NO**
Remarks:

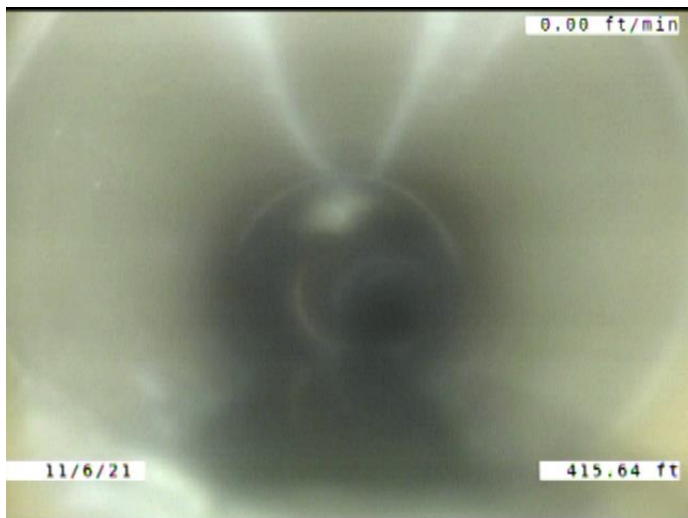
Code: **MWLS**
Description: **Miscellaneous Water Level Sag**

Distance (ft): **395.7**
Structural Grade: **2**
O&M Grade: **0**
Clock Start/From:
Clock To:
1st Value:
2nd Value:
Value Percent: **15.000**
Continuous Index: **S15**
Within 8" of Joint: **NO**
Remarks:

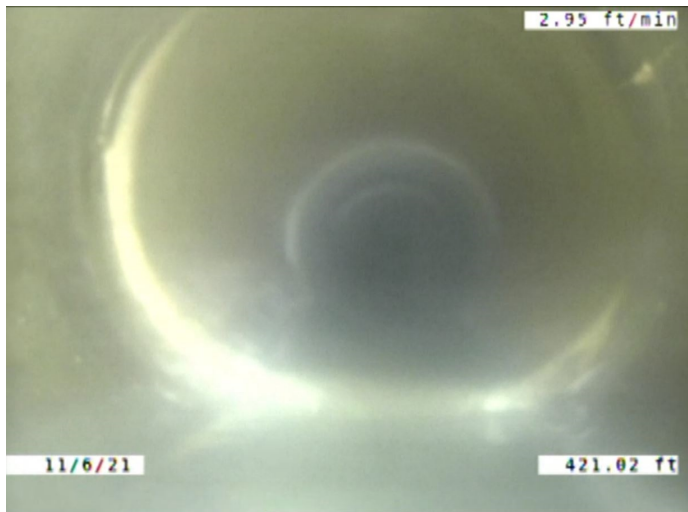
Code: **TBI**
 Description: **Tap Break-in Intruding**

Distance (ft): **420.9**
 Structural Grade: **0**
 O&M Grade: **2**
 Clock Start/From: **11**
 Clock To:
 1st Value: **4.000**
 2nd Value: **3.000**
 Value Percent:
 Continuous Index:
 Within 8" of Joint: **YES**
 Remarks: **BROKEN. CONSTANTLY DRIPPING WATER.**

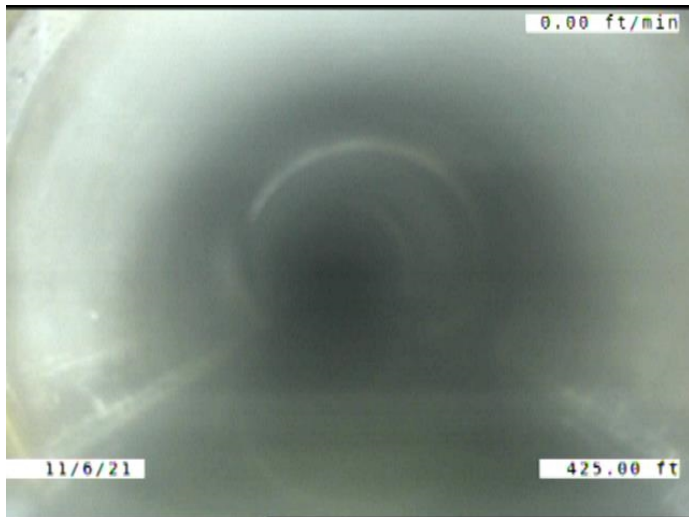
Code: **B**
 Description: **Broken**

Distance (ft): **421.0**
 Structural Grade: **4**
 O&M Grade: **0**
 Clock Start/From: **10**
 Clock To: **11**
 1st Value:
 2nd Value:
 Value Percent:
 Continuous Index:
 Within 8" of Joint: **YES**
 Remarks:

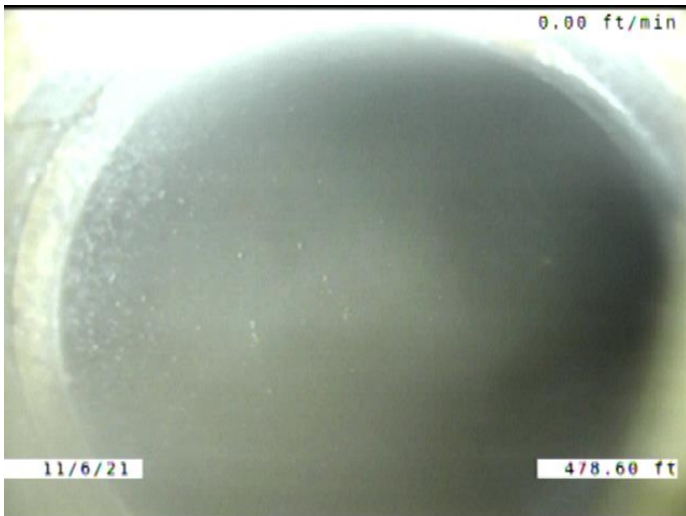
Code: **SMW**
Description: **Surface Damage Missing Wall**

Distance (ft): **478.3**
Structural Grade: **5**
O&M Grade: **0**
Clock Start/From: **1**
Clock To: **2**
1st Value:
2nd Value:
Value Percent:
Continuous Index:
Within 8" of Joint: **NO**
Remarks:

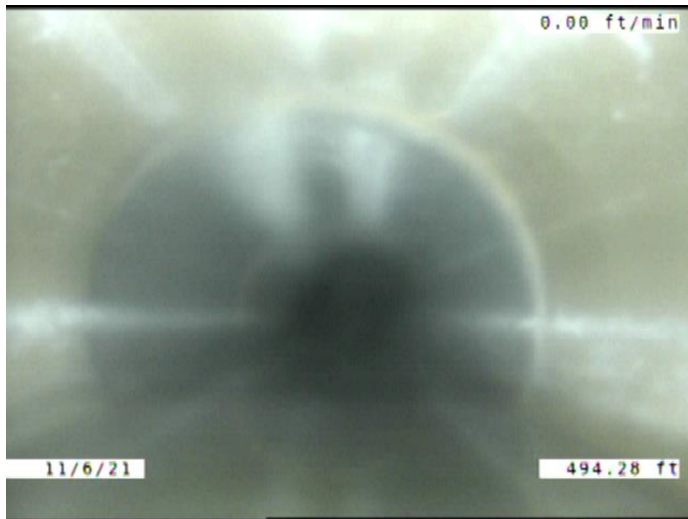
Code: **MWLS**
Description: **Miscellaneous Water Level Sag**

Distance (ft): **494.3**
Structural Grade: **2**
O&M Grade: **0**
Clock Start/From:
Clock To:
1st Value:
2nd Value:
Value Percent: **15.000**
Continuous Index: **F16**
Within 8" of Joint: **NO**
Remarks:

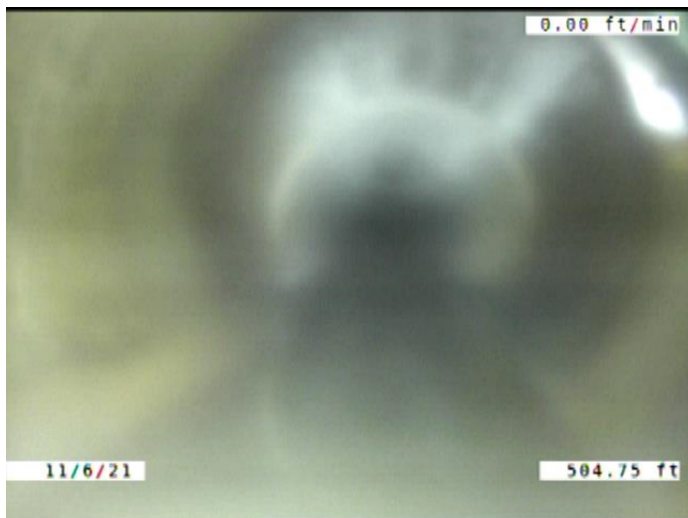
Code: **MWLS**
Description: **Miscellaneous Water Level Sag**

Distance (ft): **504.8**
Structural Grade: **2**
O&M Grade: **0**
Clock Start/From:
Clock To:
1st Value:
2nd Value:
Value Percent: **10.000**
Continuous Index: **F17**
Within 8" of Joint: **NO**
Remarks:
