RedZone
ROBOTICS

Street:	North Wabash Street		Flow Control:	Not Controlled	
City:	Hobart, IN		Year Renewed:		
Location:	Alley		Tape/Media #:		
Purpose:	Routine Assessment		Dia/Height:	12"	
Use:	Sanitary Sewage Pipe		Material:	VCP	
Drain Area:			Lining:	None	
Category:	NA				
Comment:					
Location Details:			Direction of Survey:	Upstream	
US MH:	M-404-006	DS MH:	M-404-005	Total Length Surveyed (ft):	658.6

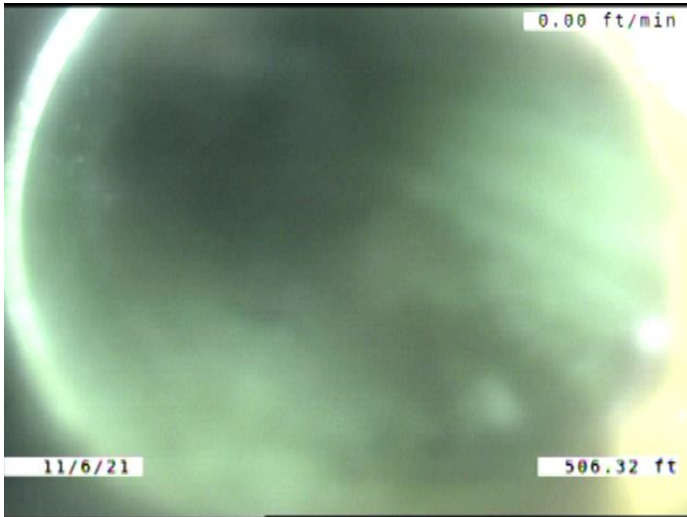
Code: **TB**
Description: **Tap Break-in/Hammer**

Distance (ft): **506.3**
Structural Grade: **0**
O&M Grade: **0**
Clock Start/From: **2**
Clock To:
1st Value: **4.000**
2nd Value:
Value Percent:
Continuous Index:
Within 8" of Joint: **YES**
Remarks:

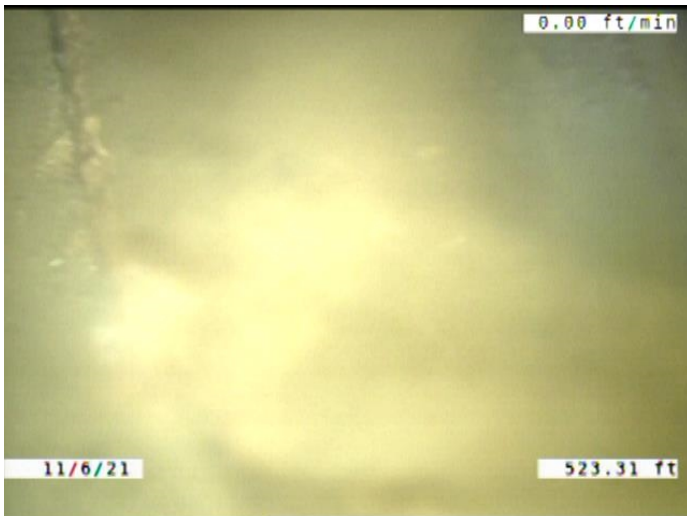
Code: **B**
Description: **Broken**

Distance (ft): **523.3**
Structural Grade: **4**
O&M Grade: **0**
Clock Start/From: **5**
Clock To: **8**
1st Value:
2nd Value:
Value Percent:
Continuous Index:
Within 8" of Joint: **YES**
Remarks:

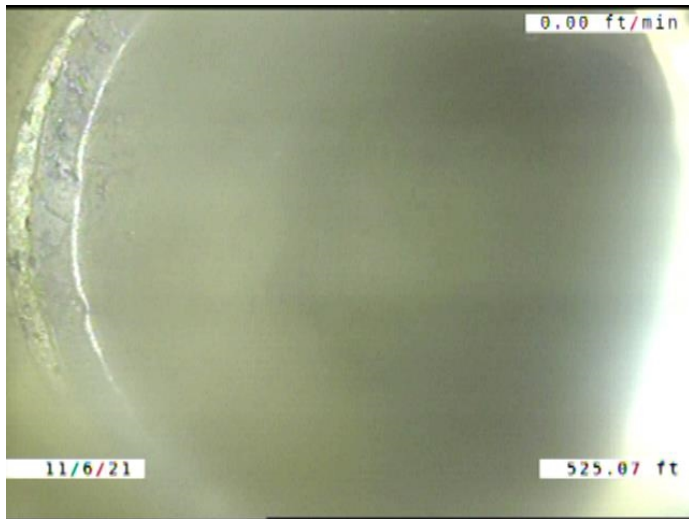
Code: **TBI**
Description: **Tap Break-in Intruding**

Distance (ft): **525.1**
Structural Grade: **0**
O&M Grade: **2**
Clock Start/From: **1**
Clock To:
1st Value: **4.000**
2nd Value: **2.000**
Value Percent:
Continuous Index:
Within 8" of Joint: **YES**
Remarks:

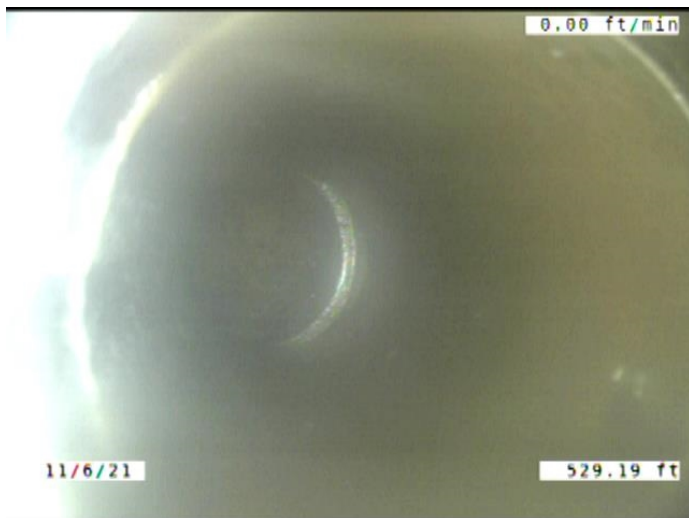
Code: **TBI**
Description: **Tap Break-in Intruding**

Distance (ft): **529.2**
Structural Grade: **0**
O&M Grade: **2**
Clock Start/From: **12**
Clock To:
1st Value: **4.000**
2nd Value: **1.000**
Value Percent:
Continuous Index:
Within 8" of Joint: **YES**
Remarks: **CONSTANTLY RUNNING WATER.**

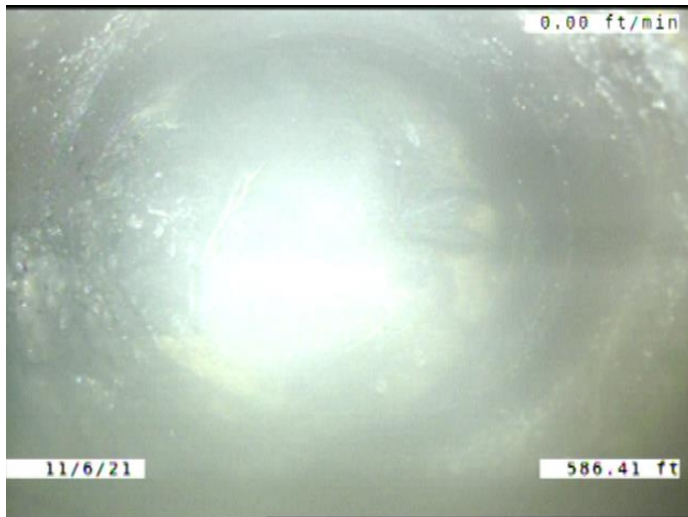
Code:	TFD
Description:	Tap Factory Defective
Distance (ft):	586.4
Structural Grade:	0
O&M Grade:	3
Clock Start/From:	11
Clock To:	
1st Value:	4.000
2nd Value:	
Value Percent:	
Continuous Index:	
Within 8" of Joint:	YES
Remarks:	ROOT AND SOIL VISIBLE. CAP BROKEN OR MISSING

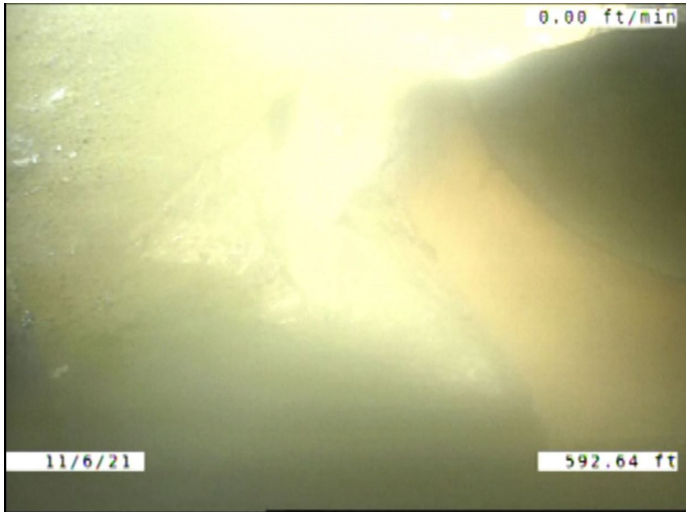
Code: **SSS**
Description: **Surface Damage Surface Spalling**

Distance (ft): **592.6**
Structural Grade: **2**
O&M Grade: **0**
Clock Start/From: **11**
Clock To: **1**
1st Value:
2nd Value:
Value Percent:
Continuous Index:
Within 8" of Joint: **NO**
Remarks:

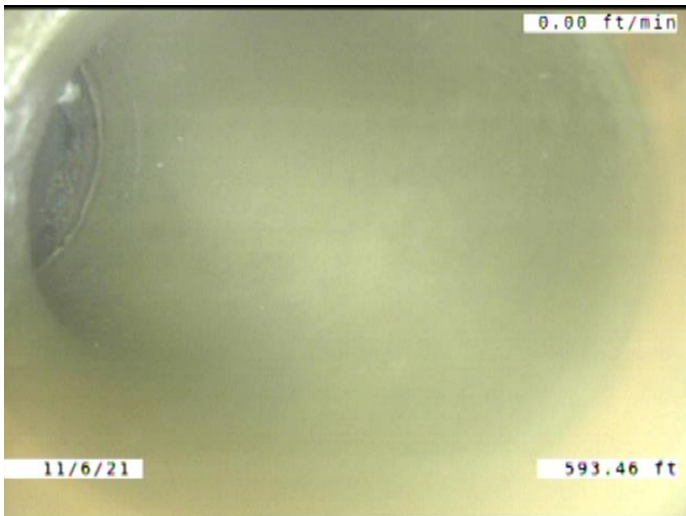
Code: **TBI**
Description: **Tap Break-in Intruding**

Distance (ft): **593.5**
Structural Grade: **0**
O&M Grade: **2**
Clock Start/From: **11**
Clock To:
1st Value: **4.000**
2nd Value: **1.000**
Value Percent:
Continuous Index:
Within 8" of Joint: **YES**
Remarks: **CONSTANTLY DRIPPING WATER.**

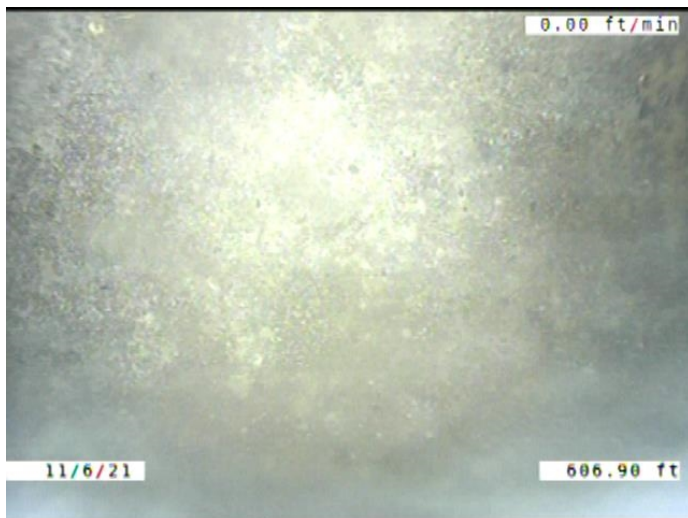
Code: **MCU**
Description: **Miscellaneous Camera Underwater**

Distance (ft): **606.9**
Structural Grade: **0**
O&M Grade: **4**
Clock Start/From:
Clock To:
1st Value:
2nd Value:
Value Percent:
Continuous Index:
Within 8" of Joint: **NO**
Remarks: **Out at 608.7**

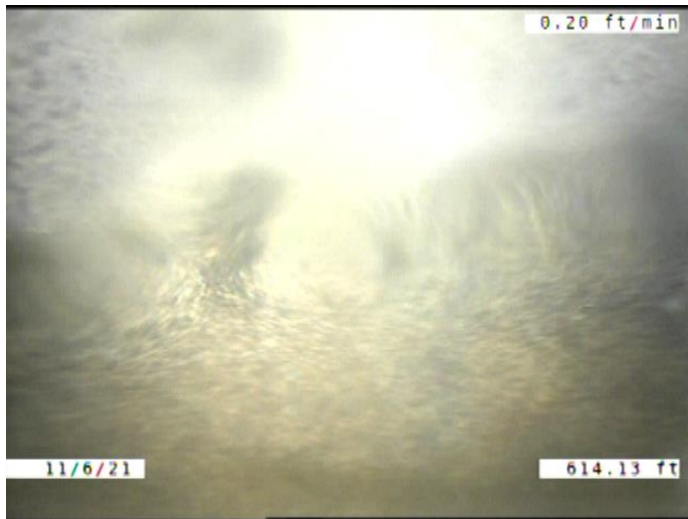
Code:	MCU
Description:	Miscellaneous Camera Underwater
Distance (ft):	614.1
Structural Grade:	0
O&M Grade:	4
Clock Start/From:	
Clock To:	
1st Value:	
2nd Value:	
Value Percent:	
Continuous Index:	
Within 8" of Joint:	NO
Remarks:	Out at 616.3

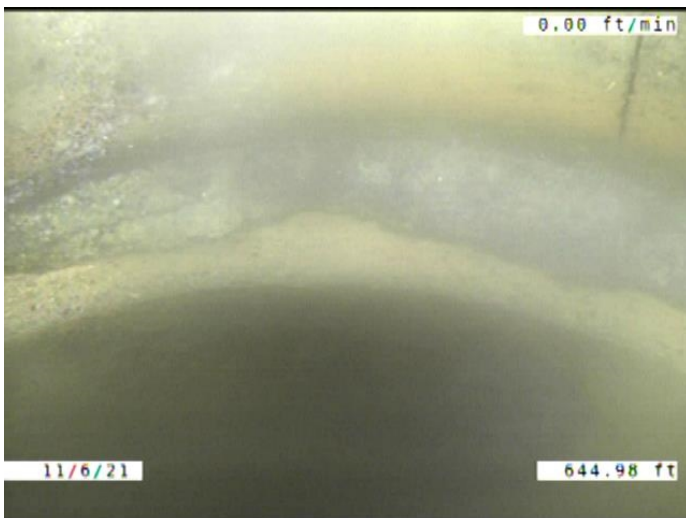
Code: **JOMD**
Description: **Joint Offset Medium Defective**

Distance (ft): **645.0**
Structural Grade: **3**
O&M Grade: **0**
Clock Start/From:
Clock To:
1st Value:
2nd Value:
Value Percent:
Continuous Index:
Within 8" of Joint: **NO**
Remarks:
