Profile/Photo Observation Report

Date:	10/23/2021	Weather:		Coding:	PACP 7.0
Pipe Length (ft):	197.2	Owner:	City of Hobart	Pre Clean:	Heavy Cleaning
P.O.#:	YES502259	Surveyor:	S. Bucklin	PSR:	P-404-012-011
Customer:	City of Hobart	Clean Date:	10/22/2021	Shape:	C

Street:	North Wabash Street	Flow Control:	Not Controlled
City:	Hobart, IN	Year Renewed:	
Location:	Woods	Tape/Media #:	
Purpose:	Routine Assessment	Dia/Height:	8"
Use:	Sanitary Sewage Pipe	Material:	VCP
Drain Area:		Lining:	None
Category:	NA		
Comment:			
Location Details:		Direction of Survey:	Upstream
US MH:	M-404-012	DS MH:	M-404-011
		Total Length Surveyed (ft):	197.2

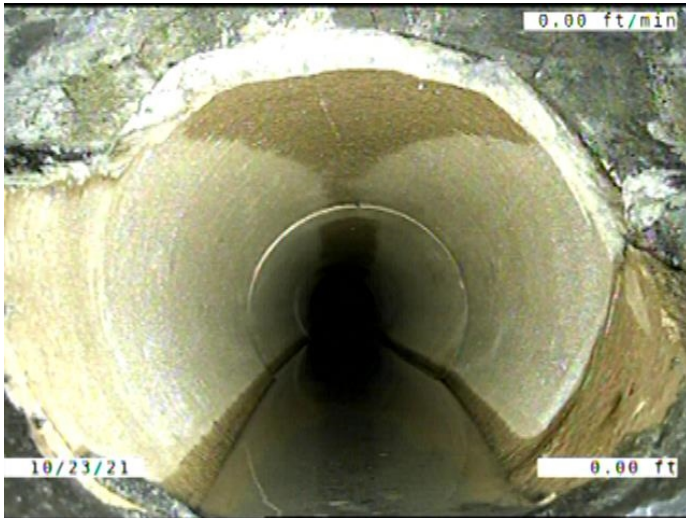
Code: **MWL**
Description: **Miscellaneous Water Level**

Distance (ft): **.0**
Structural Grade: **0**
O&M Grade: **0**
Clock Start/From:
Clock To:
1st Value:
2nd Value:
Value Percent: **5.000**
Continuous Index:
Within 8" of Joint: **NO**
Remarks:

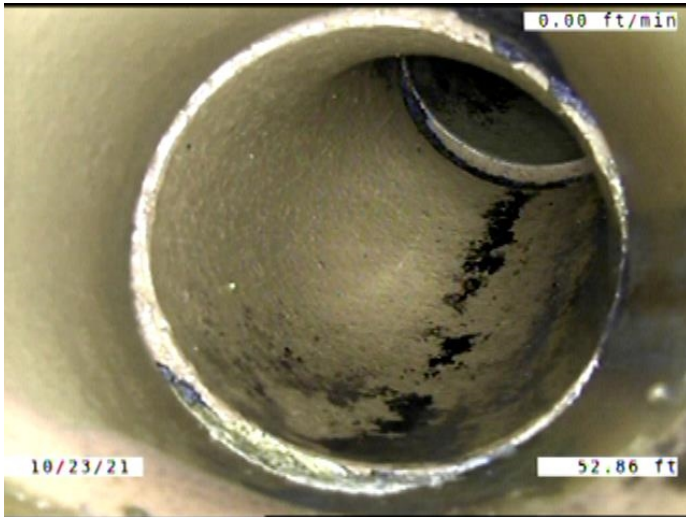
Code: **TF**
Description: **Tap Factory**

Distance (ft): **52.9**
Structural Grade: **0**
O&M Grade: **0**
Clock Start/From: **2**
Clock To:
1st Value: **4.000**
2nd Value:
Value Percent:
Continuous Index:
Within 8" of Joint: **YES**
Remarks:
