Profile/Photo Observation Report

Date:	04/08/2018	Weather:		Coding:	PACP 6.0
Pipe Length (ft):		Owner:	City of Hobart	Pre Clean:	No Pre-Cleaning
P.O.#:	20-2	Surveyor:	M. Pielacha	PSR:	M-404-013-M-504-065
Customer:	City of Hobart	Clean Date:		Shape:	C

Street:	Old Ridge Road	Flow Control:	Not Controlled
City:	Hobart, IN	Year Renewed:	
Location:	Light Highway	Tape/Media #:	DEP 20
Purpose:	Routine Assessment	Dia/Height:	24"
Use:	Sanitary	Material:	CP
Drain Area:		Lining:

US MH: **M-404-013** DS MH: **M-504-065** Total Length Surveyed (ft): **112.9**

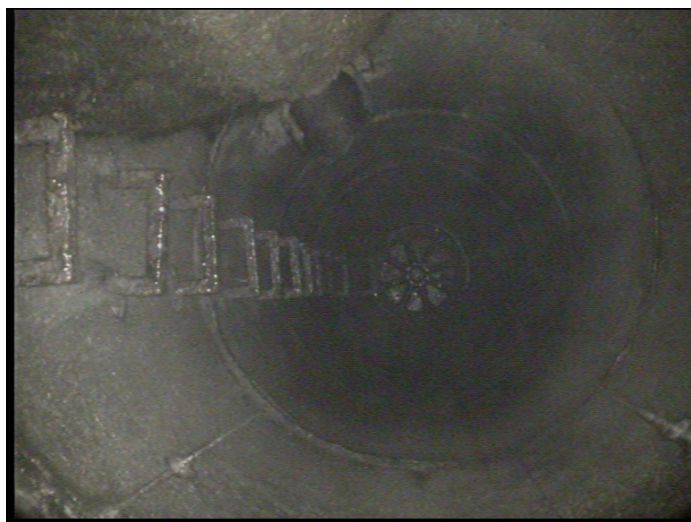
Code: **AMH**
Description: **Manhole**

Distance (ft): **.0**
Structural Grade: **0**
O&M Grade: **0**
Clock Start/From:
Clock To:
1st Value:
2nd Value:
Value Percent:
Continuous Index:
Within 8" of Joint: **NO**
Remarks: **M-504-065**
