Profile/Photo Observation Report

Date:	09/01/2021	Weather:		Coding:	PACP 7.0
Pipe Length (ft):	318.0	Owner:	City of Hobart	Pre Clean:	Light Cleaning
P.O.#:	YES502259	Surveyor:	S. Bucklin	PSR:	P-404-016-015
Customer:	City of Hobart	Clean Date:	08/29/2021	Shape:	C

Street:	North Wabash Street	Flow Control:	Not Controlled
City:	Hobart, IN	Year Renewed:	
Location:	Easement/Right of Way	Tape/Media #:	
Purpose:	Routine Assessment	Dia/Height:	10"
Use:	Sanitary Sewage Pipe	Material:	VCP
Drain Area:		Lining:	
Category:	NA		
Comment:			
Location Details:	IN FRONT OF THE HOUSE. IN THEIR	Direction of Survey:	Downstream
US MH:	M-404-015	DS MH:	M-404-016
		Total Length Surveyed (ft):	318.0

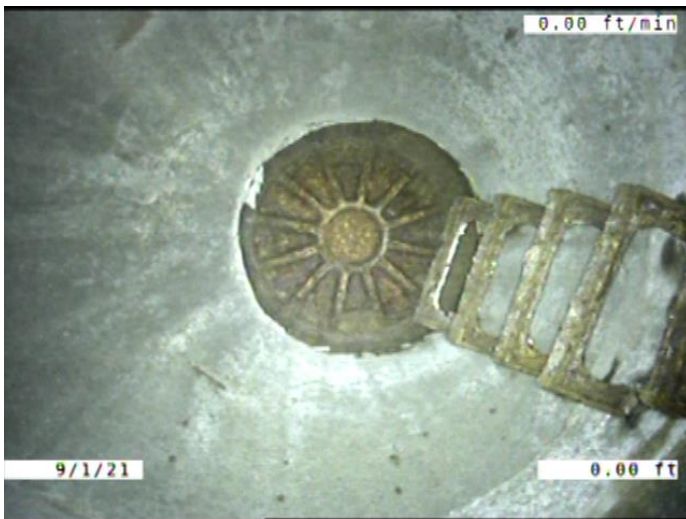
Code: **AMH**
Description: **Manhole**

Distance (ft): **.0**
Structural Grade: **0**
O&M Grade: **0**
Clock Start/From:
Clock To:
1st Value:
2nd Value:
Value Percent:
Continuous Index:
Within 8" of Joint: **NO**
Remarks: **M-404-015**

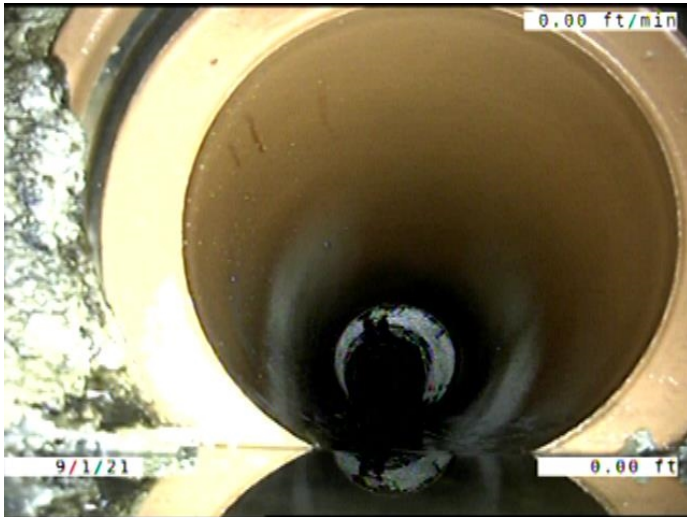
Code: **MWL**
 Description: **Miscellaneous Water Level**

Distance (ft): **.0**
 Structural Grade: **0**
 O&M Grade: **0**
 Clock Start/From:
 Clock To:
 1st Value:
 2nd Value:
 Value Percent: **5.000**
 Continuous Index:
 Within 8" of Joint: **NO**
 Remarks:

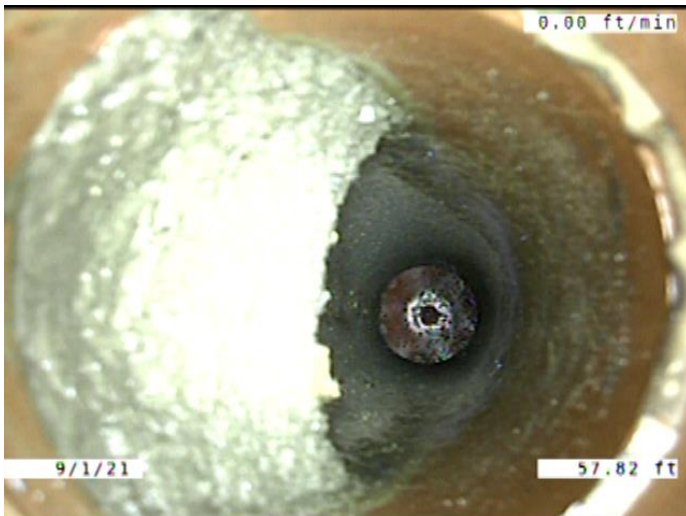
Code: **TFC**
 Description: **Tap Factory Capped**

Distance (ft): **57.8**
 Structural Grade: **0**
 O&M Grade: **0**
 Clock Start/From: **9**
 Clock To:
 1st Value: **4.000**
 2nd Value:
 Value Percent:
 Continuous Index:
 Within 8" of Joint: **YES**
 Remarks:

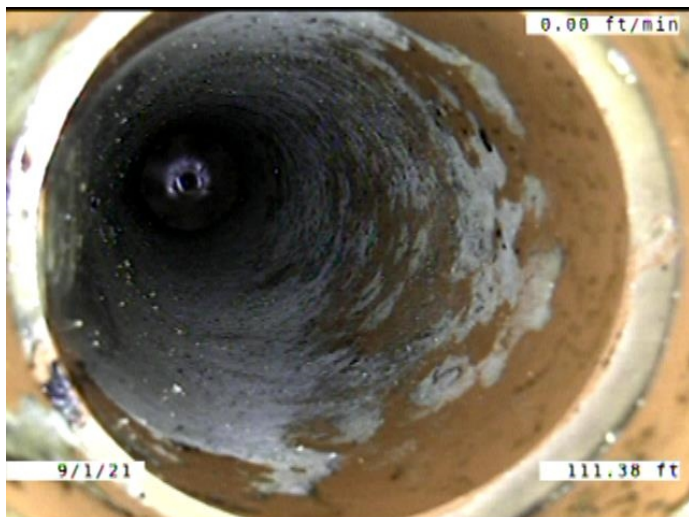
Code: **TFC**
 Description: **Tap Factory Capped**

Distance (ft): **111.4**
 Structural Grade: **0**
 O&M Grade: **0**
 Clock Start/From: **10**
 Clock To:
 1st Value: **6.000**
 2nd Value:
 Value Percent:
 Continuous Index:
 Within 8" of Joint: **YES**
 Remarks:

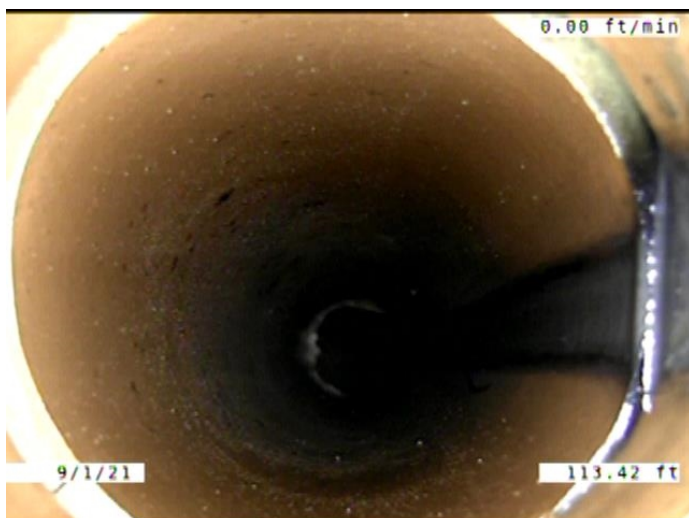
Code: **TF**
 Description: **Tap Factory**

Distance (ft): **113.4**
 Structural Grade: **0**
 O&M Grade: **0**
 Clock Start/From: **2**
 Clock To:
 1st Value: **4.000**
 2nd Value:
 Value Percent:
 Continuous Index:
 Within 8" of Joint: **YES**
 Remarks:

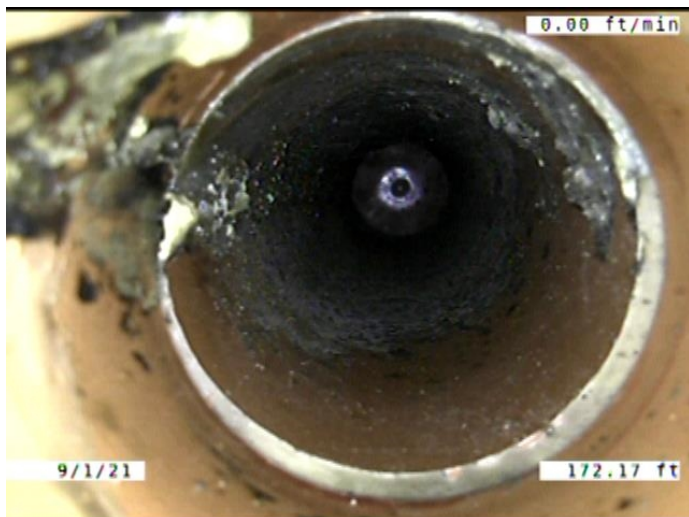
Code: **TFC**
 Description: **Tap Factory Capped**

Distance (ft): **172.2**
 Structural Grade: **0**
 O&M Grade: **0**
 Clock Start/From: **10**
 Clock To:
 1st Value: **4.000**
 2nd Value:
 Value Percent:
 Continuous Index:
 Within 8" of Joint: **YES**
 Remarks:

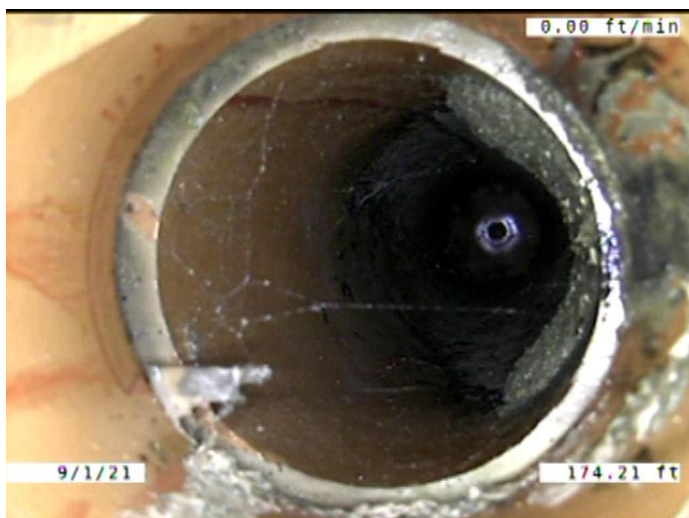
Code: **TFC**
 Description: **Tap Factory Capped**

Distance (ft): **174.2**
 Structural Grade: **0**
 O&M Grade: **0**
 Clock Start/From: **2**
 Clock To:
 1st Value: **4.000**
 2nd Value:
 Value Percent:
 Continuous Index:
 Within 8" of Joint: **YES**
 Remarks:

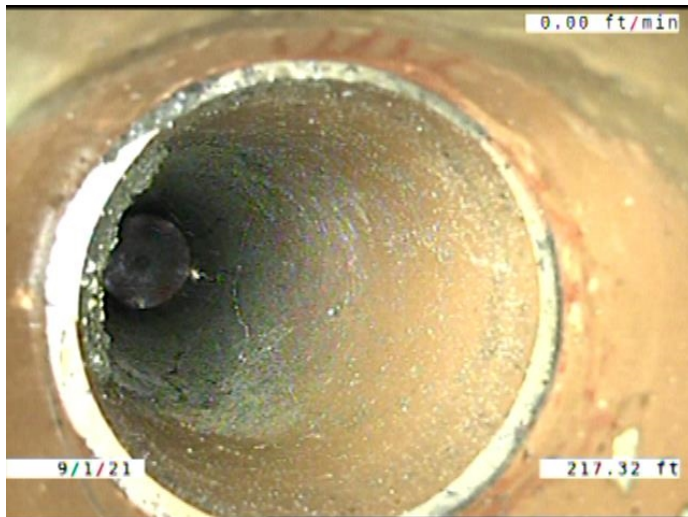
Code: **TFC**
 Description: **Tap Factory Capped**

Distance (ft): **217.3**
 Structural Grade: **0**
 O&M Grade: **0**
 Clock Start/From: **10**
 Clock To:
 1st Value: **4.000**
 2nd Value:
 Value Percent:
 Continuous Index:
 Within 8" of Joint: **YES**
 Remarks:

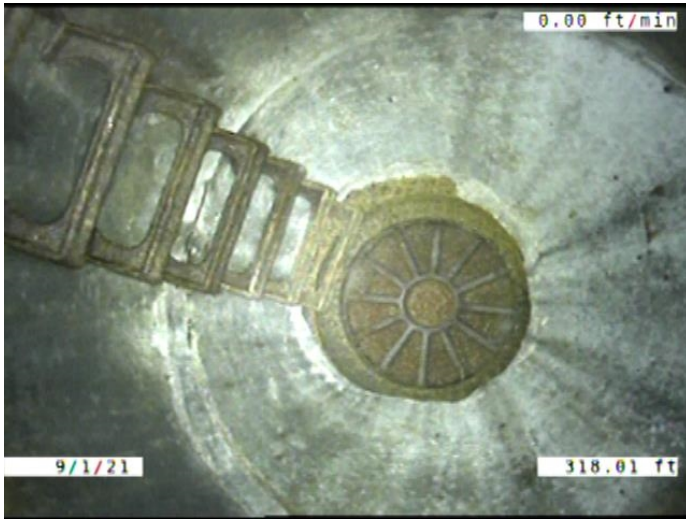
Code:	AMH
Description:	Manhole
Distance (ft):	318.0
Structural Grade:	0
O&M Grade:	0
Clock Start/From:	
Clock To:	
1st Value:	
2nd Value:	
Value Percent:	
Continuous Index:	
Within 8" of Joint:	NO
Remarks:	M-404-016
