Profile/Photo Observation Report

| P.O.#: | YES502259 | Surveyor: | S. Bucklin | PSR: | P-404-016-015 |

| Street: | North Wabash Street | Flow Control: | Not Controlled |
| US MH: | M-404-015 | DS MH: | M-404-016 |

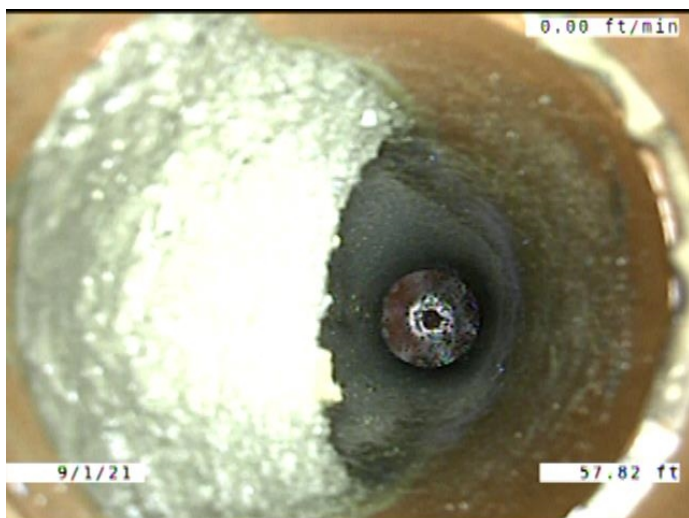
Code: **TFC**
 Description: **Tap Factory Capped**

Distance (ft): **57.8**
 Structural Grade: **0**
 O&M Grade: **0**
 Clock Start/From: **9**
 Clock To:
 1st Value: **4.000**
 2nd Value:
 Value Percent:
 Continuous Index:
 Within 8" of Joint: **YES**
 Remarks:
