Profile/Photo Observation Report

Date:	04/16/2018	Weather:		Coding:	PACP 6.0
Pipe Length (ft):	339.3	Owner:	NA	Pre Clean:	Not Known
P.O.#:		Surveyor:	Selasie Honu	PSR:	P-404-027-026
Customer:		Clean Date:	01/01/1900	Shape:	C

Street:	DEARBORN ST	Flow Control:	Not Controlled
City:	Hobart, IN	Year Renewed:	
Location:	Light Highway	Tape/Media #:	
Purpose:	Not Known	Dia/Height:	10"
Use:	Sanitary	Material:	VCP
Drain Area:	NA	Lining:	
Category:	NA		
Comment:

Location Details:		Direction of Survey:	Downstream
US MH:	M-404-026	DS MH:	M-404-027
		Total Length Surveyed (ft):	223.0

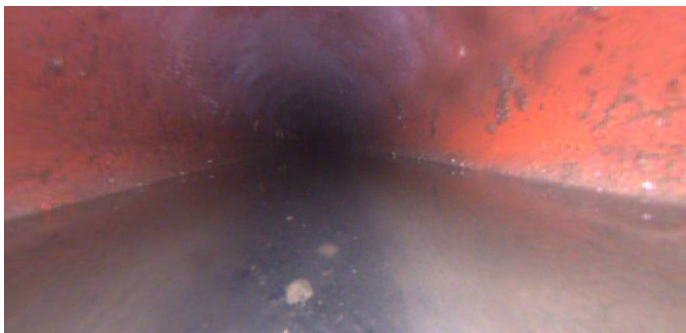
Code: **AMH**
Description: **Manhole**

Distance (ft): **.0**
Structural Grade: **0**
O&M Grade: **0**
Clock Start/From:
Clock To:
1st Value:
2nd Value:
Value Percent:
Continuous Index:
Within 8" of Joint: **NO**
Remarks: **M-404-026**

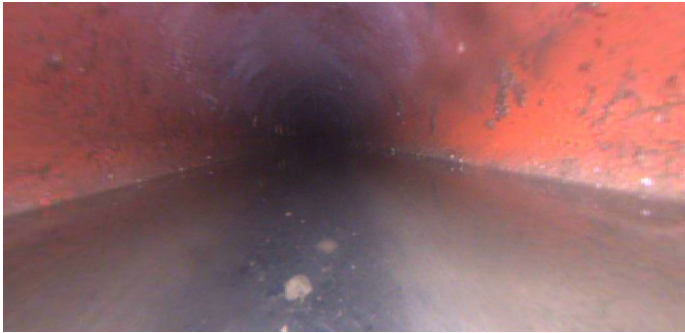
Code:	MWL
Description:	Water Level

Distance (ft):	.0
Structural Grade:	0
O&M Grade:	0
Clock Start/From:	
Clock To:	
1st Value:	
2nd Value:	
Value Percent:	5.000
Continuous Index:	
Within 8" of Joint:	NO
Remarks:

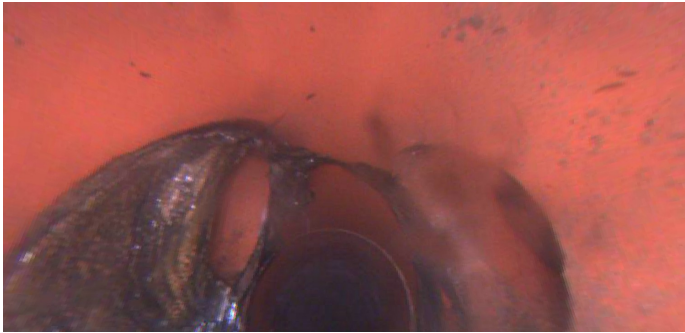
Code: **TF**
Description: **Tap Factory**

Distance (ft): **25.9**
Structural Grade: **0**
O&M Grade: **0**
Clock Start/From: **3**
Clock To:
1st Value: **4.000**
2nd Value:
Value Percent:
Continuous Index:
Within 8" of Joint:
Remarks:

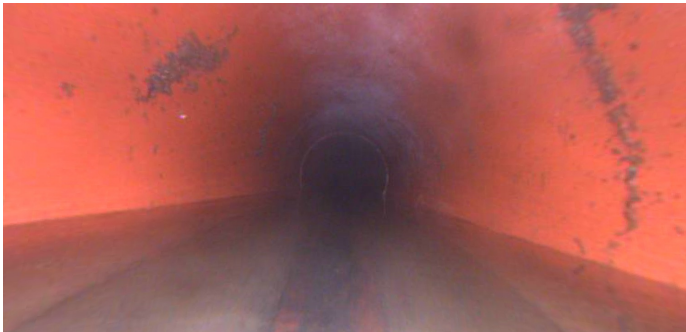
Code: **MWL**
Description: **Water Level**

Distance (ft): **40.7**
Structural Grade: **0**
O&M Grade: **0**
Clock Start/From:
Clock To:
1st Value:
2nd Value:
Value Percent: **40.000**
Continuous Index:
Within 8" of Joint: **NO**
Remarks:

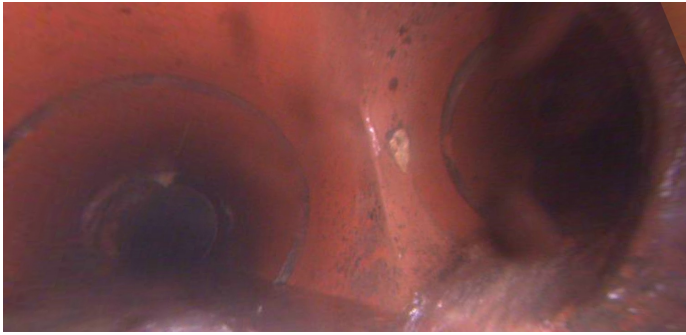
Code: **TFA**
Description: **Tap Factory Active**

Distance (ft): **81.8**
Structural Grade: **0**
O&M Grade: **0**
Clock Start/From: **3**
Clock To:
1st Value: **4.000**
2nd Value:
Value Percent:
Continuous Index:
Within 8" of Joint:
Remarks:

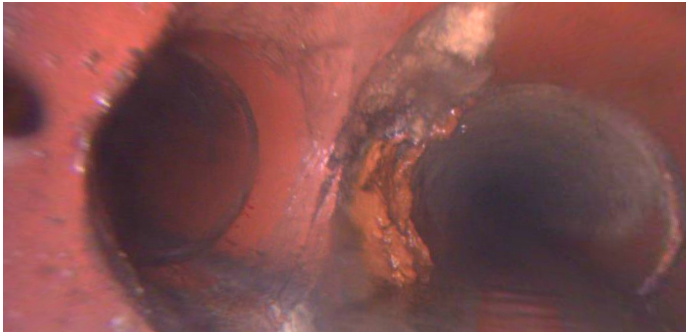
Code: **TFA**
Description: **Tap Factory Active**

Distance (ft): **83.8**
Structural Grade: **0**
O&M Grade: **0**
Clock Start/From: **9**
Clock To:
1st Value: **4.000**
2nd Value:
Value Percent:
Continuous Index:
Within 8" of Joint:
Remarks:

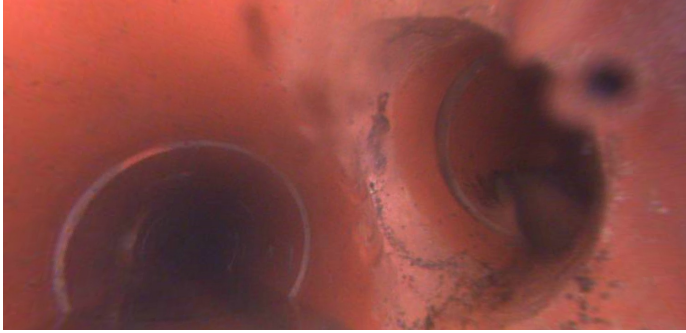
Code: **TF**
Description: **Tap Factory**

Distance (ft): **155.5**
Structural Grade: **0**
O&M Grade: **0**
Clock Start/From: **3**
Clock To:
1st Value: **4.000**
2nd Value:
Value Percent:
Continuous Index:
Within 8" of Joint:
Remarks:

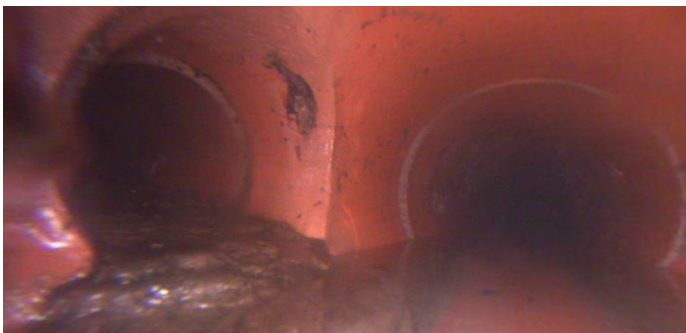
Code: **TFA**
Description: **Tap Factory Active**

Distance (ft): **157.7**
Structural Grade: **0**
O&M Grade: **0**
Clock Start/From: **9**
Clock To:
1st Value: **4.000**
2nd Value:
Value Percent:
Continuous Index:
Within 8" of Joint:
Remarks:

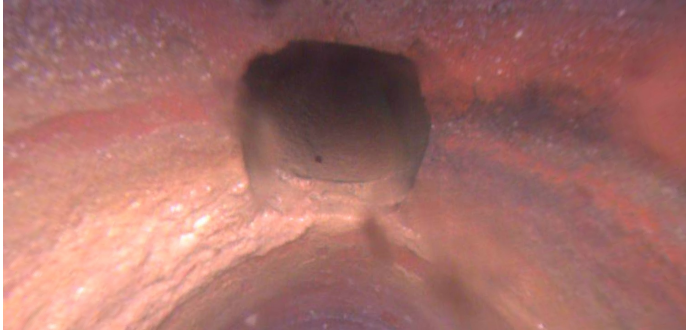
Code: **TB**
Description: **Tap Break-in**

Distance (ft): **173.8**
Structural Grade: **0**
O&M Grade: **0**
Clock Start/From: **12**
Clock To:
1st Value: **4.000**
2nd Value:
Value Percent:
Continuous Index:
Within 8" of Joint:
Remarks:

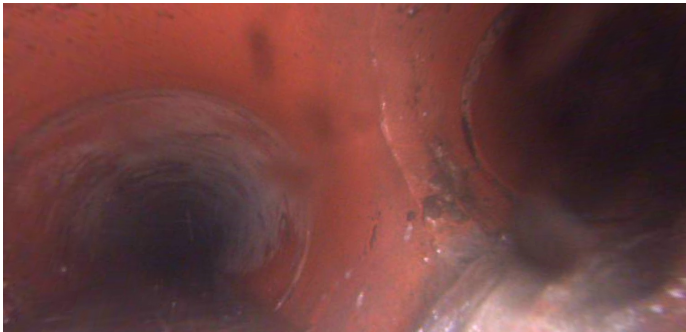
Code: **TFA**
Description: **Tap Factory Active**

Distance (ft): **202.5**
Structural Grade: **0**
O&M Grade: **0**
Clock Start/From: **3**
Clock To:
1st Value: **4.000**
2nd Value:
Value Percent:
Continuous Index:
Within 8" of Joint:
Remarks:
