## Profile/Photo Observation Report

Street:	<b>Summerlin</b>	Flow Control:	<b>Not Controlled</b>
City:	<b>Hobart, IN</b>	Year Renewed:	
Location:	<b>Light Highway</b>	Tape/Media #:	
Purpose:	<b>Not Known</b>	Dia/Height:	<b>10"</b>
Use:	<b>Sanitary</b>	Material:	<b>VCP</b>
Drain Area:	<b>NA</b>	Lining:	
Category:	<b>NA</b>		
Comment:

Location Details:		Direction of Survey:	<b>Downstream</b>
US MH:	<b>M-404-026</b>	DS MH:	<b>M-404-027</b>
		Total Length Surveyed (ft):	<b>223.0</b>

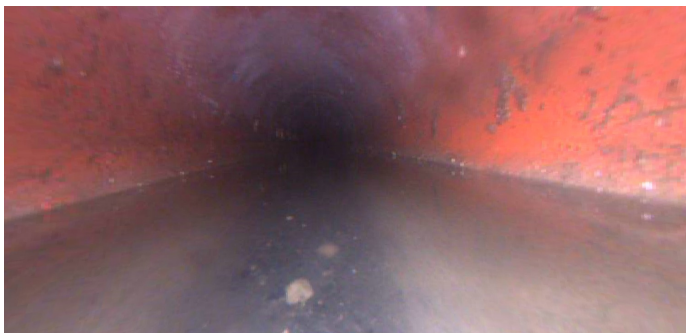
Code: **AMH**  
Description: **Manhole**

Distance (ft): **.0**  
Structural Grade: **0**  
O&M Grade: **0**  
Clock Start/From:  
Clock To:  
1st Value:  
2nd Value:  
Value Percent:  
Continuous Index:  
Within 8" of Joint: **NO**  
Remarks: **M-404-026**

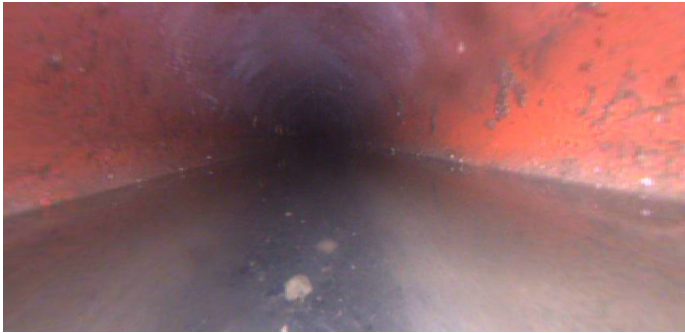
Code:	<b>MWL</b>
Description:	<b>Water Level</b>

Distance (ft):	<b>.0</b>
Structural Grade:	<b>0</b>
O&M Grade:	<b>0</b>
Clock Start/From:	
Clock To:	
1st Value:	
2nd Value:	
Value Percent:	<b>5.000</b>
Continuous Index:	
Within 8" of Joint:	<b>NO</b>
Remarks:

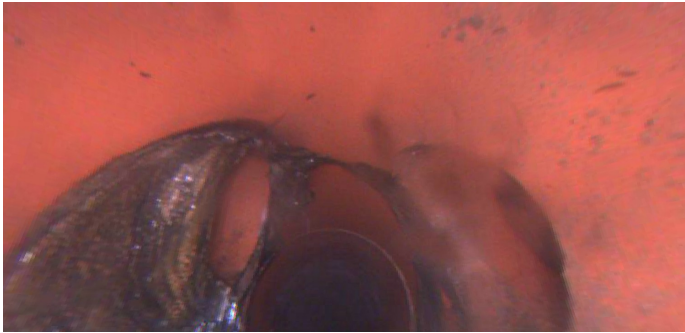
Code: **TF**  
Description: **Tap Factory**

Distance (ft): **25.9**  
Structural Grade: **0**  
O&M Grade: **0**  
Clock Start/From: **3**  
Clock To:  
1st Value: **4.000**  
2nd Value:  
Value Percent:  
Continuous Index:  
Within 8" of Joint:  
Remarks:

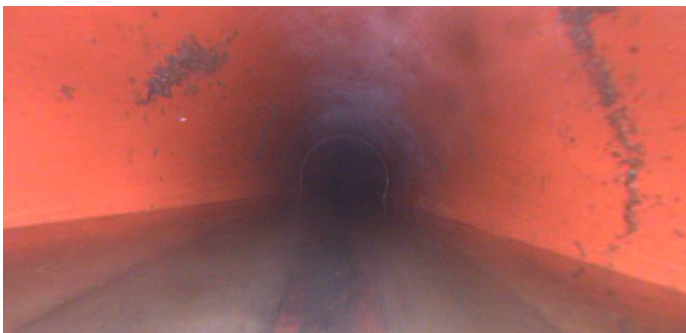
Code: **MWL**  
Description: **Water Level**

Distance (ft): **40.7**  
Structural Grade: **0**  
O&M Grade: **0**  
Clock Start/From:  
Clock To:  
1st Value:  
2nd Value:  
Value Percent: **40.000**  
Continuous Index:  
Within 8" of Joint: **NO**  
Remarks:

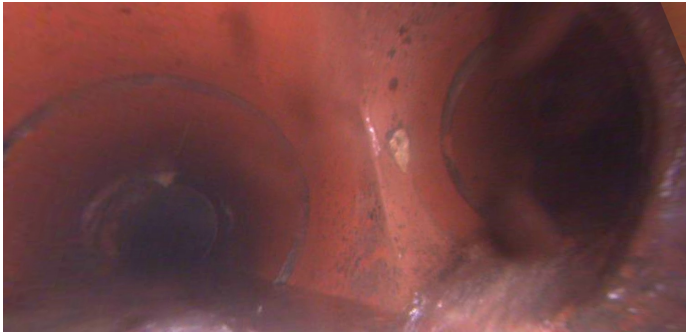
Code: **TFA**  
Description: **Tap Factory Active**

Distance (ft): **81.8**  
Structural Grade: **0**  
O&M Grade: **0**  
Clock Start/From: **3**  
Clock To:  
1st Value: **4.000**  
2nd Value:  
Value Percent:  
Continuous Index:  
Within 8" of Joint:  
Remarks:

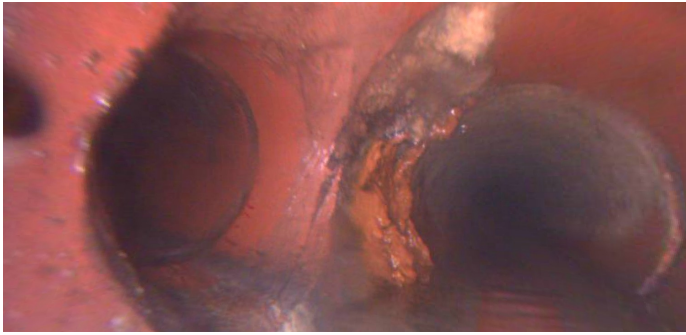
Code: **TFA**  
Description: **Tap Factory Active**

Distance (ft): **83.8**  
Structural Grade: **0**  
O&M Grade: **0**  
Clock Start/From: **9**  
Clock To:  
1st Value: **4.000**  
2nd Value:  
Value Percent:  
Continuous Index:  
Within 8" of Joint:  
Remarks:

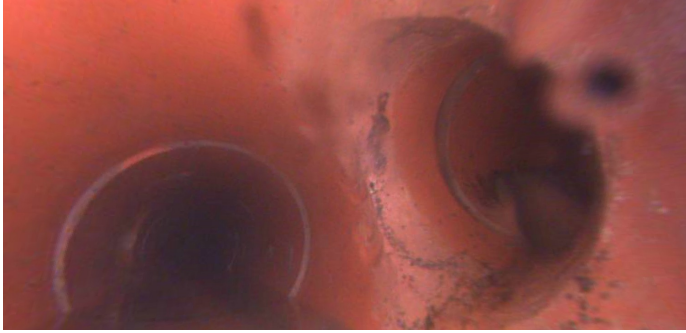
Code: **TF**  
Description: **Tap Factory**

Distance (ft): **155.5**  
Structural Grade: **0**  
O&M Grade: **0**  
Clock Start/From: **3**  
Clock To:  
1st Value: **4.000**  
2nd Value:  
Value Percent:  
Continuous Index:  
Within 8" of Joint:  
Remarks:

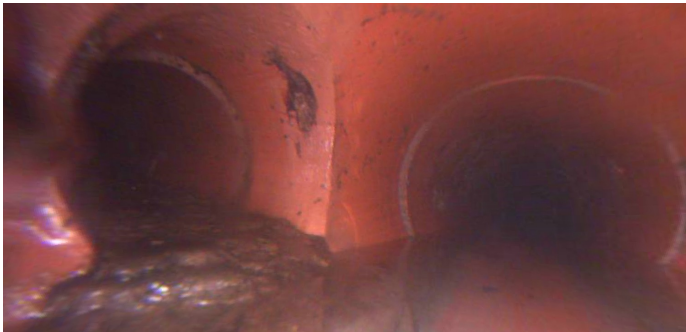
Code: **TFA**  
Description: **Tap Factory Active**

Distance (ft): **157.7**  
Structural Grade: **0**  
O&M Grade: **0**  
Clock Start/From: **9**  
Clock To:  
1st Value: **4.000**  
2nd Value:  
Value Percent:  
Continuous Index:  
Within 8" of Joint:  
Remarks:

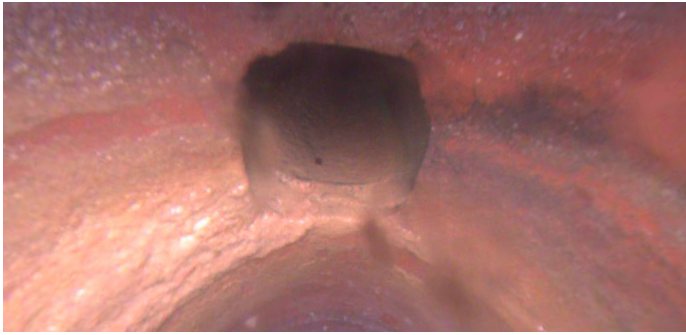
Code: **TB**  
Description: **Tap Break-in**

Distance (ft): **173.8**  
Structural Grade: **0**  
O&M Grade: **0**  
Clock Start/From: **12**  
Clock To:  
1st Value: **4.000**  
2nd Value:  
Value Percent:  
Continuous Index:  
Within 8" of Joint:  
Remarks:

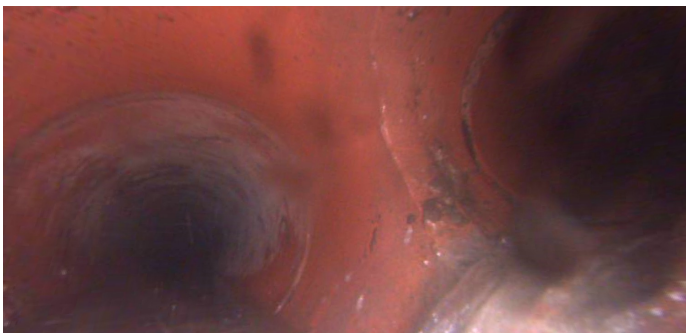
Code: **TFA**  
Description: **Tap Factory Active**

Distance (ft): **202.5**  
Structural Grade: **0**  
O&M Grade: **0**  
Clock Start/From: **3**  
Clock To:  
1st Value: **4.000**  
2nd Value:  
Value Percent:  
Continuous Index:  
Within 8" of Joint:  
Remarks:
