Profile/Photo Observation Report

Date:	04/16/2018	Weather:		Coding:	PACP 6.0
Pipe Length (ft):	339.3	Owner:	NA	Pre Clean:	Not Known
P.O.#:		Surveyor:	Selasie Honu	PSR:	P-404-027-026
Customer:		Clean Date:	01/01/1900	Shape:	C

Street:	DEARBORN ST	Flow Control:	Not Controlled
City:	Hobart, IN	Year Renewed:	
Location:	Light Highway	Tape/Media #:	
Purpose:	Not Known	Dia/Height:	10"
Use:	Sanitary	Material:	VCP
Drain Area:	NA	Lining:	
Category:	NA		
Comment:

Location Details:		Direction of Survey:	Downstream
US MH:	M-404-026	DS MH:	M-404-027
		Total Length Surveyed (ft):	349.9

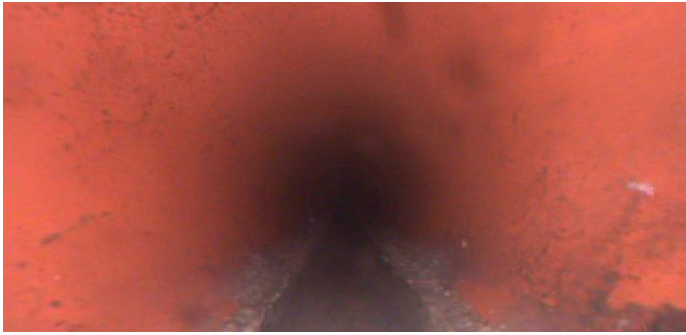
Code: **AMH**
Description: **Manhole**

Distance (ft): **.0**
Structural Grade: **0**
O&M Grade: **0**
Clock Start/From:
Clock To:
1st Value:
2nd Value:
Value Percent:
Continuous Index:
Within 8" of Joint: **NO**
Remarks: **M-404-026**

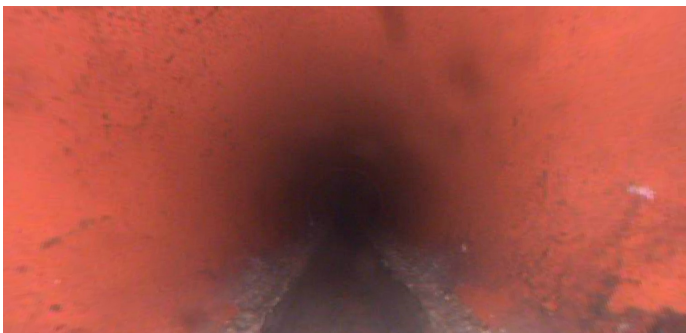
Code: **MWL**
Description: **Water Level**

Distance (ft): **.0**
Structural Grade: **0**
O&M Grade: **0**
Clock Start/From:
Clock To:
1st Value:
2nd Value:
Value Percent: **5.000**
Continuous Index:
Within 8" of Joint: **NO**
Remarks:

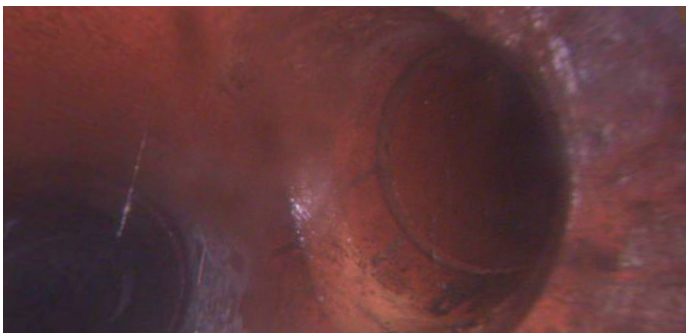
Code: **TF**
Description: **Tap Factory**

Distance (ft): **42.5**
Structural Grade: **0**
O&M Grade: **0**
Clock Start/From: **3**
Clock To:
1st Value: **4.000**
2nd Value:
Value Percent:
Continuous Index:
Within 8" of Joint:
Remarks:

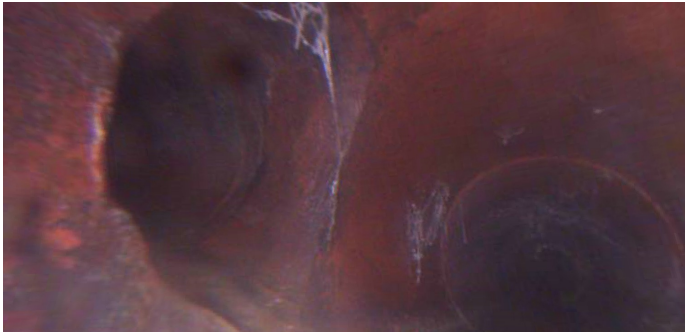
Code: **TFA**
Description: **Tap Factory Active**

Distance (ft): **44.6**
Structural Grade: **0**
O&M Grade: **0**
Clock Start/From: **9**
Clock To:
1st Value: **4.000**
2nd Value:
Value Percent:
Continuous Index:
Within 8" of Joint:
Remarks:

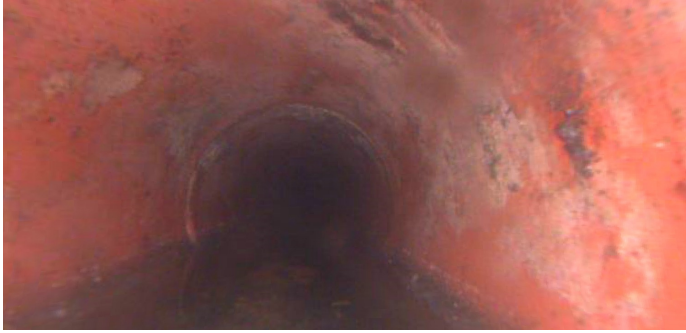
Code: **MWL**
Description: **Water Level**

Distance (ft): **92.9**
Structural Grade: **0**
O&M Grade: **0**
Clock Start/From:
Clock To:
1st Value:
2nd Value:
Value Percent: **30.000**
Continuous Index:
Within 8" of Joint: **NO**
Remarks:

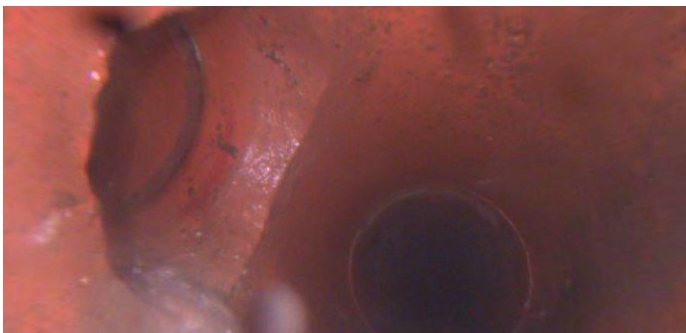
Code: **TFA**
Description: **Tap Factory Active**

Distance (ft): **144.7**
Structural Grade: **0**
O&M Grade: **0**
Clock Start/From: **9**
Clock To:
1st Value: **4.000**
2nd Value:
Value Percent:
Continuous Index:
Within 8" of Joint:
Remarks:

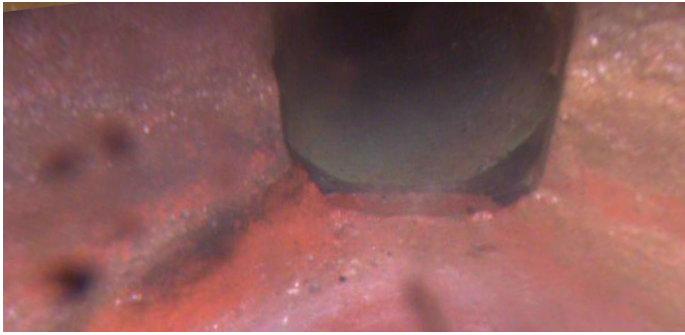
Code: **TB**
Description: **Tap Break-in**

Distance (ft): **173.7**
Structural Grade: **0**
O&M Grade: **0**
Clock Start/From: **12**
Clock To:
1st Value: **4.000**
2nd Value:
Value Percent:
Continuous Index:
Within 8" of Joint:
Remarks:

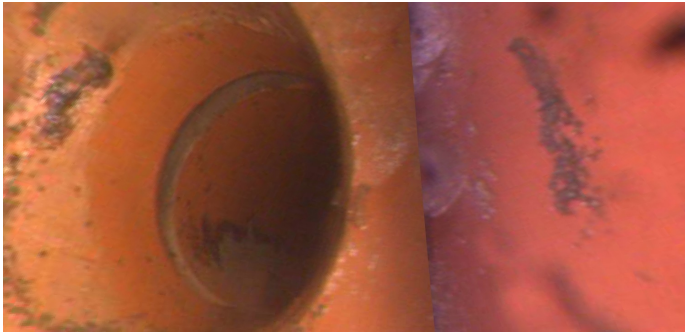
Code: **TF**
Description: **Tap Factory**

Distance (ft): **192.5**
Structural Grade: **0**
O&M Grade: **0**
Clock Start/From: **9**
Clock To:
1st Value: **4.000**
2nd Value:
Value Percent:
Continuous Index:
Within 8" of Joint:
Remarks:

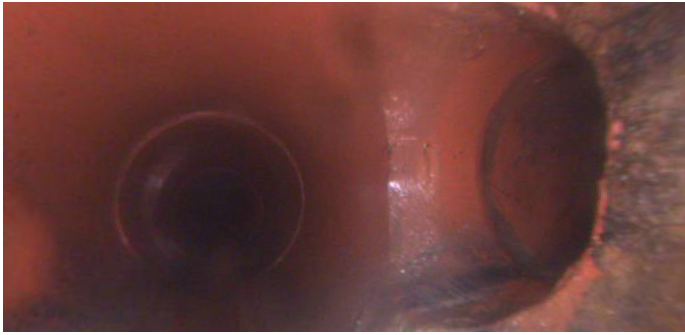
Code: **TFA**
Description: **Tap Factory Active**

Distance (ft): **263.1**
Structural Grade: **0**
O&M Grade: **0**
Clock Start/From: **3**
Clock To:
1st Value: **4.000**
2nd Value:
Value Percent:
Continuous Index:
Within 8" of Joint:
Remarks:

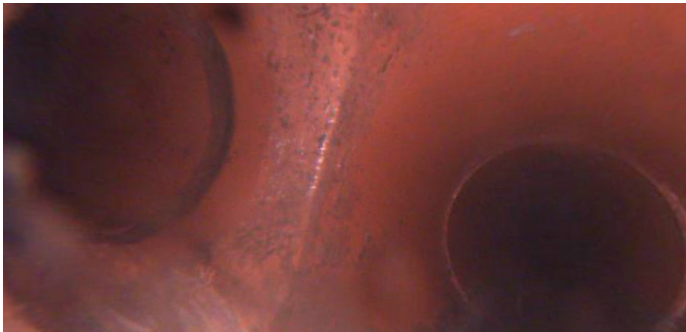
Code: **TFA**
Description: **Tap Factory Active**

Distance (ft): **265.5**
Structural Grade: **0**
O&M Grade: **0**
Clock Start/From: **9**
Clock To:
1st Value: **4.000**
2nd Value:
Value Percent:
Continuous Index:
Within 8" of Joint:
Remarks:

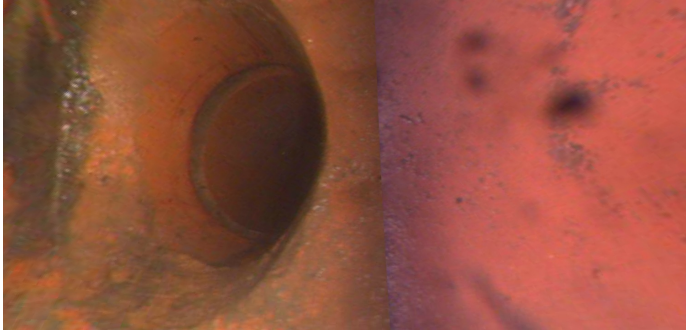
Code: **TF**
Description: **Tap Factory**

Distance (ft): **321.6**
Structural Grade: **0**
O&M Grade: **0**
Clock Start/From: **9**
Clock To:
1st Value: **4.000**
2nd Value:
Value Percent:
Continuous Index:
Within 8" of Joint:
Remarks:

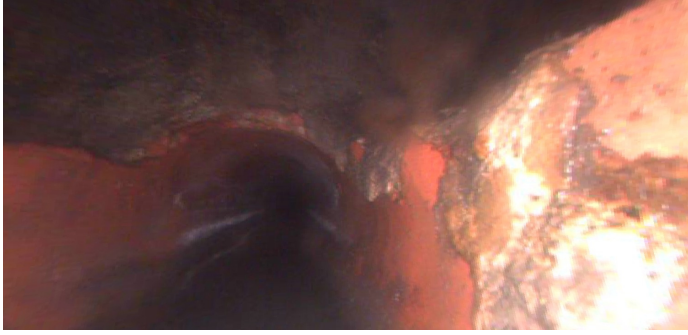
Code:	AMH
Description:	Manhole
Distance (ft):	349.9
Structural Grade:	0
O&M Grade:	0
Clock Start/From:	
Clock To:	
1st Value:	
2nd Value:	
Value Percent:	
Continuous Index:	
Within 8" of Joint:	NO
Remarks:	M-404-027
