Profile/Photo Observation Report

Date:	04/07/2018	Weather:		Coding:	PACP 6.0
Pipe Length (ft):		Owner:	City of Hobart	Pre Clean:	No Pre-Cleaning
P.O.#:	17-3	Surveyor:	M. Pielacha	PSR:	M-404-028-M-404-025
Customer:	City of Hobart	Clean Date:		Shape:	C

Street:	Old Ridge Road	Flow Control:	Not Controlled
City:	Hobart, IN	Year Renewed:	
Location:	Light Highway	Tape/Media #:	DEP 17
Purpose:	Routine Assessment	Dia/Height:	18"
Use:	Sanitary	Material:	VCP
Drain Area:		Lining:	
Category:	NA		
Comment:			
Location Details:		Direction of Survey:	Downstream
US MH:	M-404-028	DS MH:	M-404-025
		Total Length Surveyed (ft):	87.0

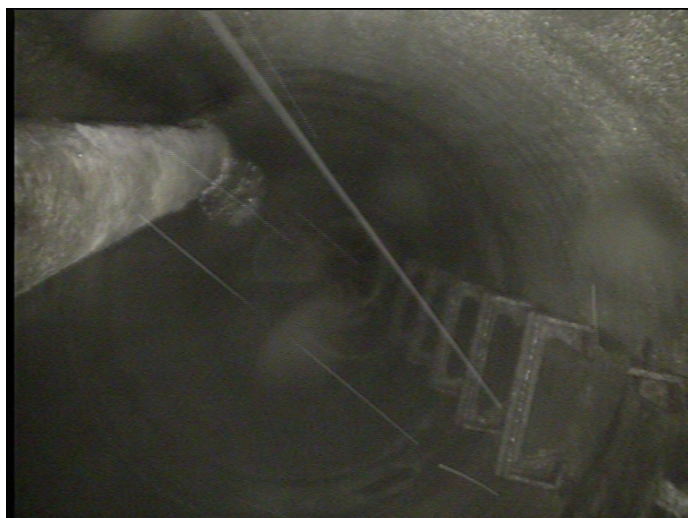
Code: **AMH**
 Description: **Manhole**

Distance (ft): **.0**
 Structural Grade: **0**
 O&M Grade: **0**
 Clock Start/From:
 Clock To:
 1st Value:
 2nd Value:
 Value Percent:
 Continuous Index:
 Within 8" of Joint: **NO**
 Remarks: **M-404-028**
