Profile/Photo Observation Report

Street:	Old Ridge Road	Flow Control:	Not Controlled
City:	Hobart, IN	Year Renewed:	
Location:	Light Highway	Tape/Media #:	DEP 17
Purpose:	Routine Assessment	Dia/Height:	18"
Use:	Sanitary	Material:	VCP
Drain Area:		Lining:	
Category:	NA		
Comment:			
Location Details:		Direction of Survey:	Downstream
US MH:	M-404-028	DS MH:	M-404-025
		Total Length Surveyed (ft):	87.0

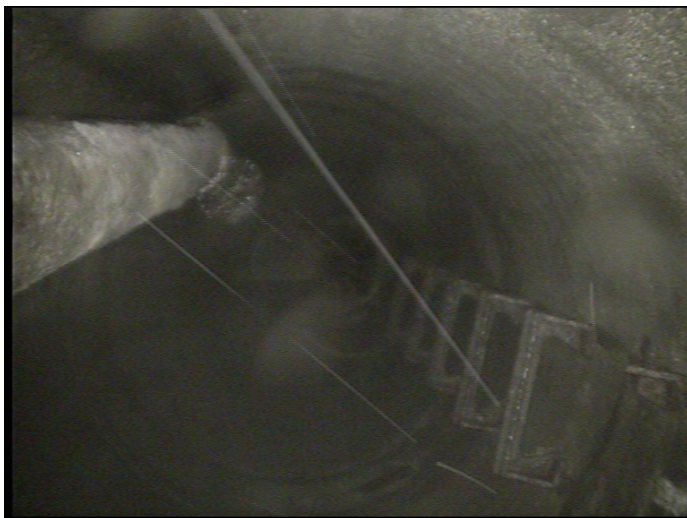
Code: **AMH**
 Description: **Manhole**

Distance (ft): **.0**
 Structural Grade: **0**
 O&M Grade: **0**
 Clock Start/From:
 Clock To:
 1st Value:
 2nd Value:
 Value Percent:
 Continuous Index:
 Within 8" of Joint: **NO**
 Remarks: **M-404-028**
