Profile/Photo Observation Report

Date:	04/07/2018	Weather:		Coding:	PACP 6.0
Pipe Length (ft):		Owner:	City of Hobart	Pre Clean:	No Pre-Cleaning
P.O.#:	16-1	Surveyor:	M. Pielacha	PSR:	M-404-033-M-404-032
Customer:	City of Hobart	Clean Date:		Shape:	C

Street:	Old Ridge Road	Flow Control:	Not Controlled
City:	Hobart, IN	Year Renewed:	
Location:	Light Highway	Tape/Media #:	DEP 16
Purpose:	Routine Assessment	Dia/Height:	18"
Use:	Sanitary	Material:	VCP
Drain Area:		Lining:	
Category:	NA		
Comment:			
Location Details:		Direction of Survey:	Upstream
US MH:	M-404-033	DS MH:	M-404-032
		Total Length Surveyed (ft):	363.7

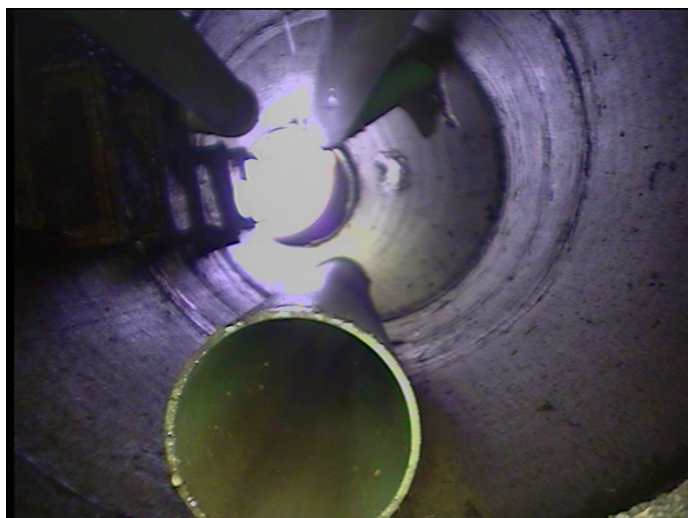
Code: **AMH**
 Description: **Manhole**

Distance (ft): **.0**
 Structural Grade: **0**
 O&M Grade: **0**
 Clock Start/From:
 Clock To:
 1st Value:
 2nd Value:
 Value Percent:
 Continuous Index:
 Within 8" of Joint: **NO**
 Remarks: **M-404-032**

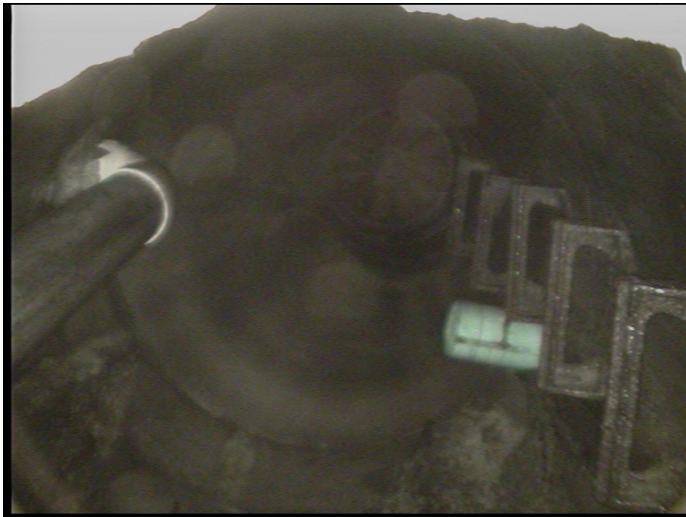
Code: **AMH**
Description: **Manhole**

Distance (ft): **363.7**
Structural Grade: **0**
O&M Grade: **0**
Clock Start/From:
Clock To:
1st Value:
2nd Value:
Value Percent:
Continuous Index:
Within 8" of Joint: **NO**
Remarks: **M-404-033**
