Profile/Photo Observation Report

Date:	01/15/2022	Weather:		Coding:	PACP 7.0
Pipe Length (ft):	234.9	Owner:	City of Hobart	Pre Clean:	Light Cleaning
P.O.#:	YES502259	Surveyor:	S. Bucklin	PSR:	P-505-091-001
Customer:	City of Hobart	Clean Date:	01/13/2021	Shape:	C

Street:	West 4th Place	Flow Control:	Not Controlled
City:	Hobart, IN	Year Renewed:	
Location:	Local rural streets with light traffic, t	Tape/Media #:	
Purpose:	Routine Assessment	Dia/Height:	8"
Use:	Sanitary Sewage Pipe	Material:	VCP
Drain Area:		Lining:	Not Known
Category:	NA

Comment:		Direction of Survey:	Downstream
Location Details:			
US MH:	M-405-001	DS MH:	M-505-091
		Total Length Surveyed (ft):	234.9

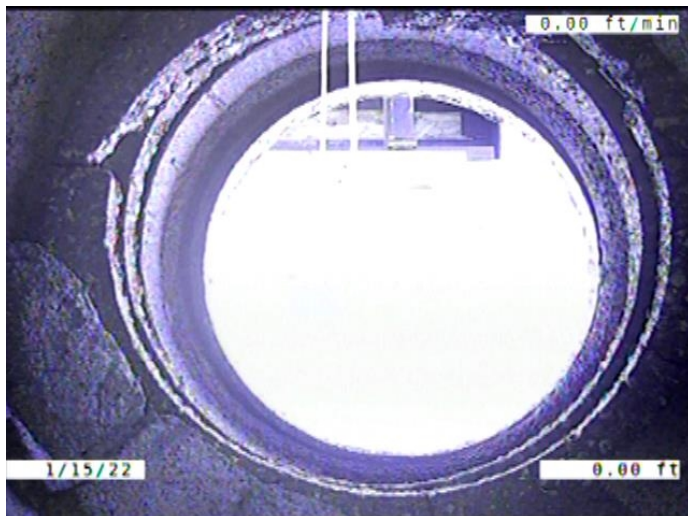
Code: **AMH**
 Description: **Manhole**

Distance (ft): **.0**
 Structural Grade: **0**
 O&M Grade: **0**
 Clock Start/From:
 Clock To:
 1st Value:
 2nd Value:
 Value Percent:
 Continuous Index:
 Within 8" of Joint: **NO**
 Remarks: **M-405-001**

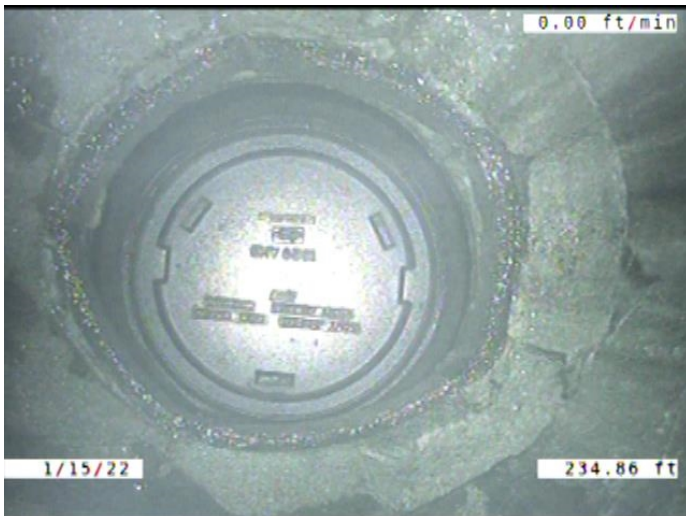
Code: **AMH**
 Description: **Manhole**

Distance (ft): **234.9**
 Structural Grade: **0**
 O&M Grade: **0**
 Clock Start/From:
 Clock To:
 1st Value:
 2nd Value:
 Value Percent:
 Continuous Index:
 Within 8" of Joint: **NO**
 Remarks: **M-505-091**
