## Profile/Photo Observation Report

Date:	<b>04/22/2018</b>	Weather:		Coding:	<b>PACP 6.0</b>
Pipe Length (ft):	<b>294.8</b>	Owner:	<b>NA</b>	Pre Clean:	<b>No Pre-Cleaning</b>
P.O.#:		Surveyor:	<b>Mark Ruby</b>	PSR:	<b>P-405-002.3-002.2</b>
Customer:		Clean Date:	<b>01/01/1900</b>	Shape:	<b>C</b>

Street:	<b>S WABASH ST</b>	Flow Control:	<b>Not Controlled</b>
City:	<b>Hobart, IN</b>	Year Renewed:	
Location:	<b>Light Highway</b>	Tape/Media #:	
Purpose:	<b>Routine Assessment</b>	Dia/Height:	<b>8"</b>
Use:	<b>Sanitary</b>	Material:	<b>PVC</b>
Drain Area:	<b>NA</b>	Lining:	
Category:	<b>NA</b>		
Comment:	<b>P_C at 241 ft CU/debris . Flow direction wrong</b>		
Location Details:		Direction of Survey:	<b>Downstream</b>
US MH:	<b>M-405-002.2</b>	DS MH:	<b>M-405-002.3</b>
		Total Length Surveyed (ft):	<b>242.9</b>

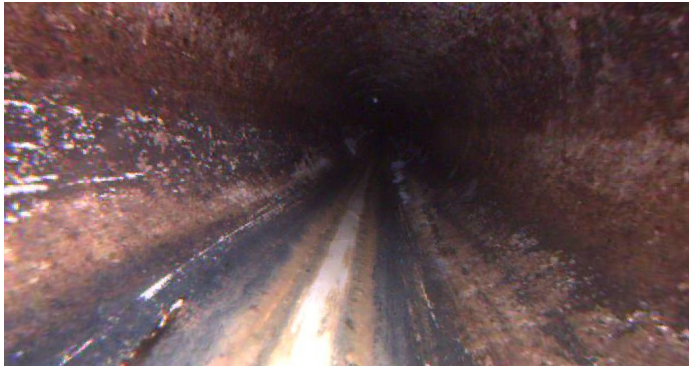
Code: **MWL**  
Description: **Water Level**

Distance (ft): **.0**  
Structural Grade: **0**  
O&M Grade: **0**  
Clock Start/From:  
Clock To:  
1st Value:  
2nd Value:  
Value Percent: **10.000**  
Continuous Index:  
Within 8" of Joint: **NO**  
Remarks:
