## Profile/Photo Observation Report

Date:	<b>04/14/2018</b>	Weather:		Coding:	<b>PACP 6.0</b>
Pipe Length (ft):	<b>289.9</b>	Owner:	<b>NA</b>	Pre Clean:	<b>No Pre-Cleaning</b>
P.O.#:		Surveyor:	<b>Jen Costello</b>	PSR:	<b>P-405-005-004</b>
Customer:		Clean Date:	<b>01/01/1900</b>	Shape:	<b>C</b>

Street:	<b>FOXCROFT STREET</b>	Flow Control:	<b>Not Controlled</b>
City:	<b>Hobart, IN</b>	Year Renewed:	
Location:	<b>Yard</b>	Tape/Media #:	
Purpose:	<b>Routine Assessment</b>	Dia/Height:	<b>10"</b>
Use:	<b>Sanitary</b>	Material:	<b>VCP</b>
Drain Area:	<b>NA</b>	Lining:	<b>Cured in Place</b>
Category:	<b>NA</b>		
Comment:	<b>Flow direction is marked wrong.</b>		
Location Details:		Direction of Survey:	<b>Upstream</b>
US MH:	<b>M-405-004</b>	DS MH:	<b>M-405-005</b>
		Total Length Surveyed (ft):	<b>174.6</b>

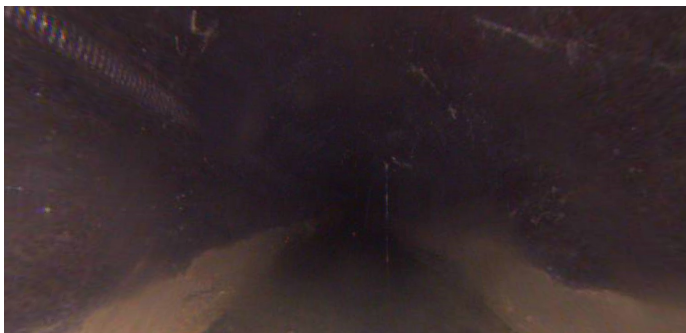
Code: **AMH**  
Description: **Manhole**

Distance (ft): **.0**  
Structural Grade: **0**  
O&M Grade: **0**  
Clock Start/From:  
Clock To:  
1st Value:  
2nd Value:  
Value Percent:  
Continuous Index:  
Within 8" of Joint: **NO**  
Remarks: **M-405-005**

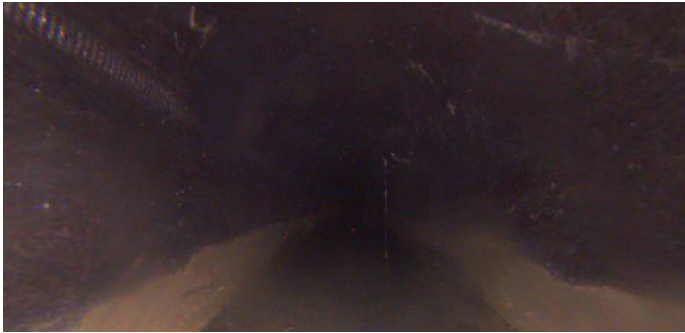
Code:	<b>MWL</b>
Description:	<b>Water Level</b>

Distance (ft):	<b>.0</b>
Structural Grade:	<b>0</b>
O&M Grade:	<b>0</b>
Clock Start/From:	
Clock To:	
1st Value:	
2nd Value:	
Value Percent:	<b>10.000</b>
Continuous Index:	
Within 8" of Joint:	<b>NO</b>
Remarks:
