## Profile/Photo Observation Report

Date:	<b>01/16/2022</b>	Weather:		Coding:	<b>PACP 7.0</b>
Pipe Length (ft):	<b>287.9</b>	Owner:	<b>City of Hobart</b>	Pre Clean:	<b>Heavy Cleaning</b>
P.O.#:	<b>YES502259</b>	Surveyor:	<b>S. Bucklin</b>	PSR:	<b>P-405-005-004</b>
Customer:	<b>City of Hobart</b>	Clean Date:	<b>01/13/2021</b>	Shape:	<b>C</b>

Location Details:		Direction of Survey:	<b>Upstream</b>
US MH:	<b>M-405-004</b>	DS MH:	<b>M-405-005</b>
		Total Length Surveyed (ft):	<b>287.9</b>

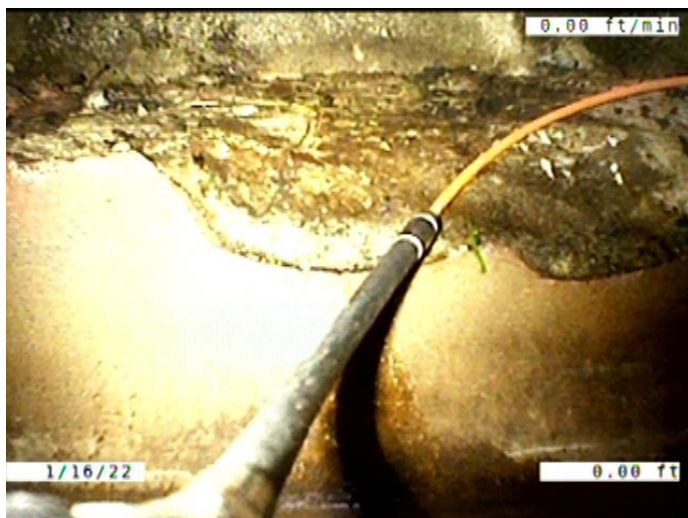
Code: **AMH**  
 Description: **Manhole**

Distance (ft): **.0**  
 Structural Grade: **0**  
 O&M Grade: **0**  
 Clock Start/From:  
 Clock To:  
 1st Value:  
 2nd Value:  
 Value Percent:  
 Continuous Index:  
 Within 8" of Joint: **NO**  
 Remarks: **M-405-005**

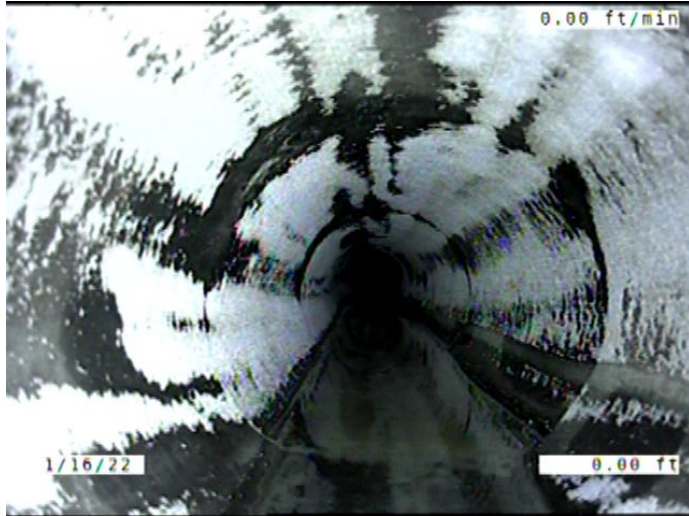
Code: **MWL**  
Description: **Miscellaneous Water Level**

Distance (ft): **.0**  
Structural Grade: **0**  
O&M Grade: **0**  
Clock Start/From:  
Clock To:  
1st Value:  
2nd Value:  
Value Percent: **10.000**  
Continuous Index:  
Within 8" of Joint: **NO**  
Remarks:

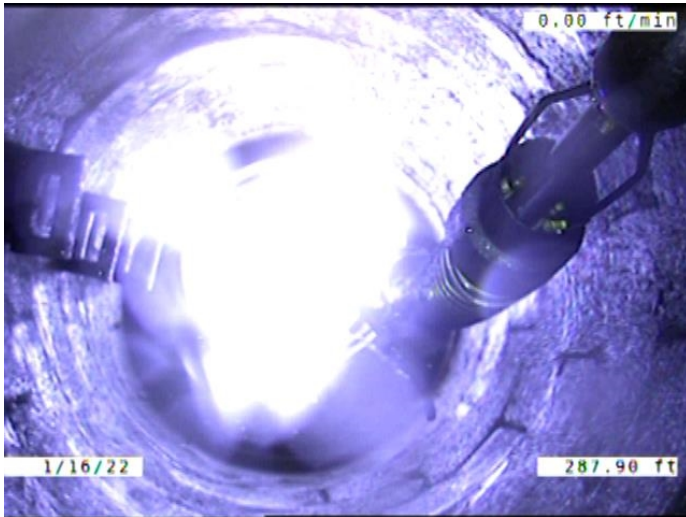
Code:	AMH
Description:	Manhole
Distance (ft):	287.9
Structural Grade:	0
O&M Grade:	0
Clock Start/From:	
Clock To:	
1st Value:	
2nd Value:	
Value Percent:	
Continuous Index:	
Within 8" of Joint:	NO
Remarks:	M-405-004
